PATIKARI POWER PVT LTD

2 X 8 MW

Annual O&M Report

FY 2011-12

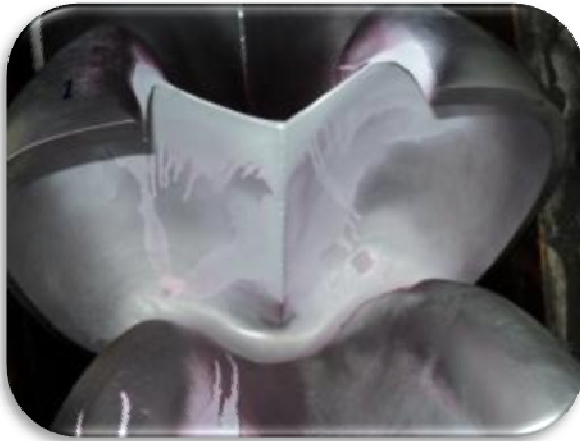
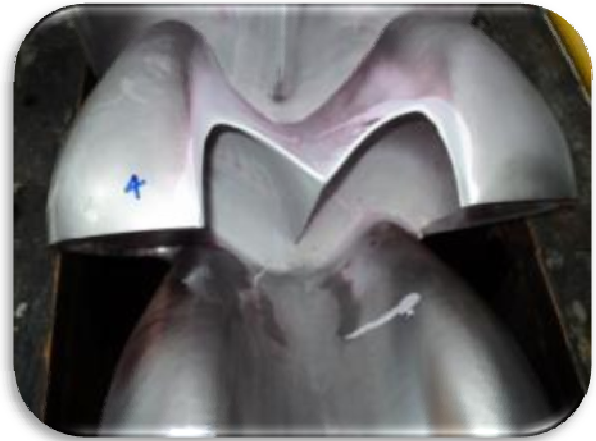
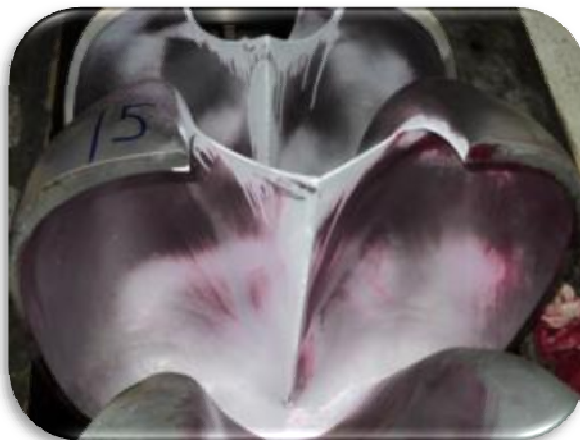
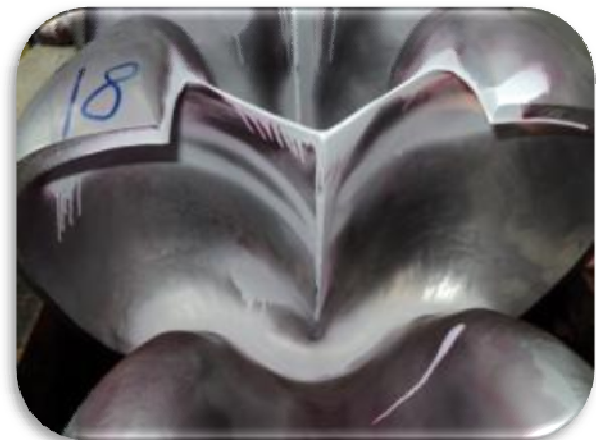
No traces of appreciable erosion damages were found and as such no major overhauling works were required to be undertaken on the runners.

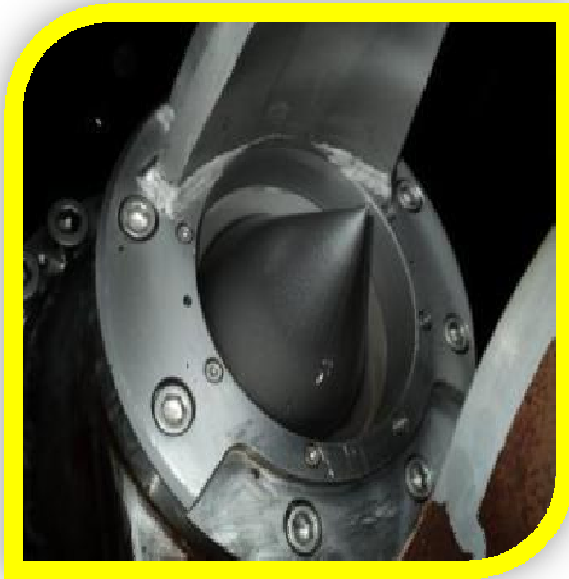
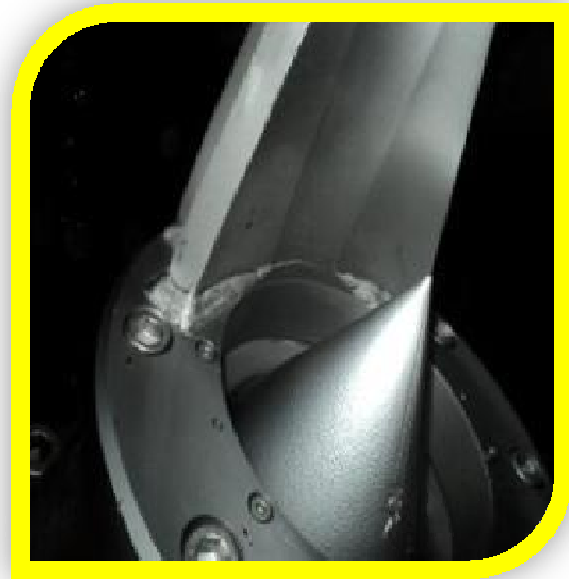
- ✓ Major dents & erosion were found on Unit-I Nozzle
- ✓ One dent in Unit-II nozzle due to striking of foreign material

The nozzles of unit-I were replaced with the available spare ones. The damaged nozzles need touch-up works to be done. Nozzles of Unit-II, as such, didn't require any major maintenance/overhauling work.

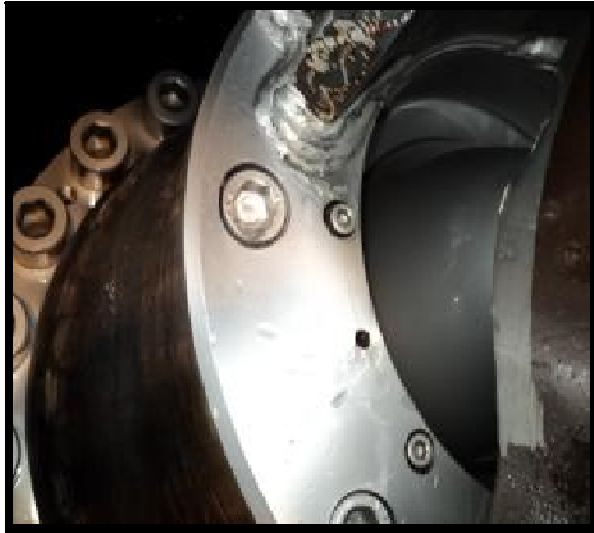
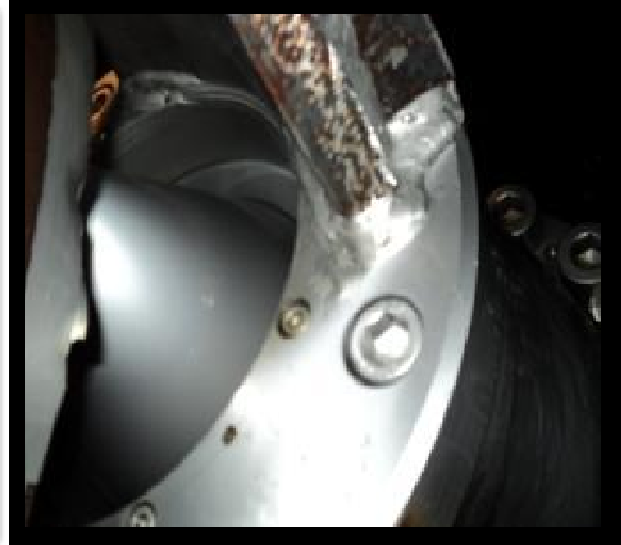
Unit-I:

Flanges with Buckler of Unit-I had got damaged. The same had been replaced with the spare one.

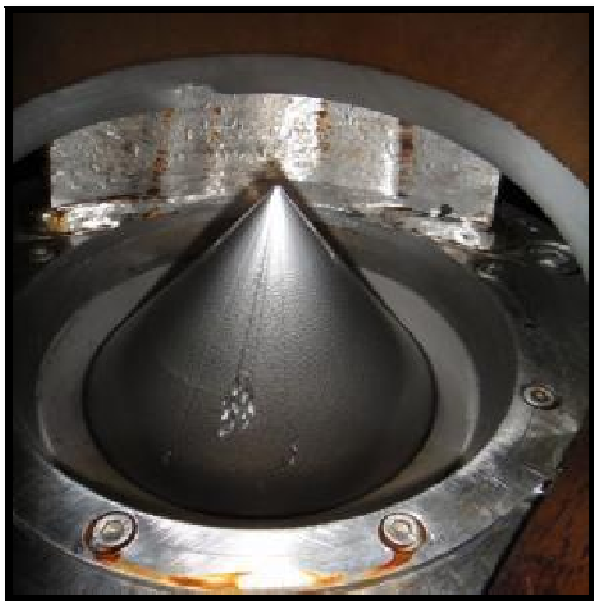
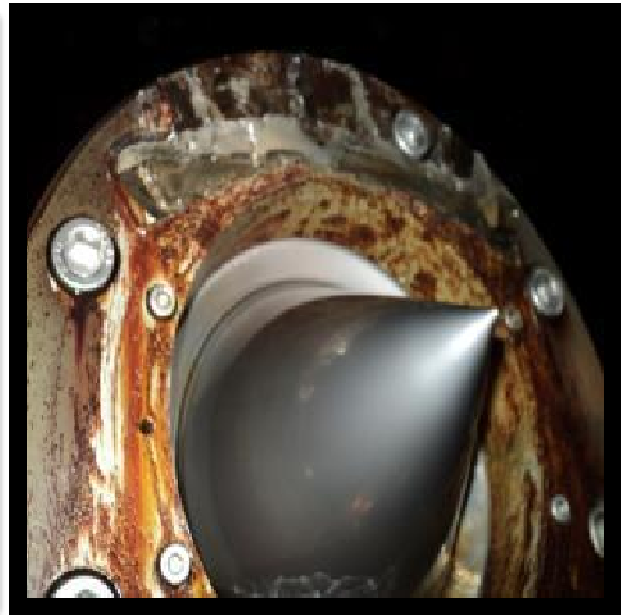
Unit-II:

Unit-II had been operated with buckler. Flanges of Unit-II got rusted.

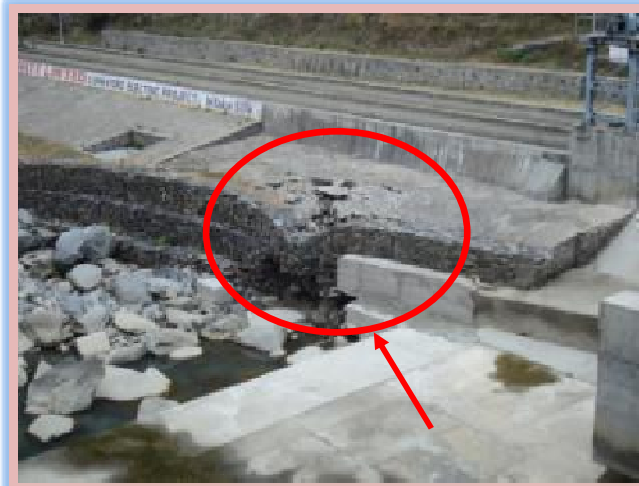
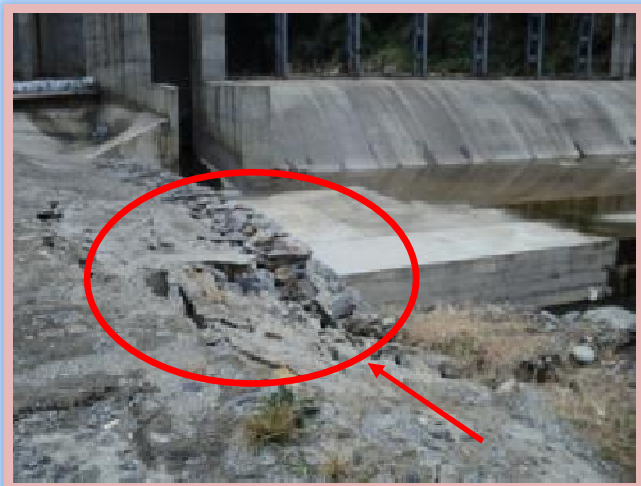
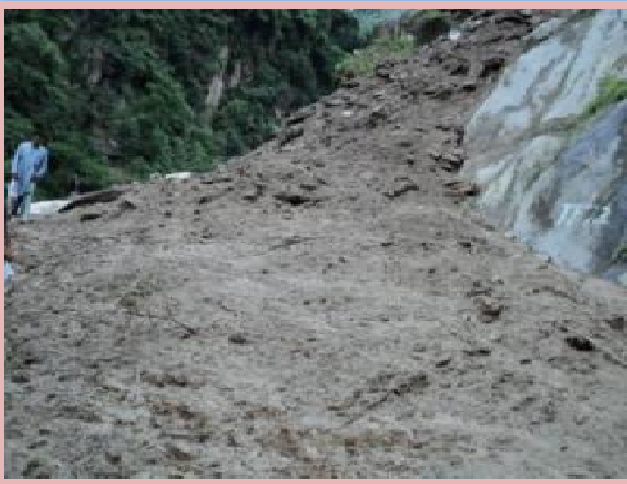
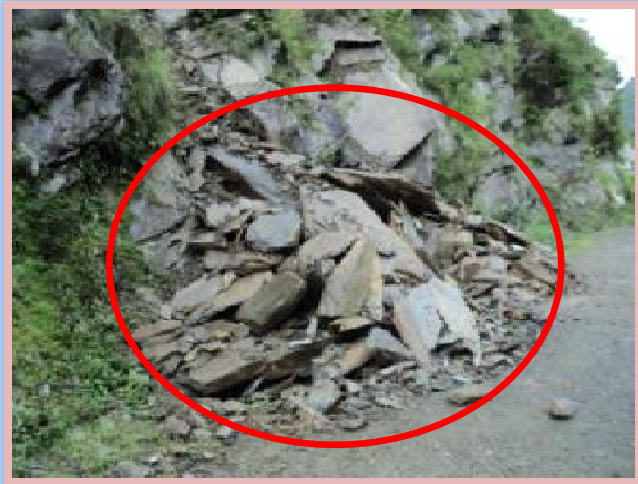
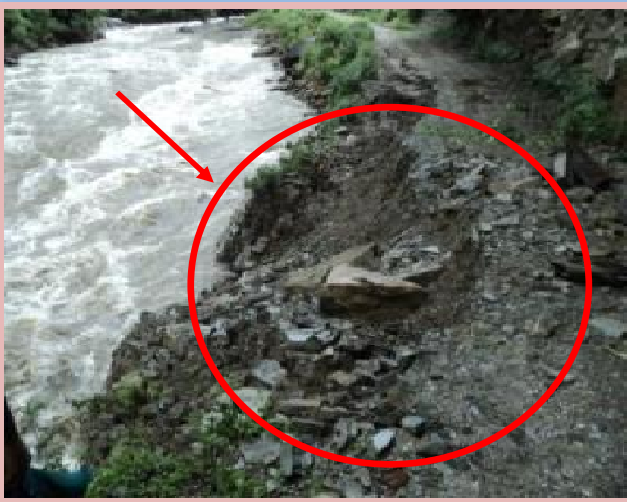
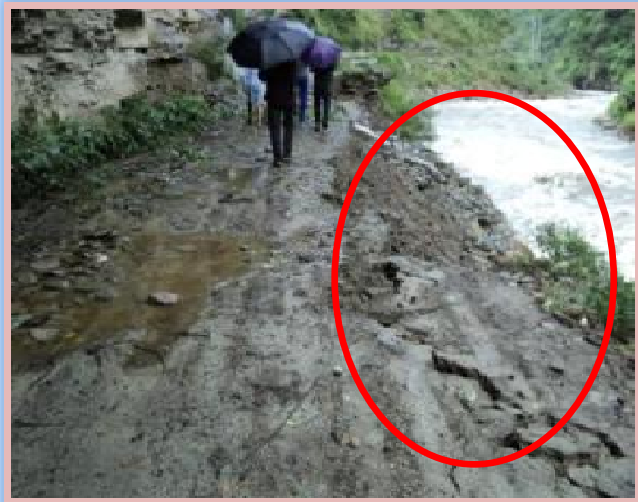
- Approach road from Kuklah Village to Power House got damaged from various places
- Wire crates for road protection got damaged at some places
- Land Slides on Approach roads to Power House & Weir site
- Approach road to weir site got damaged at several places
- Wire crates beside Desanders on the downstream of the weir got damaged at various places

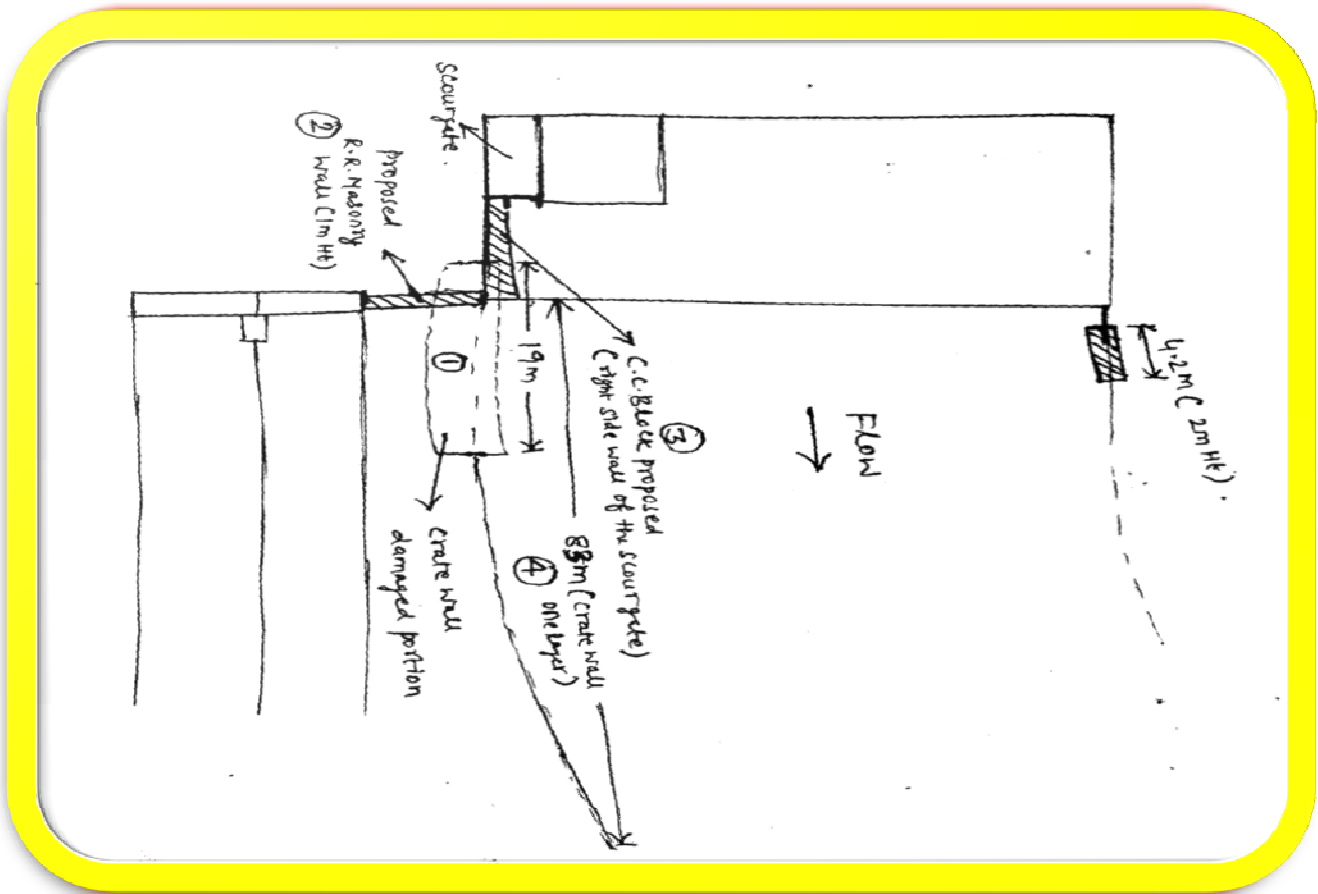
- “About 19m long stretch of the crate wall on the downstream right side near to the surplus escape structure has been damaged. This repair work needs to be urgently completed otherwise subsequent floods can damage the de sander foundations.”

- “Raising of the right side crate wall by 1 m to prevent the flood water spilling over to the terrace on the left side of the de-sander. During the last flood season, the flood water has over topped this crate wall and flooded the terrace on left side of de- sander.”
- “Repair of about 5 m portion of the crate wall on the left side.”

The Civil Design wing thereafter provided a sketch showing details of the above mentioned repair works. The sketch is given below.

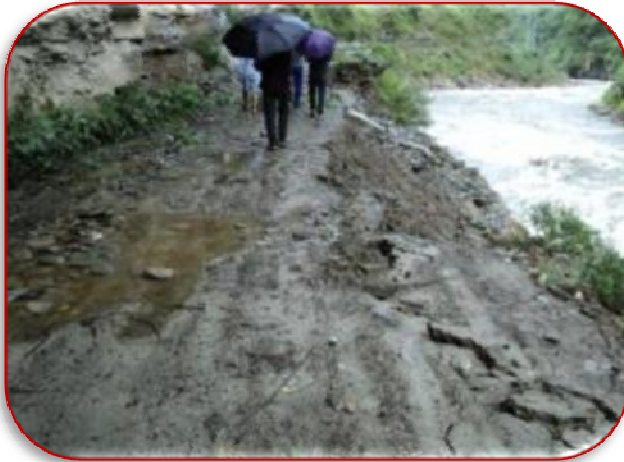
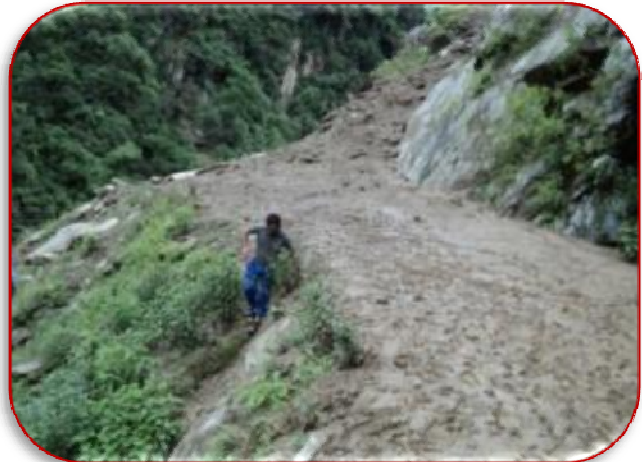
- “For the 5 Km long project road the following repair works are required to be done:
 - At five places, slope failures have occurred on the river side. The slopes need to be protected by building R.R. Masonry wall.
 - At two places slope failure of the hill of the right side bank have taken place. Materials lying on the road to be removed and the slope to be protected.
 - Blasting and removal of big sized boulders lying on the road at two places.
 - Repair of Cross Drainage works at two places.
 - Removing the cracked portion and laying new concrete on the transmission tower no.33.”

- “Widening of the river using splitter upstream of the power house.”
- “Packing boulders on left bank of Bakhli Khad river deploying excavator.”
- “Water proofing of the roof of the control block.”
- “Slope protection works behind the proposed location of staff building. Already a portion of the slope has fallen down.”

Due to the funds constraints, above mentioned works have been put on hold. However, the above said works shall be completed before the onset of next monsoons.

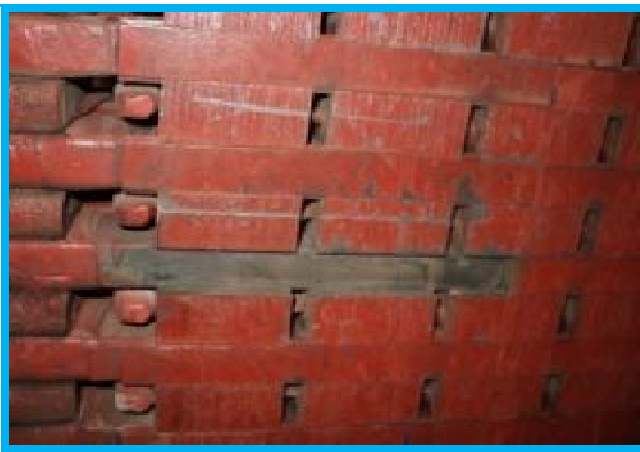
On further examination after dismantling of Generator it was observed that number of Stator Core wedges were missing or broken. There was damage to winding coils inside core slots. Three end slots of the stator core adjacent to the damaged winding were badly blackened and pitted.

Photograph 1: Missing End Wedge

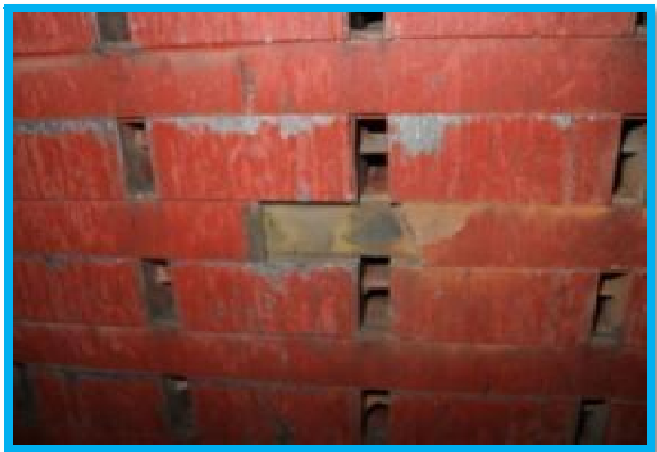
Photograph 2: Broken Wedge

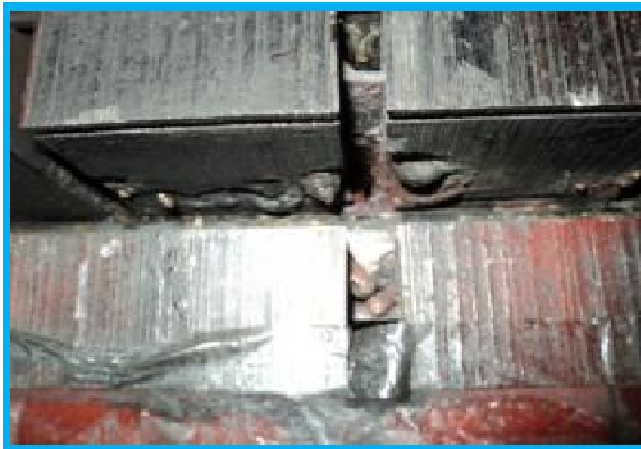
Photograph 3: Core Damage (Upper side)

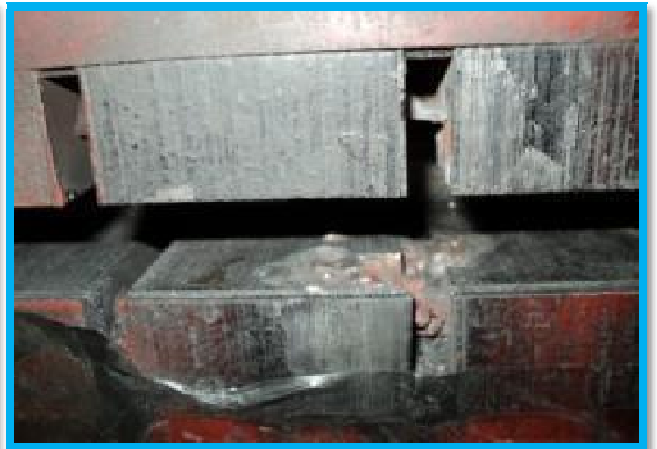
Photograph 4: Core Damage (Lower side)

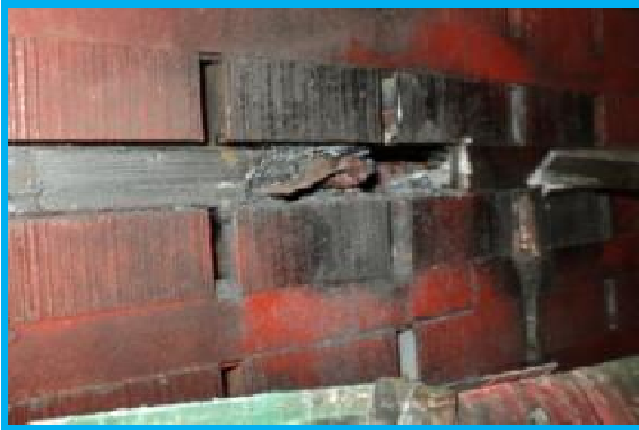
Photograph 5: Pitted Stator Core Segment

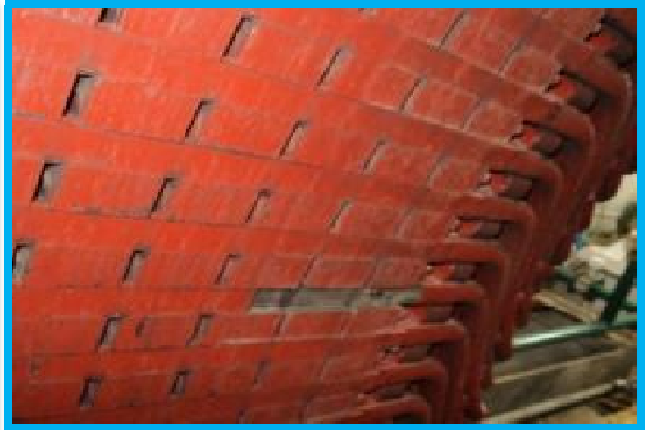
Photograph 6: Missing End Wedge

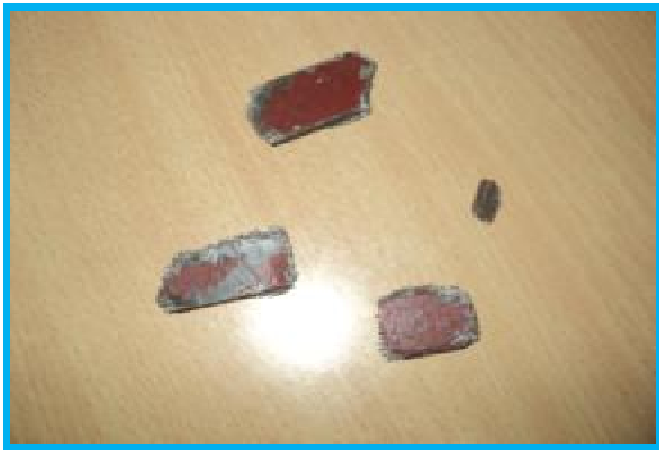
Photograph 7: Broken wedge pieces

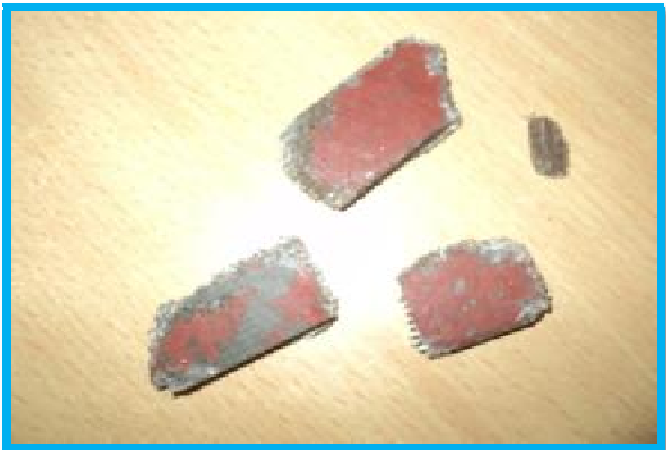
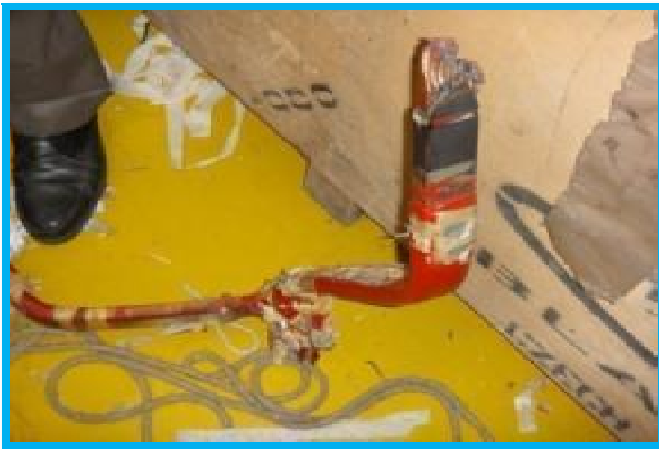
Photograph 8: Damaged Coil

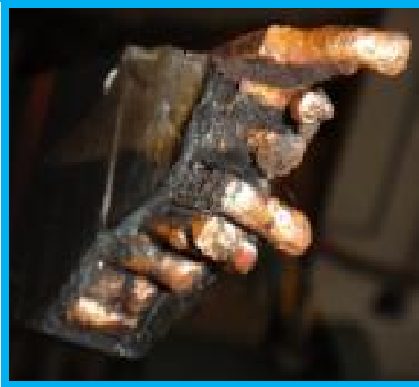
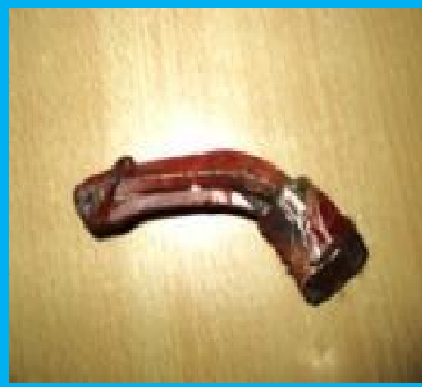
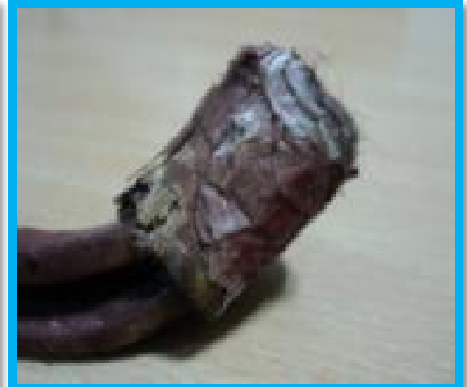
Photograph 9: Burnt Coil

M/s Fitwell team worked very hard round the clock to restore the damaged Generator within the minimum possible time. The damaged coils of the stator were replaced with the available spare ones.

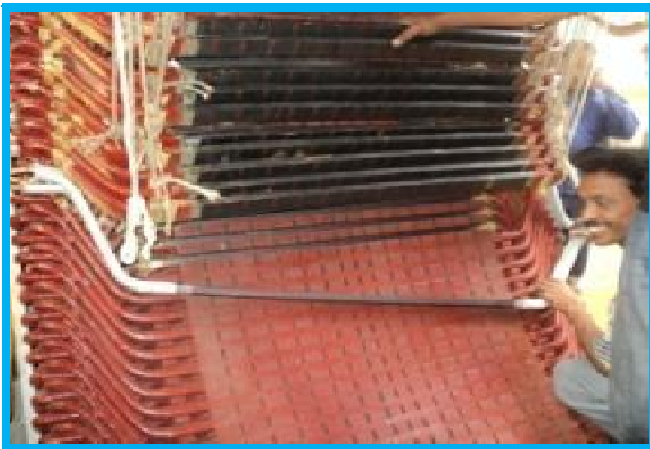
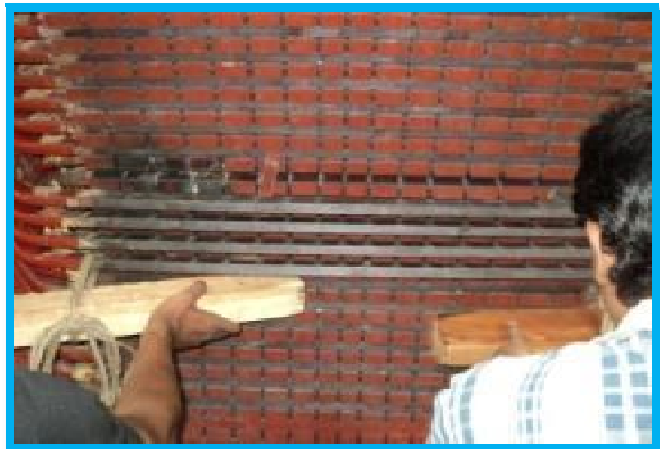
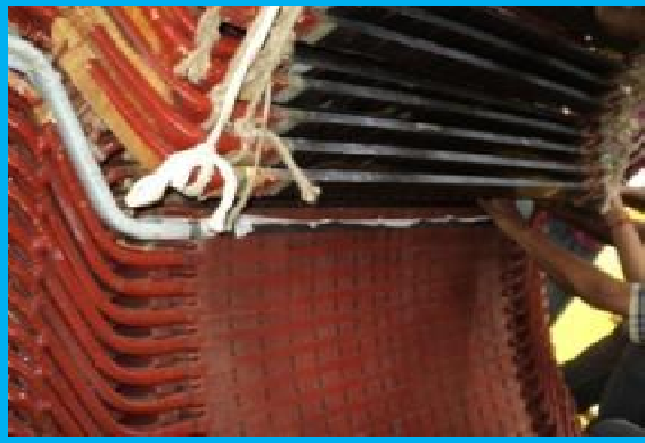
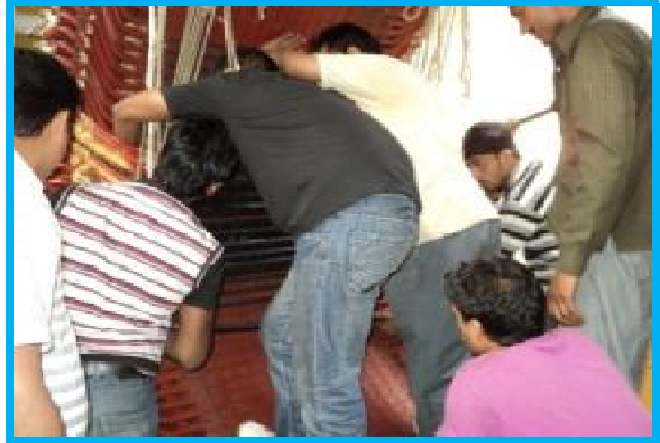
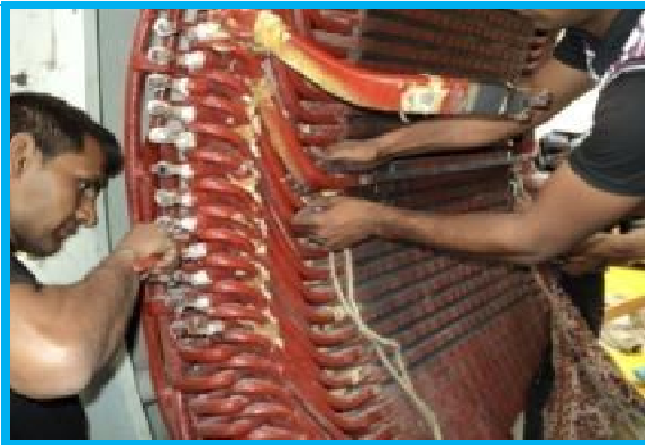
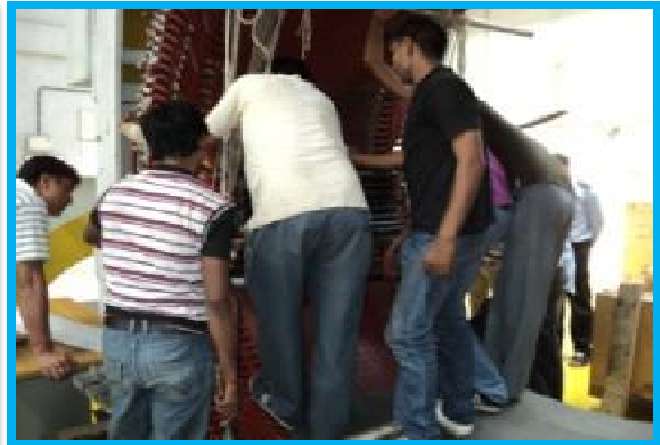
However, the coils which had to be partially lifted (being two layered winding) to replace the damaged coils, failed during high voltage test as the insulation on these coils was found to be hardened.

Photograph 10: Initial Repair works by M/s Fitwell

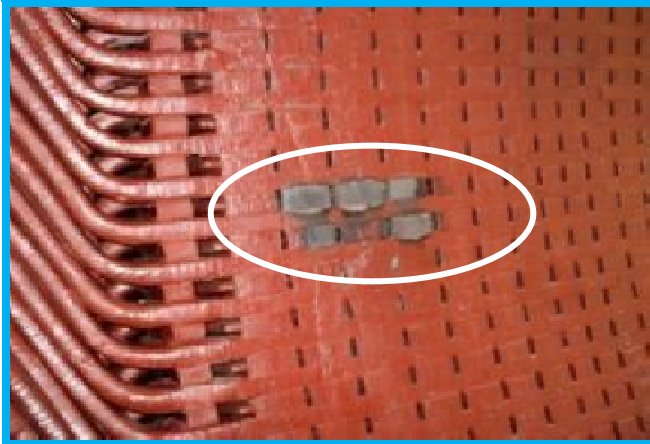
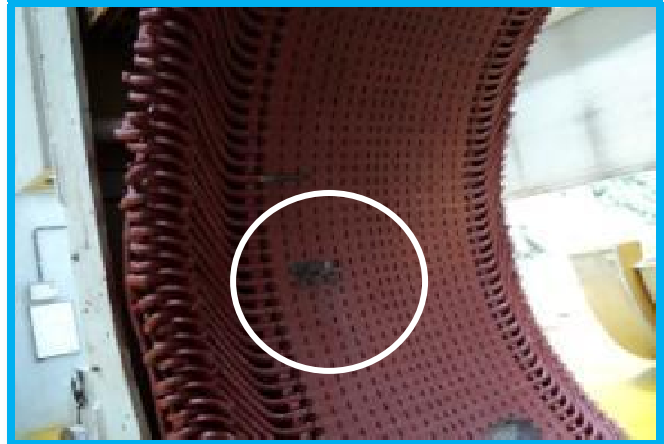
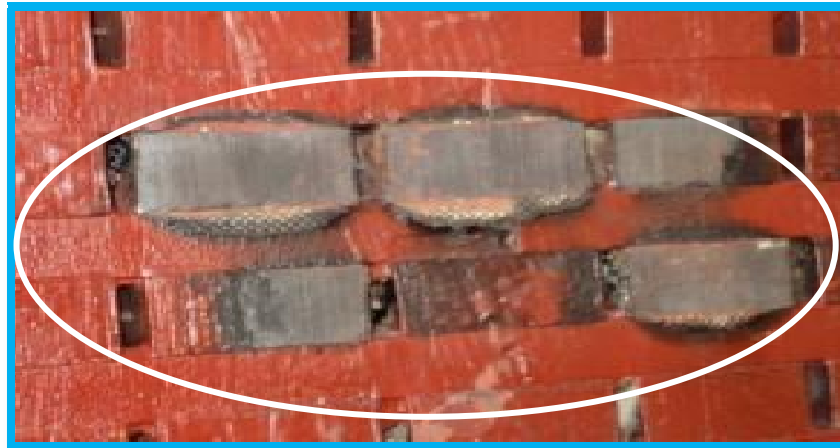
Photograph 11: Damages after dismantling the machine

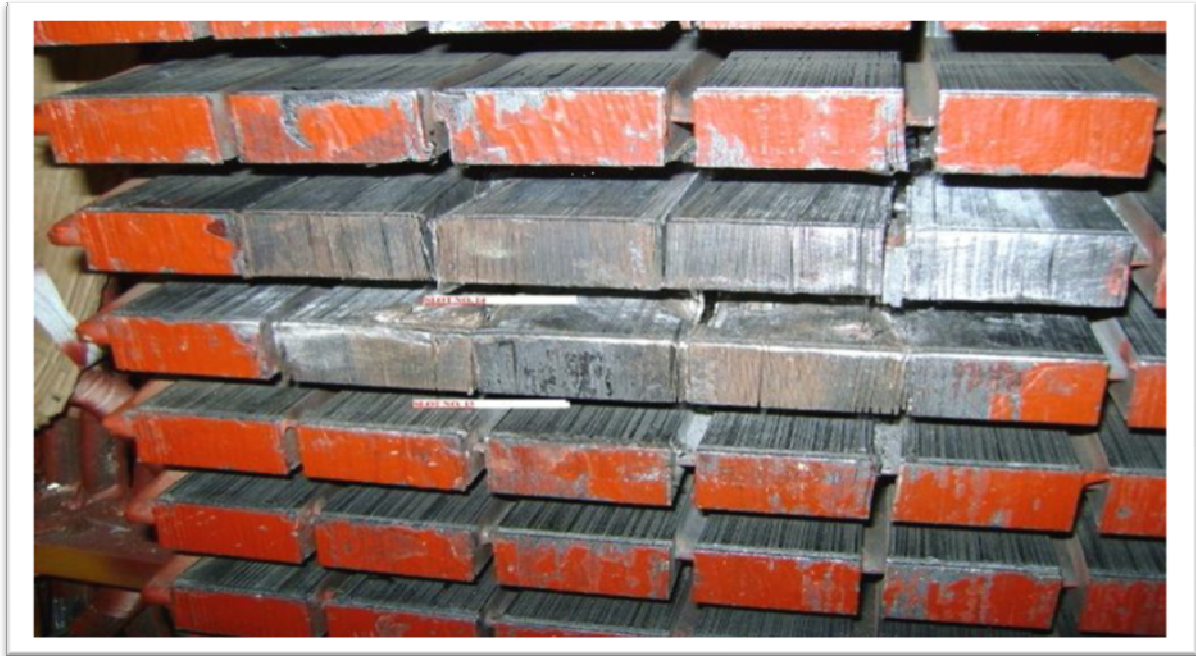
Photograph 14: Core Faults seen in Slot no. 14

In view of the repeated attempts to locally repair the damaged core spots not yielding the desired results, it was concluded that disassembling of core laminations and re-staggering after site rectifications of punchings is the only alternative left for safe and fastest restoration of the Generator under shutdown. Hence the service order had been placed on M/s GENMOT Coils, Bangalore for the stator core repair. The stator core repair works were carried out before taking up the rewinding of the Stator.

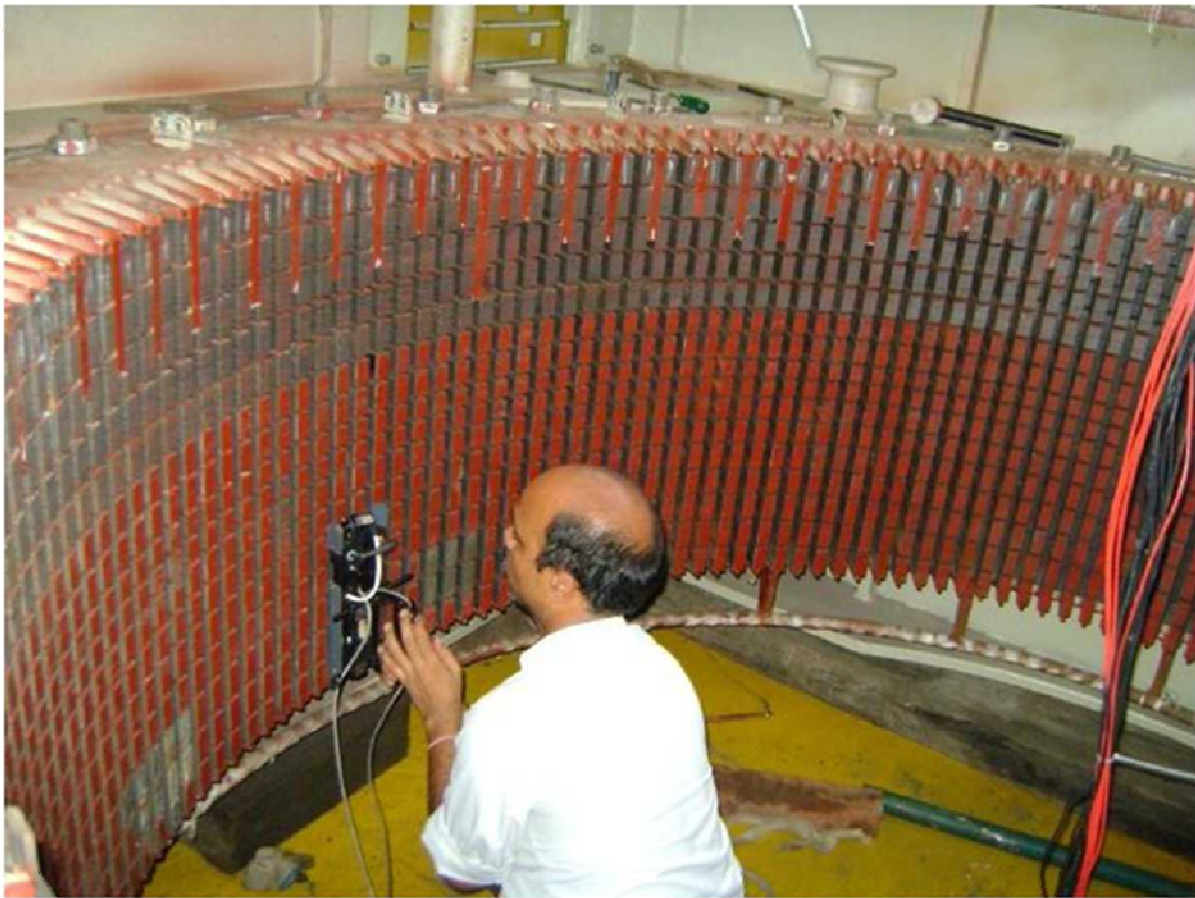
I. ELCID test performed after partial restacking of core

After the core repair works, ELCID test had been conducted again to ascertain the healthiness of the core. The ELCID test after repair indicated that major core laminations shorting which was in slot no. 14 was successfully removed. However, locations where ELCID currents were above threshold limit of 100

mAs, are required to be monitored for any abnormal temperature rise in these locations. For this, placing of RTD sensors in these locations was recommended which has been implemented. The ELCID Test report after core repair is enclosed as **Appendix-2**.
