**2 X 8 MW Patikari Hydro Power Project  
Annual Plant Performance Report  
For the year 2017-2018**

2 X 8 MW Patikari Hydroelectric Project, Himachal Pradesh  
Annual Report

### **3. Site Visit:**

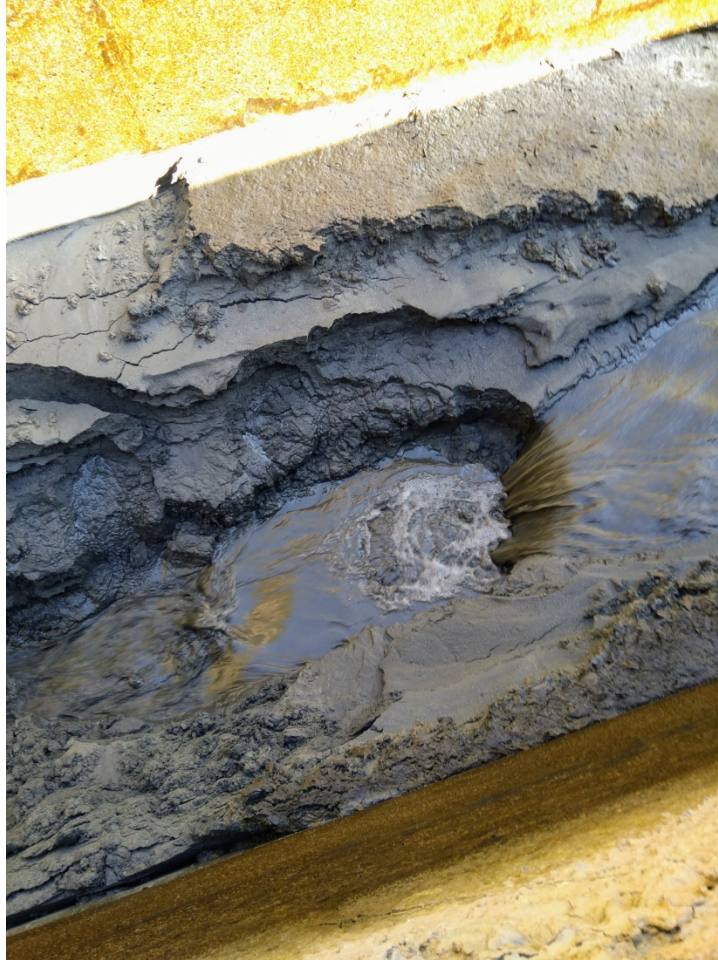
**Silt Deposition in Desilting Chamber**

size of particles from the water entering the head race tunnel. The suspended silt load deposited at the bottom of the de-silting chambers is trapped and flushed out at 3 locations along the length of the chambers. During the site visit, only one chamber was under operation while the other chamber was closed. A lot of silt was seen to have deposited in the chamber which was not in operation.

During visit to the site, one such drawdown flushing operation was actually carried out in one chamber and it was seen that the deposited materials could be easily flushed out.

To prevent choking of the silt flushing system, the project authorities were advised to resort to drawdown flushing of the deposited materials in the chamber. This drawdown flushing by lowering the water level in the de-silting chamber should be carried out in one chamber at a time. For carrying out the flushing operation, the d/s gate of the chamber and silt flushing conduit/pipe gates should be closed and about 0.3 cumec discharge shall be released from the inlet gate.

After the water level in the chamber rises slightly above the deposited sediments/silt, one silt flushing conduit gate should be opened and flushing of sediments continued for some time. This process should be repeated by opening the other silt flushing gates also (but only one gate at a time).

After completing one cycle for each of the silt flushing gates, the exercise should be repeated 3 to 4 times. The project authorities were advised to first clean the 1<sup>st</sup> silt flushing pipe, which as reported by them has been choked, by a jet of water.

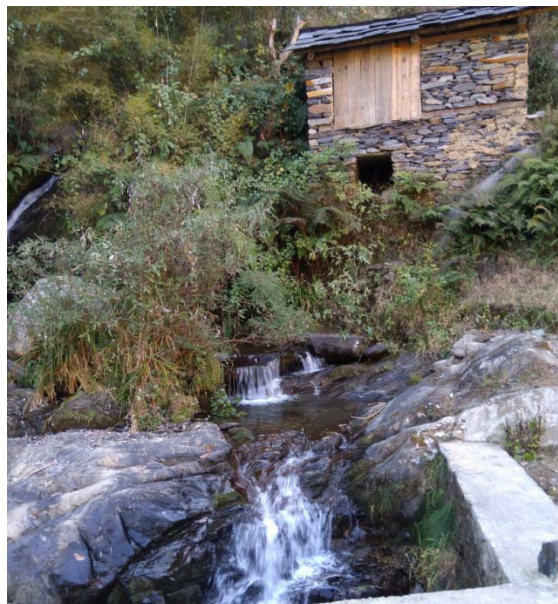
**WATER MILL**

As reported Moreover, at the proposed diversion site of both the nalas, water mills have already been constructed by the locals and it may be difficult to now tap this low lean period discharges from the proposed sites. In addition, construction/laying of surface steel pipe from the diversion works up to the Patikari water conductor system particularly at

Any rolling boulders from above will damage the pipe laid on the left bank from the Bakora Nala weir site up to the water conductor system of the project. In view of above, it may not be advisable from techno-economic considerations to tap these nallas at the proposed locations for augmentation of project discharge during lean months. by the project authorities, the lean period discharge in the river is observed to be less than the corresponding 90% dependable year figures.

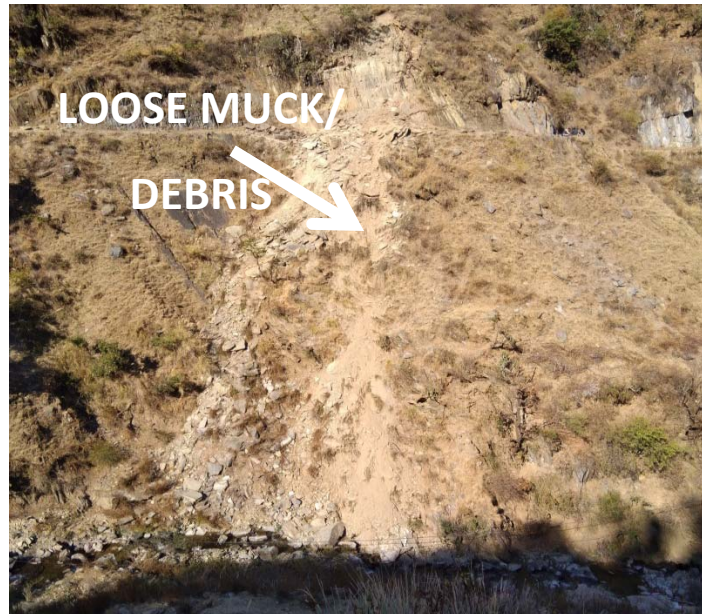
**Left Bank Hill Slope at Bakora Nala**

Bakora Nala will be very difficult. The left bank hill slopes of the Bakora Nala along which the formation cut of earlier proposed road had already been cut is covered with loose muck/debris.

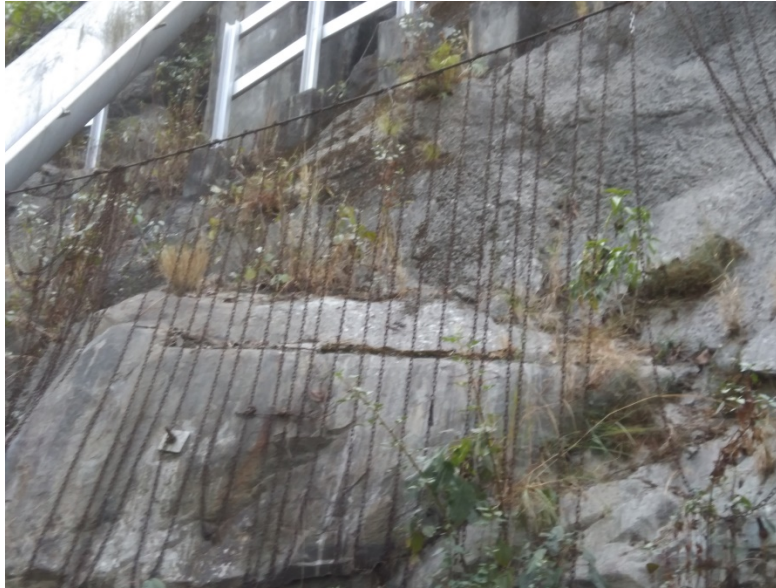
**Steel Chains provided u/s of Power House**

The Power House civil structures seem to be generally in order. To prevent rolling boulders from the upstream hill side hitting and damaging the power house upstream wall, steel chains have been provided just upstream of the power house. During inspection, it was seen that these steel chains are simply hanging from the top cable and are free at the bottom. The project authorities were advised to provide a cable through a bottom of these chains so that they prevent the falling boulders hitting the upstream wall of power house.

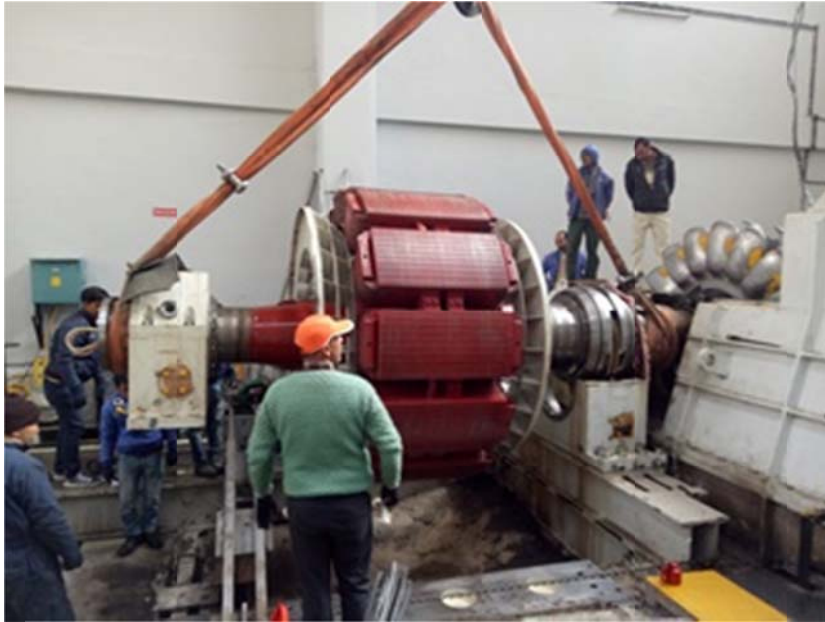
### Runner Replacement

The runner chamber for unit#2 was opened and runner was inspected for any deterioration in surface thickness or hard coating erosion. However, after thorough inspection, the runner was found to be in order. Small patches of hard coating erosion at some locations were found; however, they were not significant.

Further, since the available spare runner, was repaired to rectify the crack at the root of the bucket, it was recommended to replace the Unit #2 runner with the spare (repaired) runner prior to high flow season and monitor the repaired crack during operation.

As a follow up measure, the Unit#2 runner was replaced with spare runner on 17<sup>th</sup> January 2018. DPT Tests were performed on February 2018 to check development of cracks on the joints. However, found in appropriate condition.

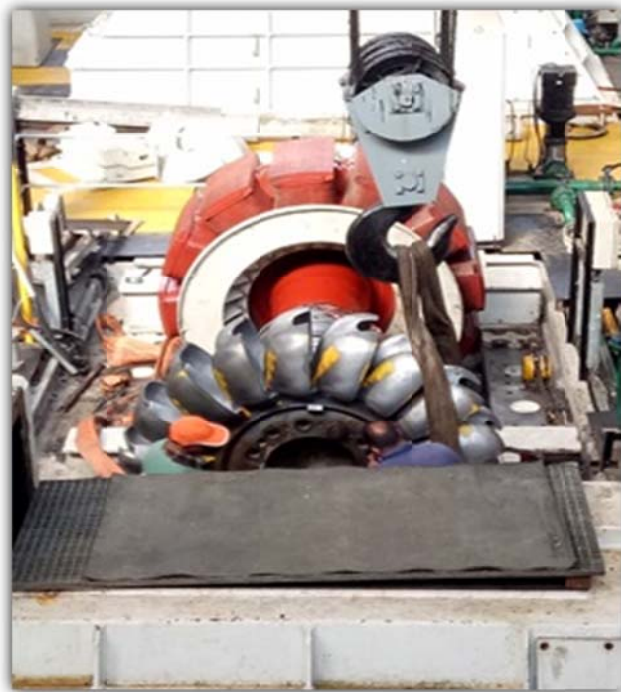
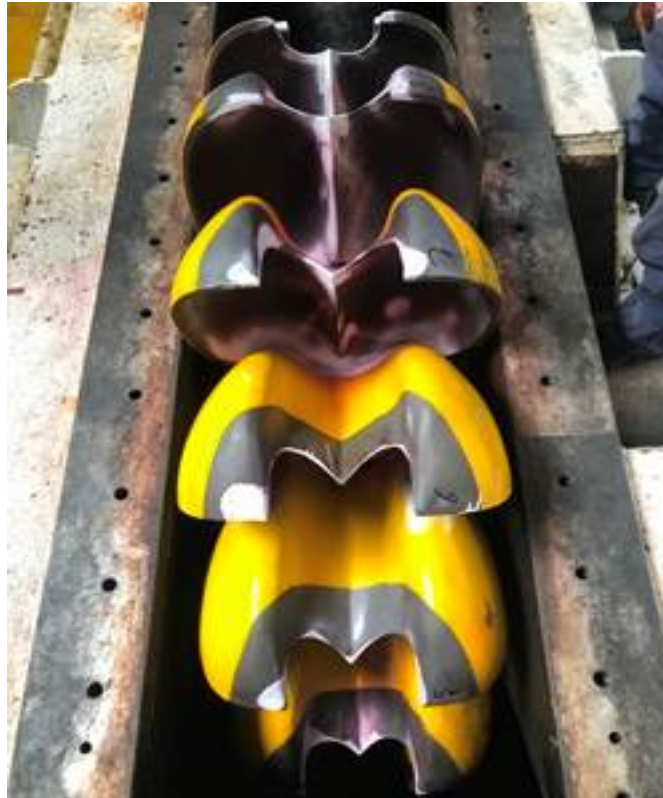
### ***Dye Penetration Test***

The Dye Penetration Test for the runner was performed on 15<sup>th</sup> February 2018 and checked that the buckets were in the appropriate condition. AEMPL team confirms that there is no need for further hard coating of any of the three runners for 2018-19.

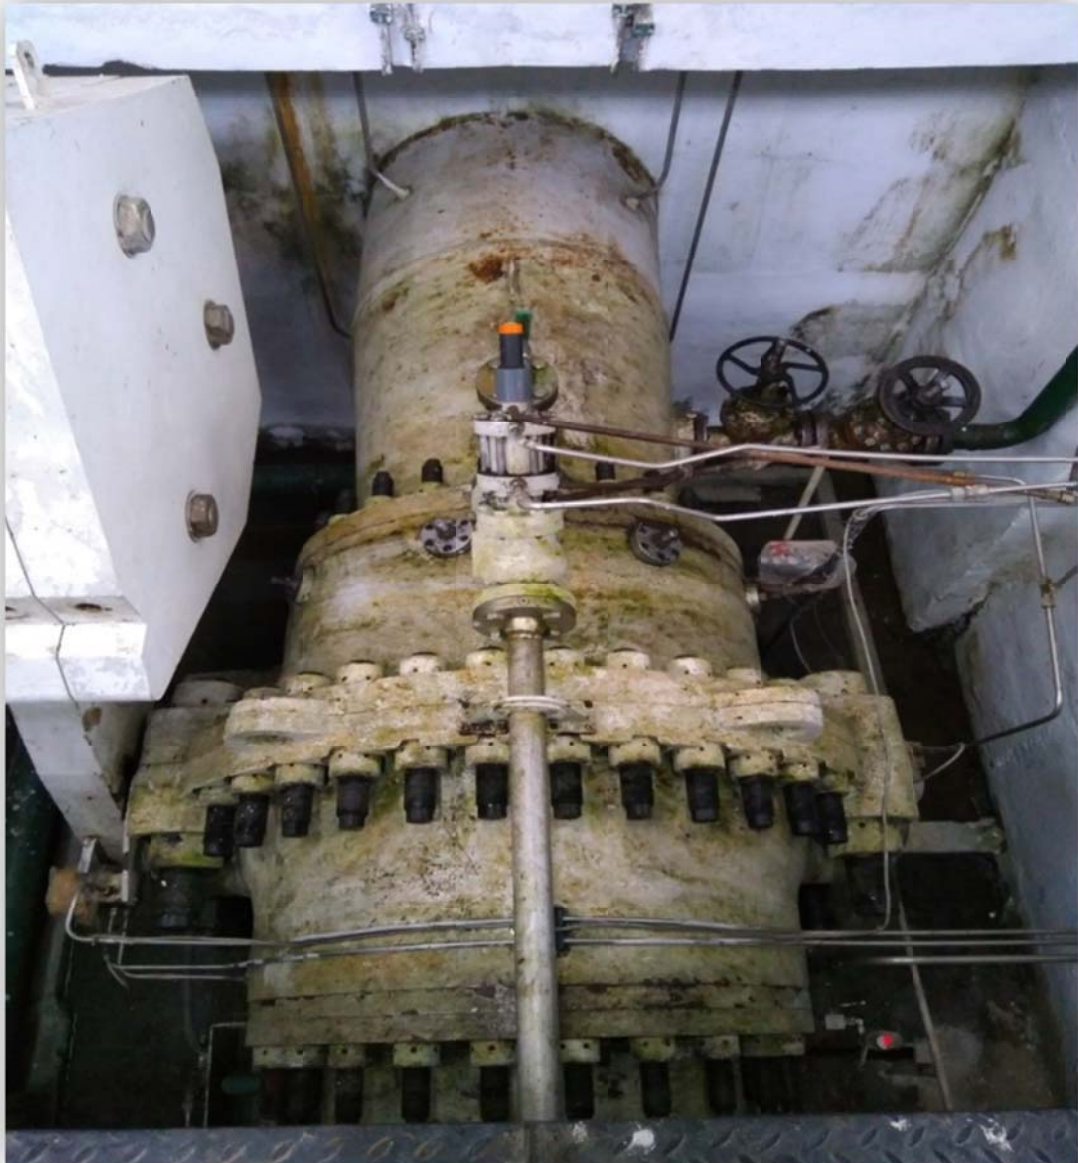
**Rusting on Penstock/MIV during Site Visit**

The penstock was inspected for any erosion in surface painting. It was found that the external penstock (outside the power house building) painting was intact. However, inside the Power House, the painting has started to peel off and rusting has begun at some places. A suitable Anti Rust painting was recommended to be applied over penstock inside powerhouse which has been procured and applied over the penstock.

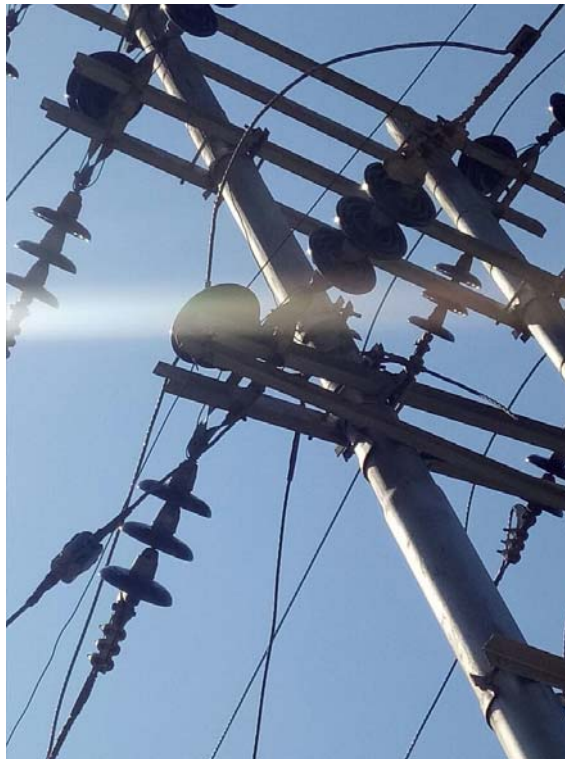
The 33kV transmission line b/w. Patikari SHP and Pandoh sub-station of HPSEB is being maintained by Patikari SHP. However, there were incidences of line tripping (due to Phase to Earth fault) once the single circuit line carrying capacity increased beyond 12 MW. The issue was discussed at site and it was observed that the Earth wire conductor has been installed below the current carrying AAAC conductor.

In case of single circuit carrying more than 12 MW power, the sag in the main AAAC conduct, in the longer spans, increases which reduces Phase to earth clearance between AAAC conductor and the Earth wire, resulting in Phase to Earth Fault.

It was decided to increase the separation between Phase and Earth wire conductors in longer spans. The same was performed on 31th March 2018. The line is working in order since then. . We will review the situation during high flow period and conclude the suitability of this provision.

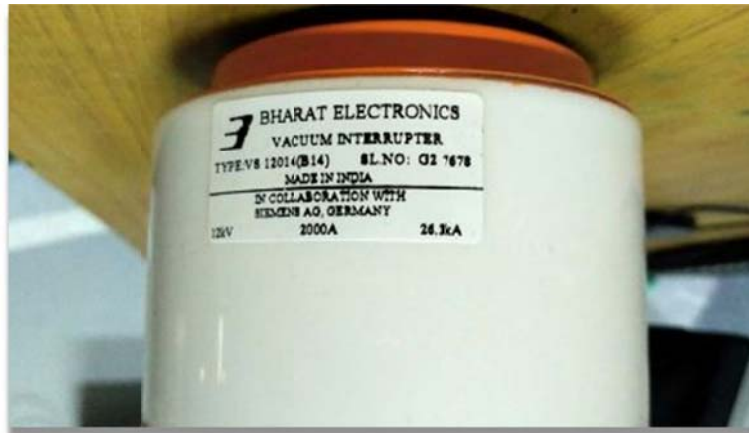
**Bharat Electronics VCB**

Patikari Power has raised an issue about procurement of new 11kV and 33kV VCB to be retrofitted into the existing breaker panel. The issue has been reviewed and it was found that only breaker poles need replacement.

AEMPL has arranged offers for the Vacuum Interrupters for the 11kV and 33kV circuit breakers from the Originals Equipment suppliers as well other traders. Spare poles were procured and replaced by PPPL.
