PATIKARI POWER PVT LTD 2X8000KW Mandi District, Himachal Pradesh

Annual O&M Report FY 2010-11

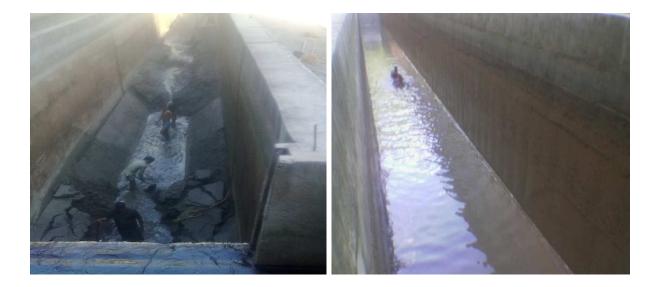
To avoid the choking of Desanding channel during monsoon months, regular cleaning of the Trash Racks and De-sanders, as depicted in following photograph, is being carried out during monsoon months.

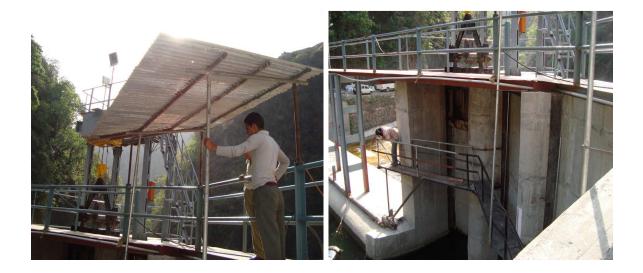
During monsoon season, it was becoming difficult for the deployed labour force to stand in rain and continuously keep clearing the wooden trash and debris collecting upstream of the Trash Racks at the beginning of the De-sanders. To overcome this problem, a CGI sheets covering arrangement has been provided over the trash rack bridge.

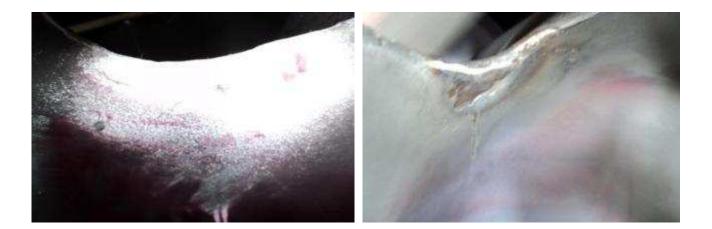
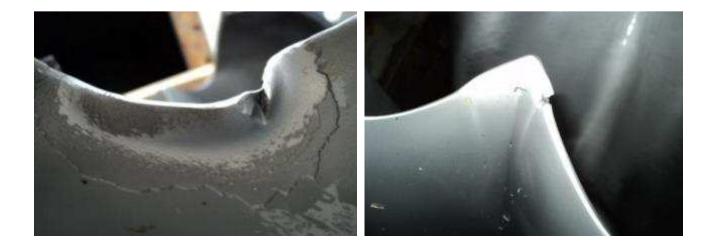
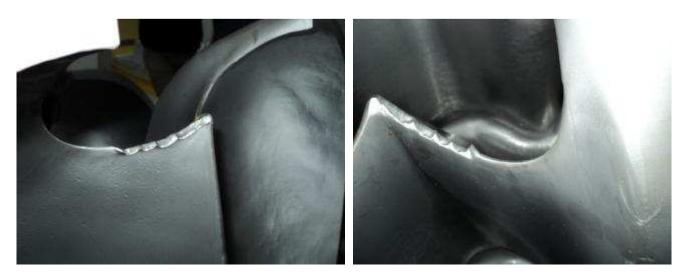
<u>Unit-I:</u>

Runners of both the units have been inspected after the monsoon months. The unit wise photographs of Runner Buckets as taken during these inspections are shown below.

- Unit-I :
 - ✓ Traces of erosion at the edges were found
 - ✓ One bucket was damaged probably due to striking of the broken parts of flange with buckler
- Unit-II:
 - ✓ Dents on a few buckets were found due to striking of foreign materials
 - ✓ One bucket was damaged due to striking of the broken parts of flange with buckler

No major overhauling works were required to be done on runners. Above said damages can be rectified by welding/grinding/touch up works. Accordingly minor touch up works such as welding, grinding was carried out on the runners. The photographs showing such touch up works under progress are given below.

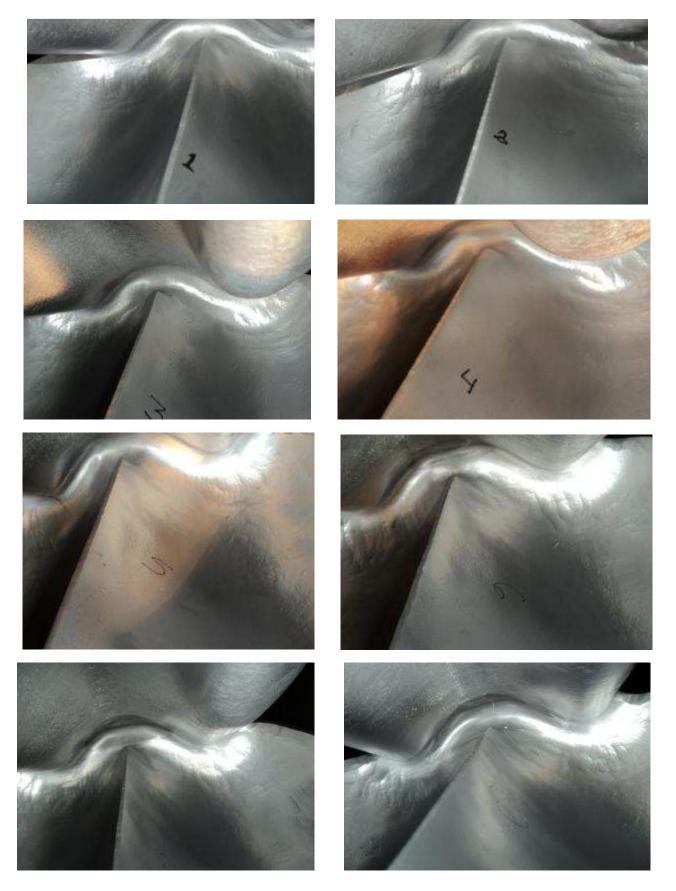
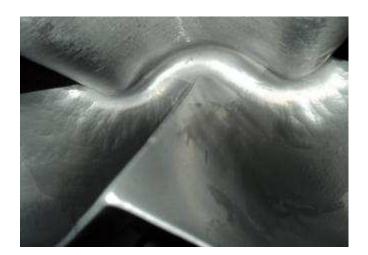
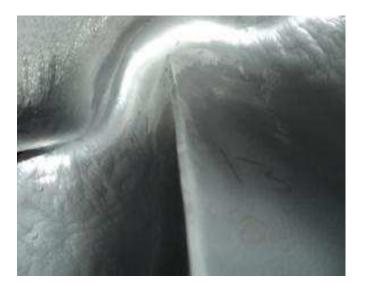
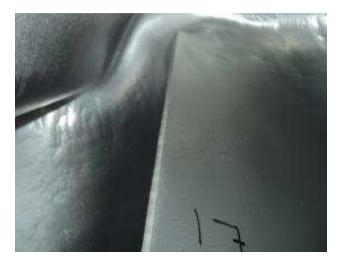
<u>Unit-I:</u>

Photographs after Touch up works:

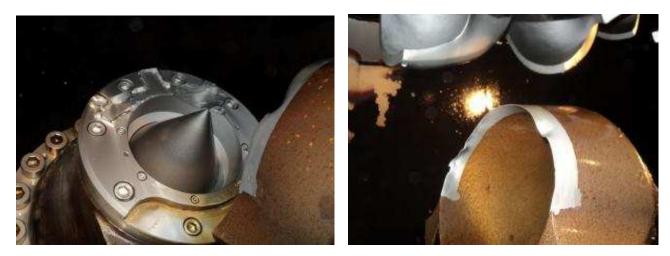
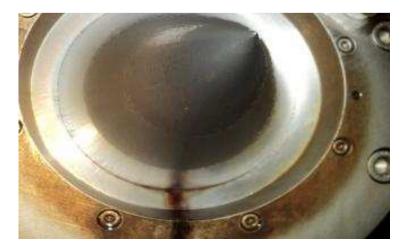
<u>Unit-I:</u>

- ✓ One dent in Unit-II nozzle due to striking of foreign material which might have come from Penstock earlier
- ✓ No other dents/damages were found

The nozzles, as such, didn't require any major maintenance/overhauling work.

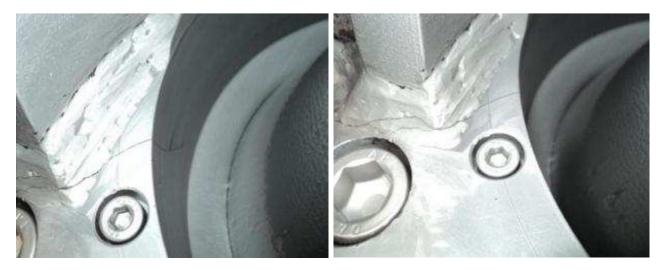
<u>Unit-I:</u>

As the Flanges with Buckler of both units had been getting damaged, the same were inspected from time to time during the year. The unit wise photographs of such damaged Flanges are shown below.

Flanges with Buckler of both units had got damaged. Two (2) no. of Flange with Bucklers were got modified locally through M/s New Namhari Auto engineers. Modified Flange with Bucklers has now been replaced. Performances of these modified Flanges with Buckler are under observation now & decision would be taken accordingly after next post monsoon inspections. Meanwhile to cater for any exigencies, additional four Flanges with Buckler will be got fabricated and kept in stock. The photographs of the Modified Flange with Bucklers are shown below.

Flanges with Buckler have been getting damaged off and on during operation of the Turbines. Different modified versions of Flanges with Buckler have been tried but problem is still not completely solved. Two (2) no. of damaged Flanges with Buckler have been got repaired with some modifications. Their performance will be monitored during coming monsoon rains. In the meantime, change in design of the Flange with Buckler in consultation with the OEM and other manufacturers is also being explored.

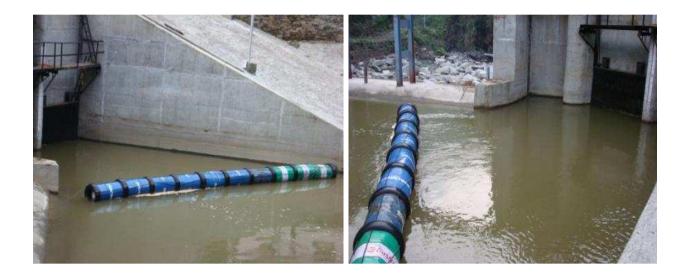
Trash Rack choking has contributed to the generation loss during monsoon season. Drum arrangement for diversion of drift wood has been provided at the intake to stop the clogging of the trash rack. Continuous clearing of Trash Racks manually during monsoon months is being carried out. These measures have yielded the desired results.

To uninterrupted clearing out of the trash / debris upstream of Trash Racks during monsoon months, a CGI sheets covering arrangement has been provided over the trash rack bridge.

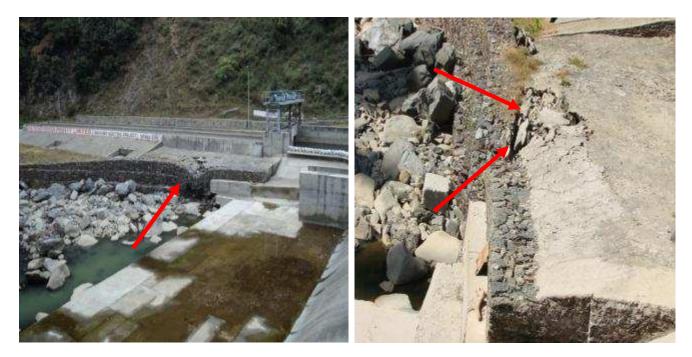
Wire crates downstream of the Weir had got damaged due to the monsoon floods during the year under report. No other visible damages were observed at Weir site.

Repair works of these damaged wire crates would be taken up during the first quarter of the financial year 2011-12.

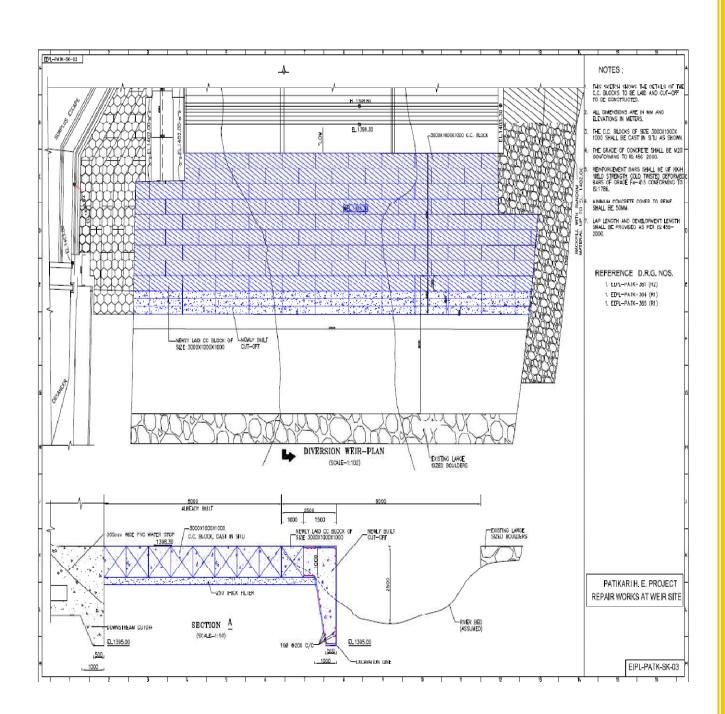
Wire Crate works in the riverbed downstream of Weir Site used to get damaged or washed away during monsoon season. In this context Civil Design Wing at HO was requested to evolve a permanent solution for this problem. Civil Wing suggested to extend the CC blocks in the riverbed downstream of the Weir Site & issued a drawing for the same as shown below in this context.

Thus the restoration works as suggested by civil design wing were carried out as per the above approved drawing before the onset of monsoons during year under report. Besides restoring the damaged crates, the concrete cladding on vertical faces of these crates was provided up to certain length. The performance of the restored / modified civil structures was found to be satisfactory as it is evident from the following photographs during and after restoration works that these structures are intact after the monsoons of 2010-11.

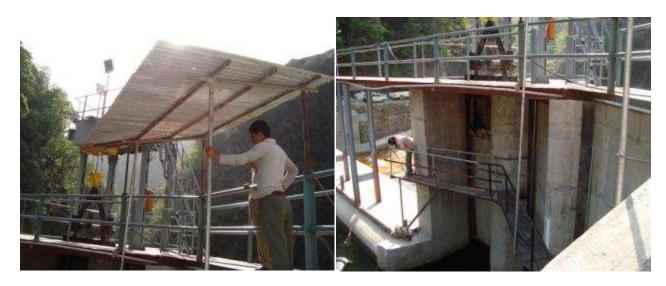
CGI Sheets covering arrangement was provided on the Trash Rack Bridge to carry out the cleaning works of the Trash Rack during monsoon season. It would also prevent the deposition of debris in the Trash Rack.

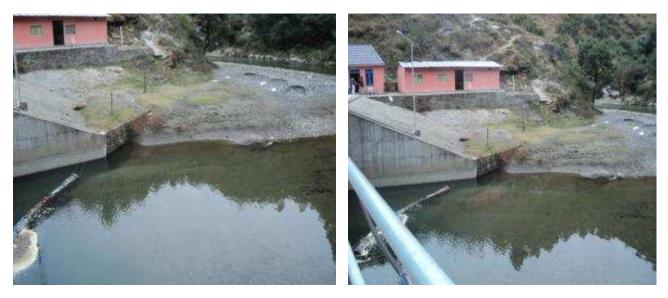
It has been pointed out by Civil Design Wing that the upstream River Bed on right side of the Weir structure had eroded to some extent and may require some additional protection works. However, it is evident from the recent photographs below that the silt has now got deposited at the right bank & there is no immediate threat as such to nearby civil structures. It would be monitored regularly & pre-emptive action, if required, would be taken in due course of time. The photographs of the right bank upstream of the Intake Structure are depicted below.
