# 2 X 8 MW Mandi District, Himachal Pradesh

Annual O&M Report FY 2014-15

16 MW Patikari Project, implemented by Patikari Power Private Limited, is a run of the river hydro power project developed on Bakhli Khad, a tributary of Beas River and is located in Mandi district of Himachal Pradesh, India. Two (2) generating Units driven by horizontal shaft Pelton Turbines, each having a rated output of 8.0 MW (having 15% CMR), are installed in the Power Station. The Design Energy of the Power Plant is 78.81 million KWh of electrical energy based on the 90% Dependable Discharge and rated output of 16 MW.

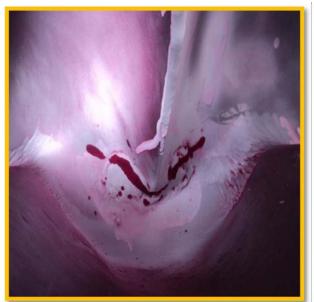
Inspection of the runner of both the units was carried out. During the DPT of Unit-II Runner, a crack was observed in the bucket no. 5. The Runner repair works of Unit-II was carried out by gouging, grinding & welding etc.

DPT of the runner of Unit-II

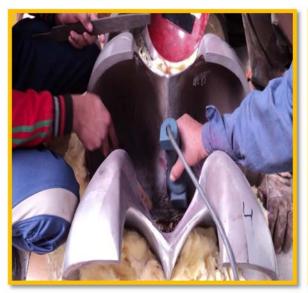
Repair work on the runner of Unit-II

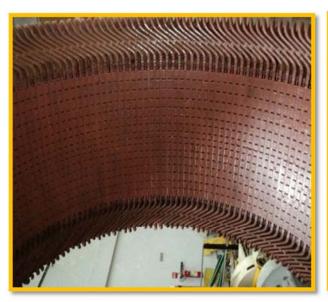
Photograph of the stator winding after restoration of wedges

During inspection of the stator, it was found that some wedges in the winding of unit-I were misplaced. The misplaced wedges were replaced by the M/s EMCO Electrodyne Pvt. Ltd. The photographs of the stator winding of Unit-I before repair works and after repair works are below.

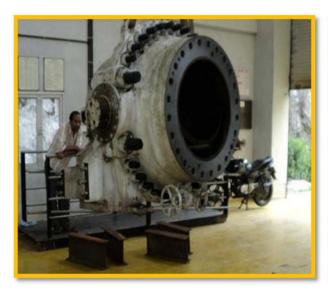
Dismantling of the MIV

Since commissioning of the project, first time MIV was taken out for the replacement of the service seal and maintenance seal. To avoid generation loss, bulk head (dummy) was placed at the penstock to facilitate the running of other unit. Replacement and repair works on the maintenance and service seal were carried out, related photographs are as below.

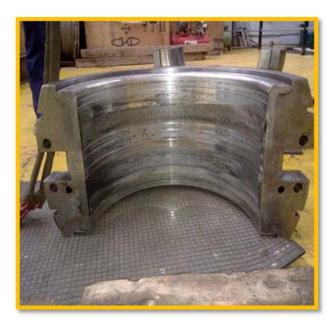
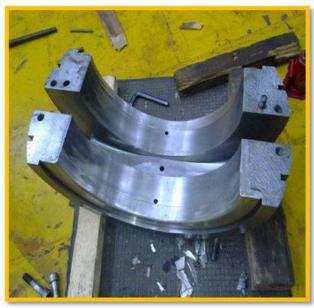
On 20th July-14 at 5: 58 AM, when both the units were running smoothly at overload 9.2MW each, Unit-I was suddenly tripped in emergency condition (Class A tripped) due to very high temperature of the DE bearing. After the inspection of the bearing, it was found that the DE bearing was completely damaged. Photograph of the spare DE bearing is as below.

Photograph of the spare DE bearing

Cause of the failure was interrogated through detailed review of the event list of the SCADA system, in which it was observed that the failure was due to the choking of the lube oil filter.

As spare parts of the damaged bearing was available at site, so that the restoration work was carried out at the earliest, and unit was successfully restored within 24 hrs of the failure by the maintenance team and put the unit under operation at 6:06 AM on 21 July-2016.

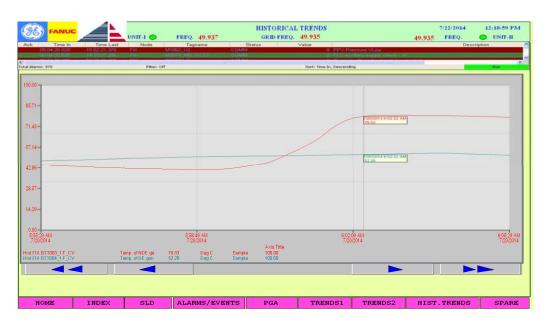
The screenshot of the SCADA system taken during the tripping due to temperature rise is as below.

Trend of the temp during bearing failure

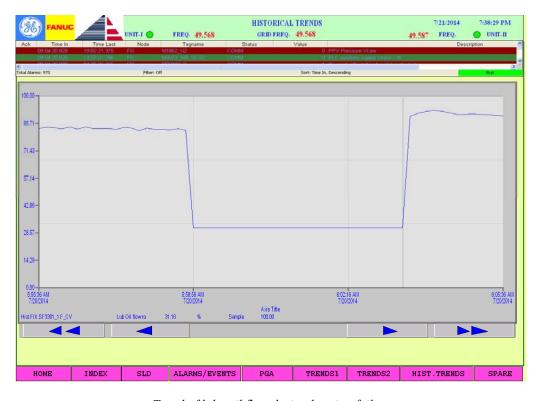
Trend of lube oil flow during bearing failure
