PATIKARI POWER PVT LTD

2 X 8 MW **Mandi District, Himachal Pradesh**

Annual O&M Report
FY 2015-16

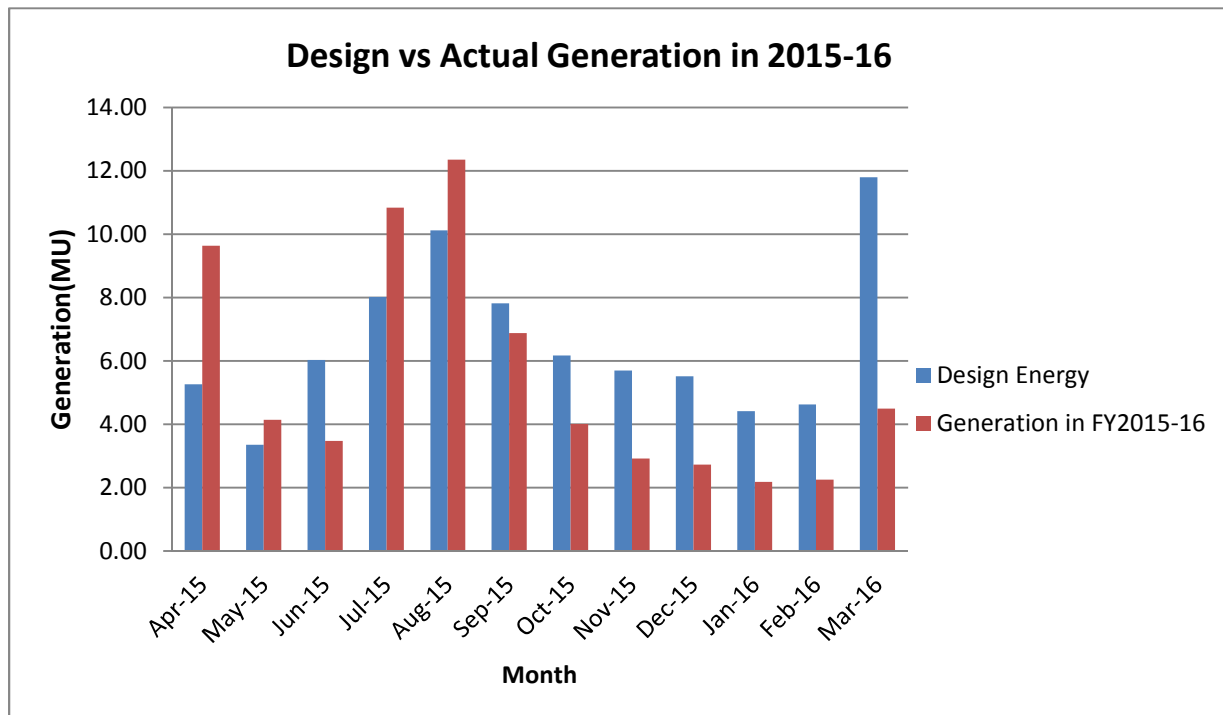
Month wise Design Energy and corresponding actual generation from the Project during 2015-16 and reasons for variations between the two are tabulated hereunder.

As evident from above, against Design Energy of 78.81 MU based on 90% Dependable Year Discharges, Project generated 65.92 MU during the financial year 2015-16. The Generation during financial year 2015-16 was thus 83.62 % of the Design Energy.

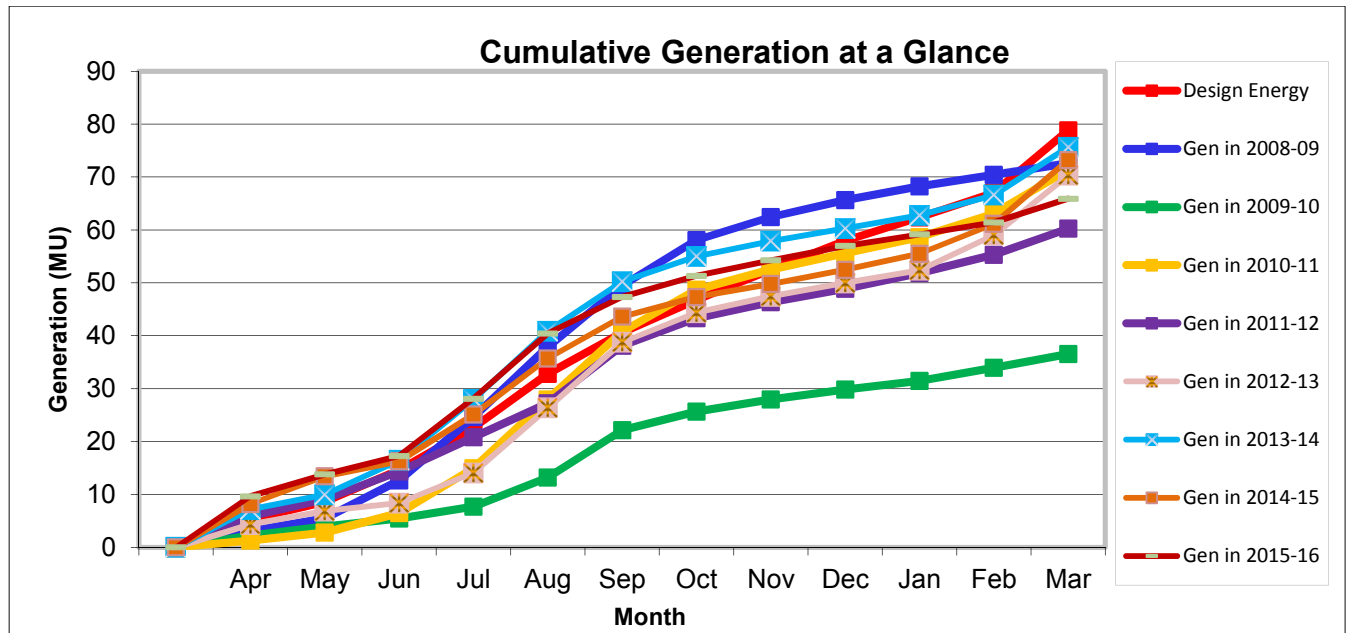
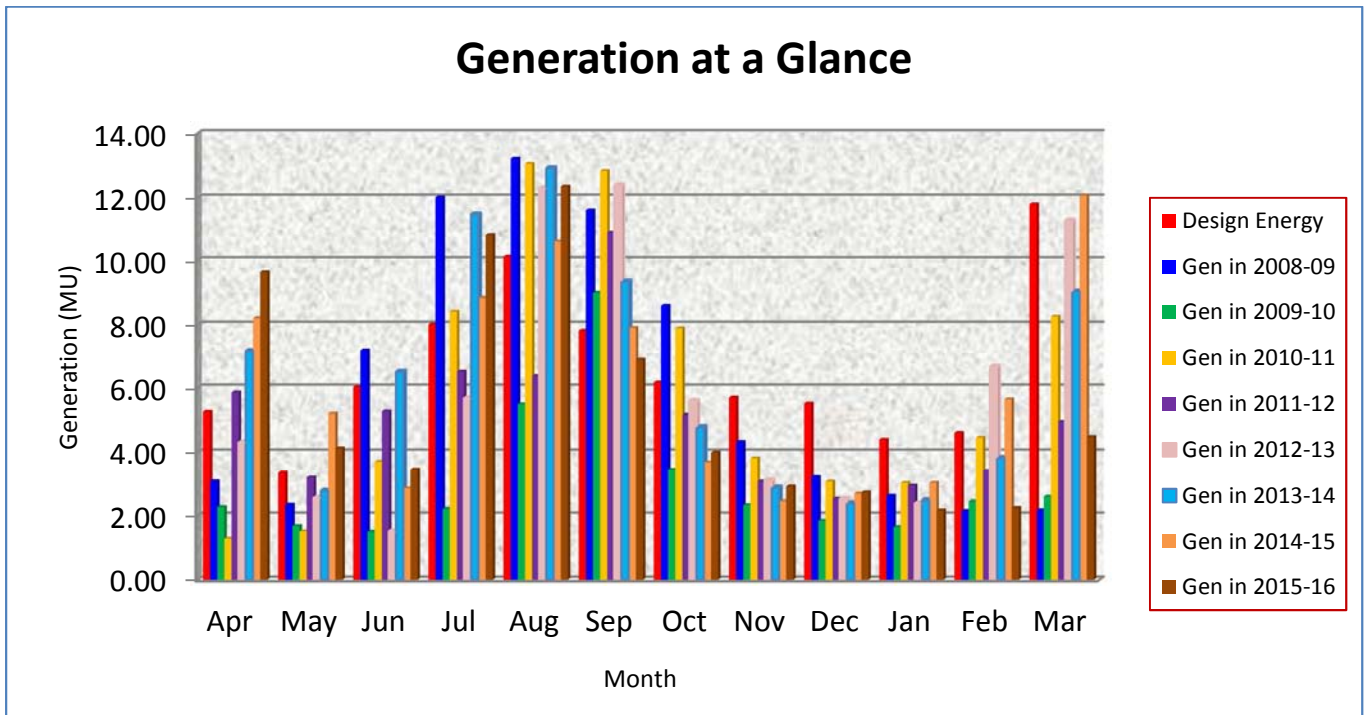
Generation during the month of April-2015 was the highest recorded for this month and generation during the month of September-2015 was the lowest for this month so far since commissioning of the Project.

As is evident from above table, generation during 1st and 2nd quarters was above Design Energy but the generation during 3rd and 4th quarter was very less because of poor river discharges during corresponding months.

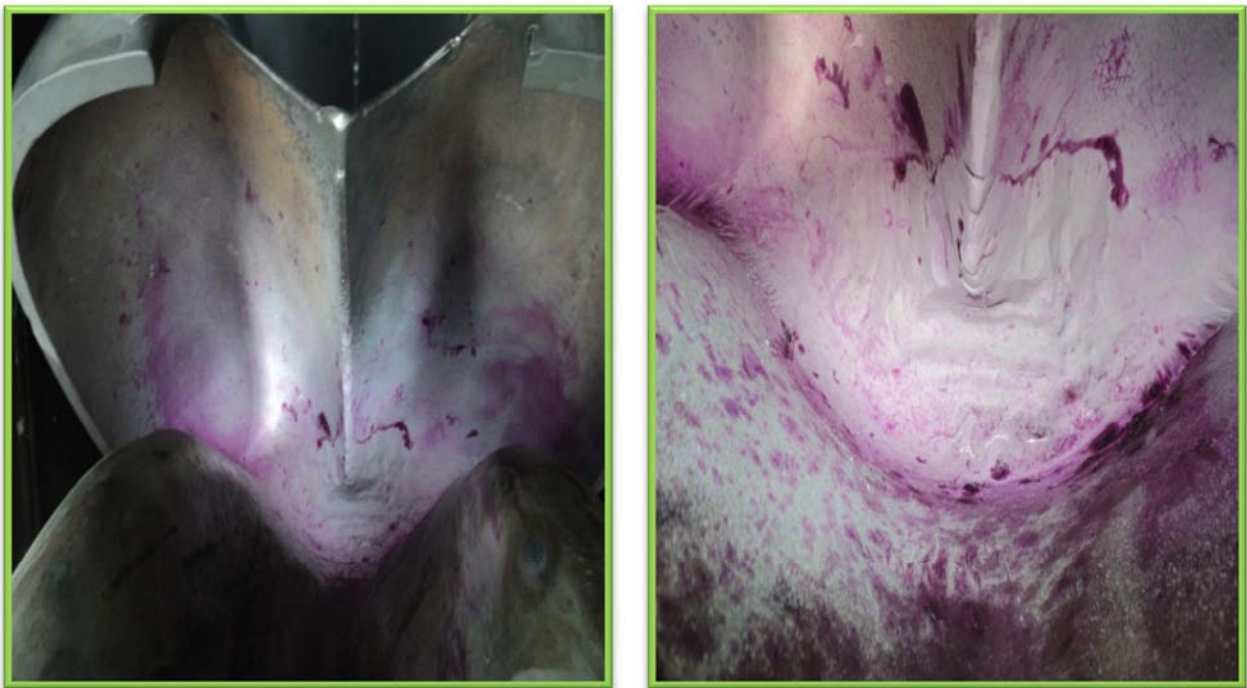
DP test

Runners of both the units have been inspected before the monsoon months, to assure the readiness of the machine during monsoon. One bucket of Runner of Unit-II was found in the damaged condition. The Photographs of Runner Buckets as taken during Dye Penetration Tests (DPT) and repairing work on the damaged bucket are shown below.

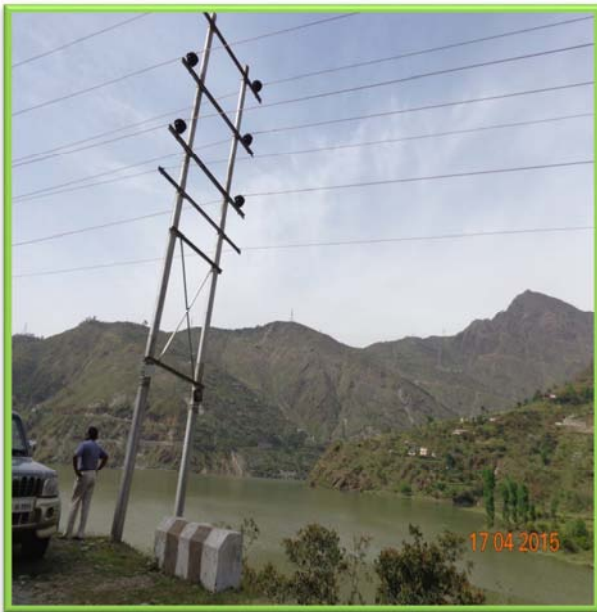
To ensure the availability of transmission line during monsoon, patrolling of the transmission line was carried out. During patrolling, some cracks were observed in the foundation of pole-51 and pole was also found in tilted position. Any further damages in the foundation could have caused complete outage of the transmission line. Therefore, the shifting of the foundation of that pole was done on the priority basis. The proposed and selected position for the shifting of the pole is depicted in the below photograph.

Tilted pole due to slide of foundation

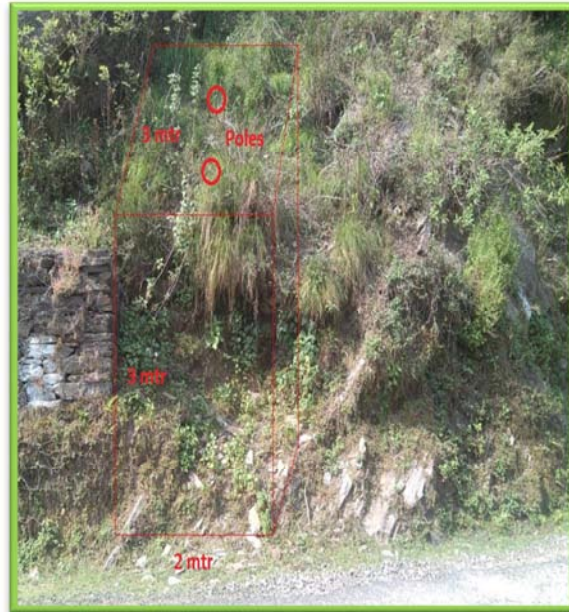
proposed space for new foundation

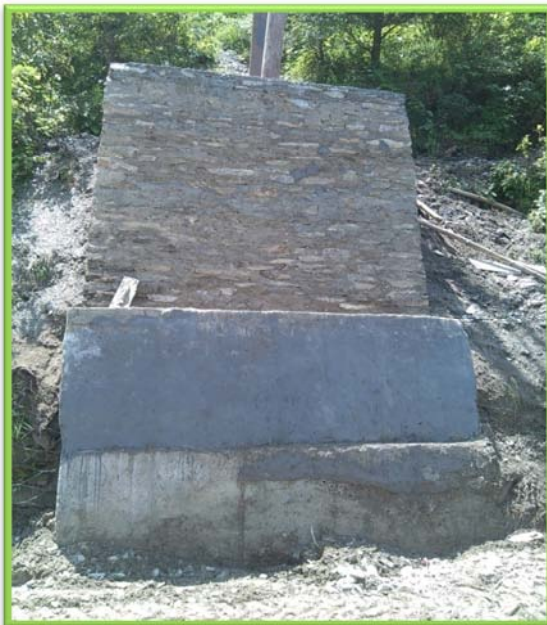
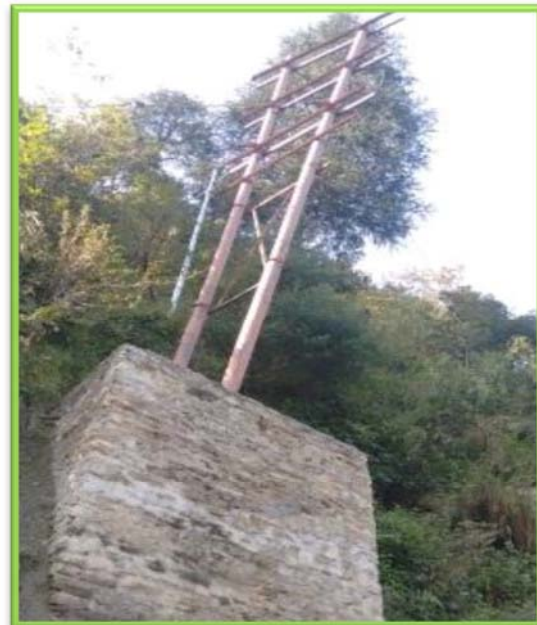
Newly constructed foundation

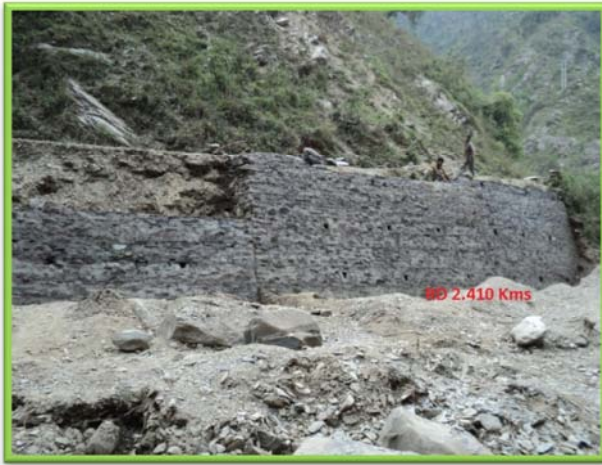
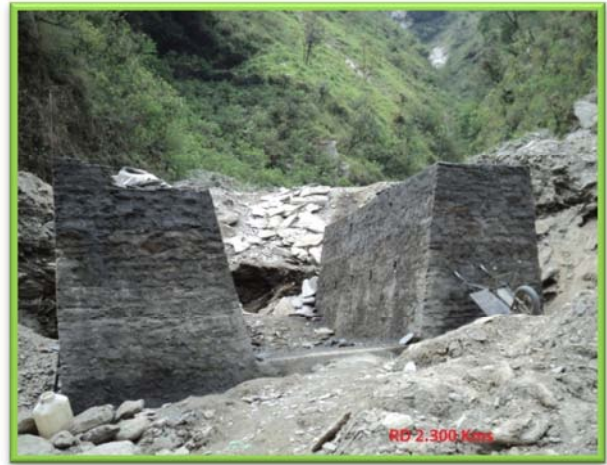
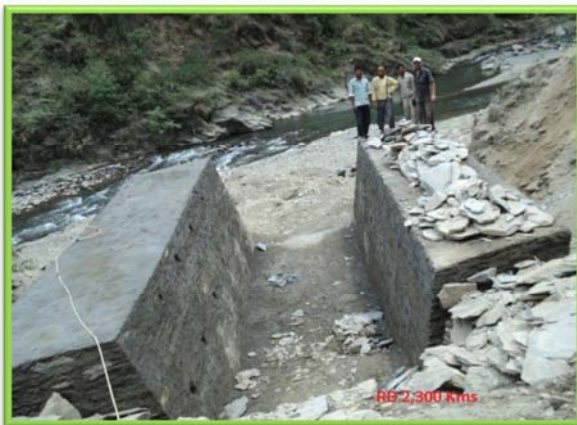
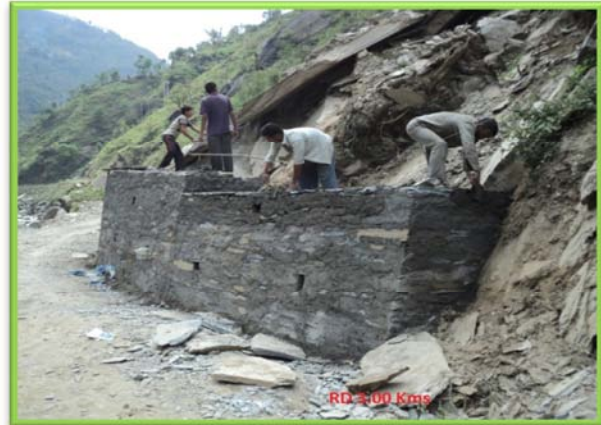
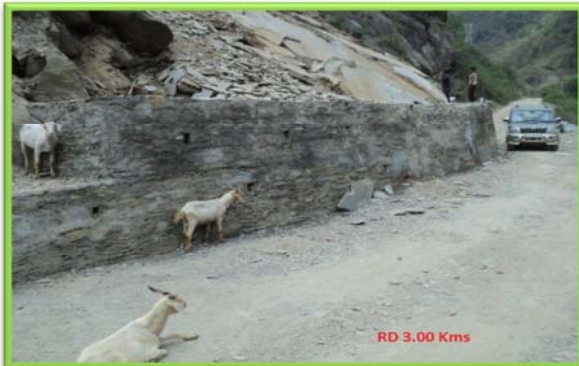
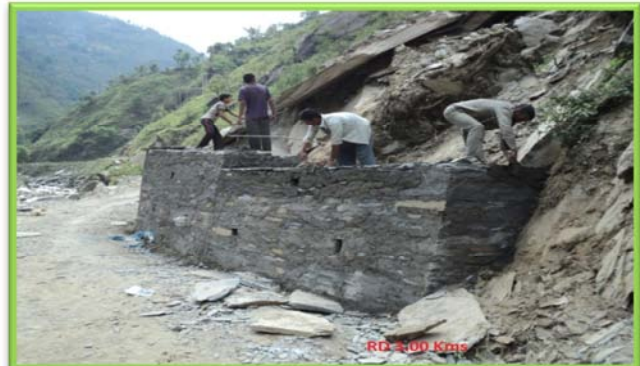
Due to heavy rains in the preceding monsoon some damages have taken place to the approach roads to the Power House & Weir site. The repair works as carried on the damaged portion of the roads as shown in the below photographs.

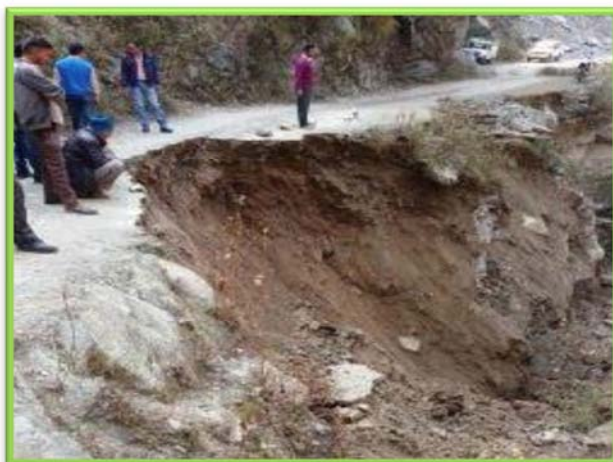
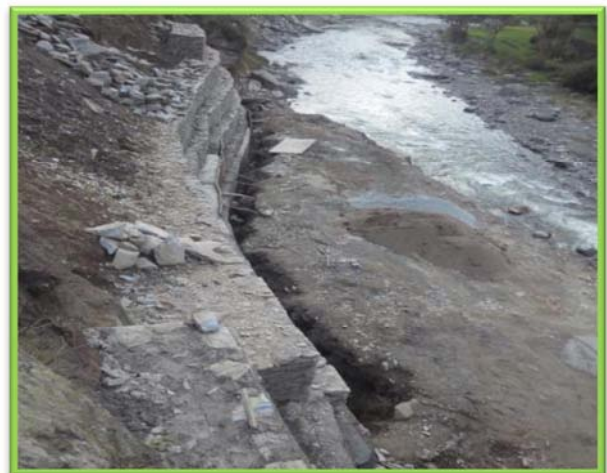
A cave-in had taken place in the power house approach road on 26th Feb which restricted the access of powerhouse. Restoration works was carried out on the damaged portion of the road.

Photograph blocked road & during repair works

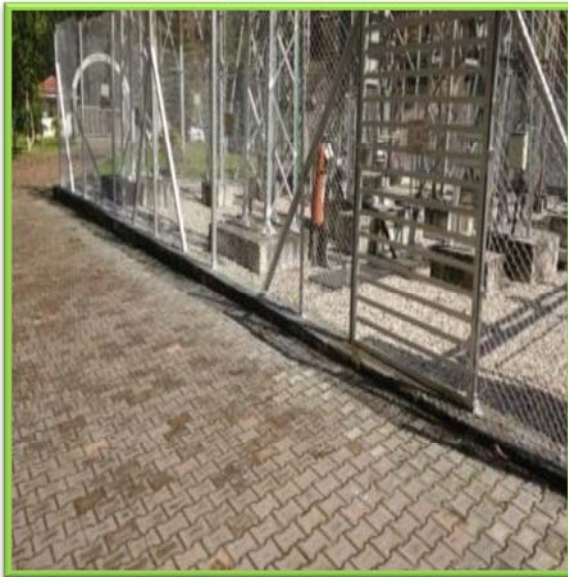
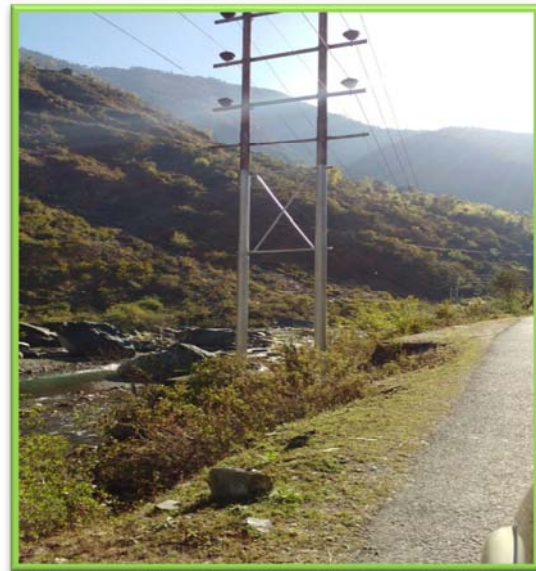
Painting works in Switchyard and Transmission poles

Since the commissioning of the project painting work of the powerhouse premises and weir site structures were not carried out. The painting of the power house premises, penstock, weir site structures as well as machinery including switchyard structure & transmission poles were carried out. The photographs of the painted structures and buildings are depicted as below.

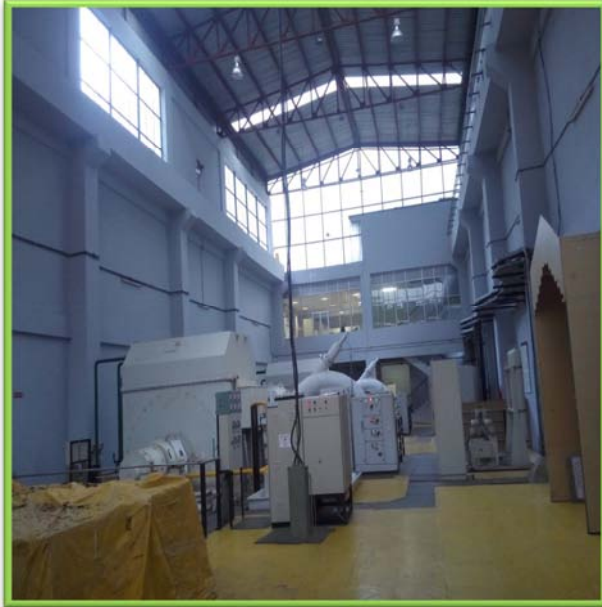
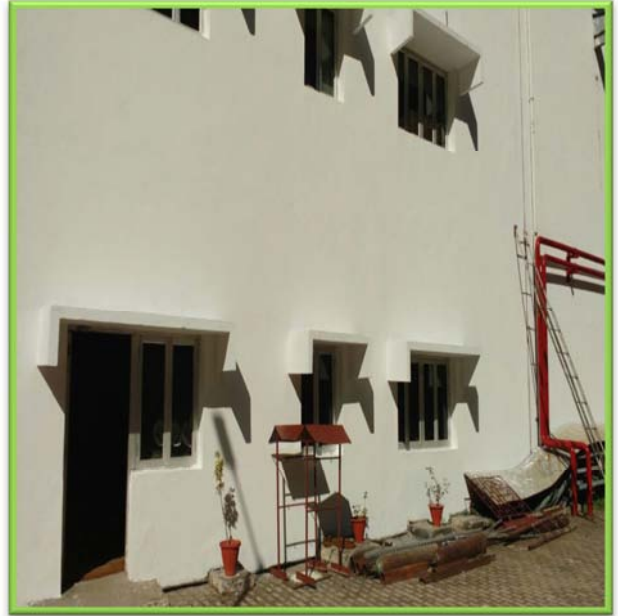
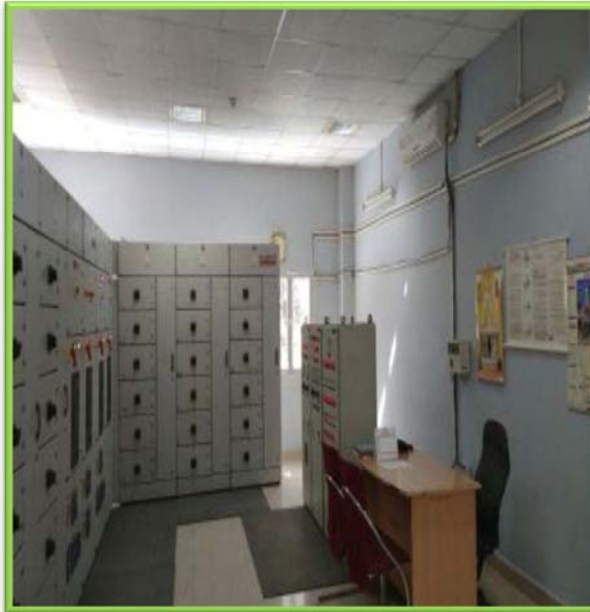
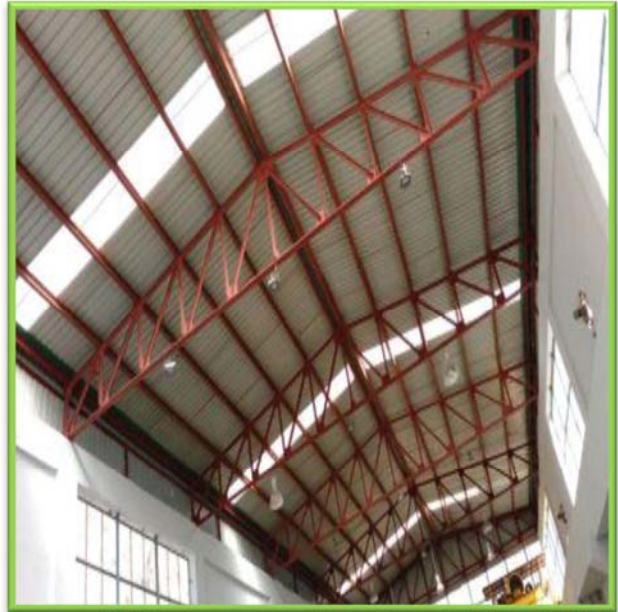
Painting works in Power house premises

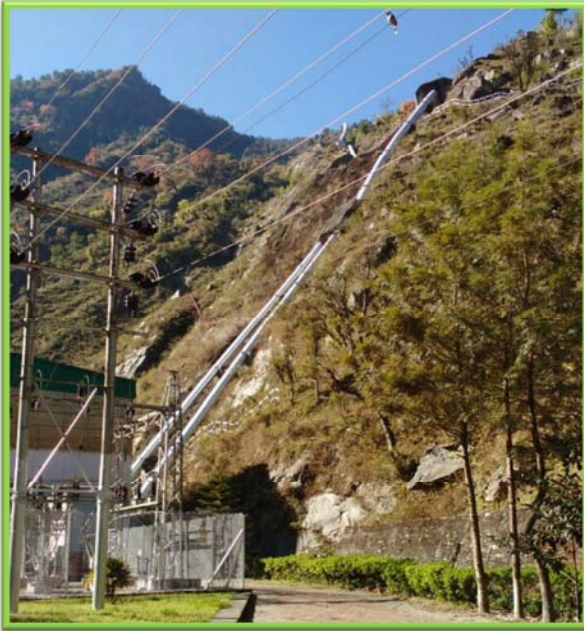
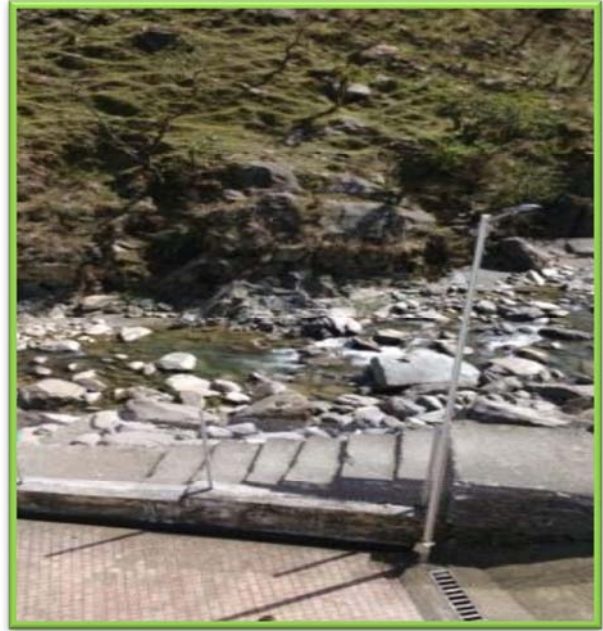
Painting of Penstock and illumination poles

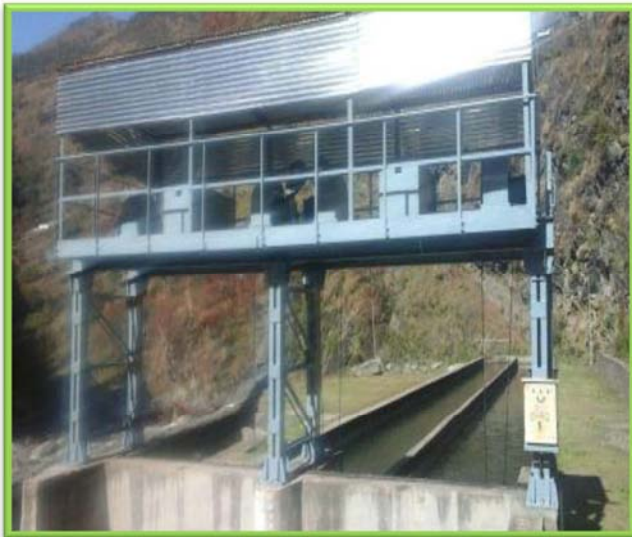
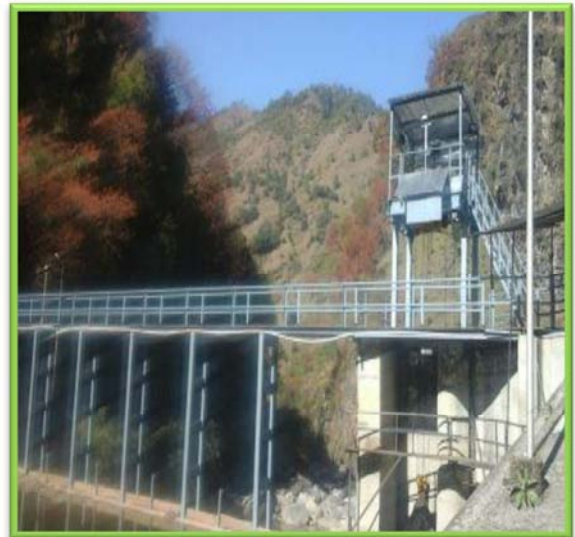
Painting works at weir site

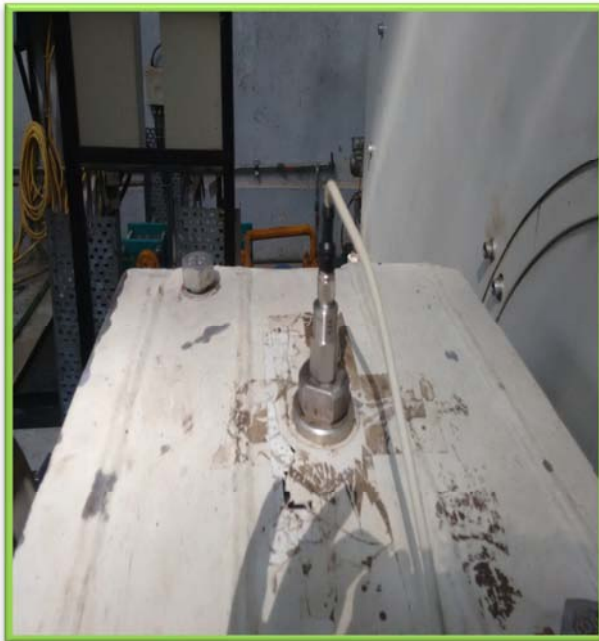
Vibration Sensor

The vibration sensors installed on the bearing of generators were not working properly. To ensure the healthiness of the machine, the vibration sensors & monitors were replaced with Masibus make instead of OME make. The functioning of the newly installed vibration sensors & monitors were checked and found working properly. The photographs of the newly installed sensors and monitors are as below:

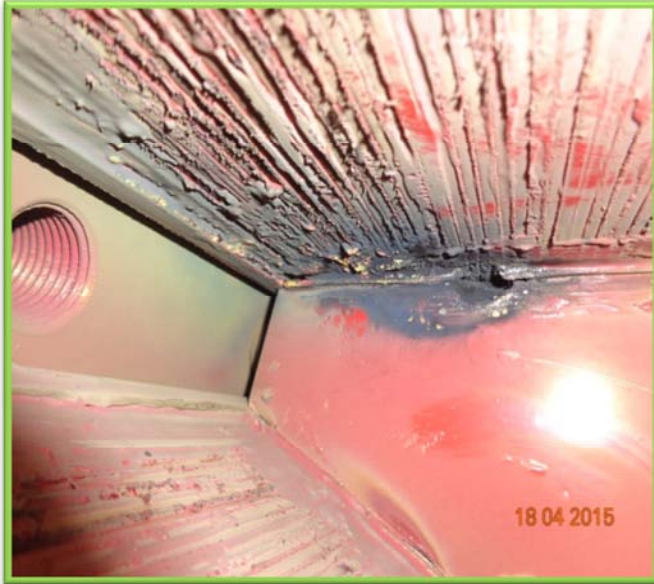
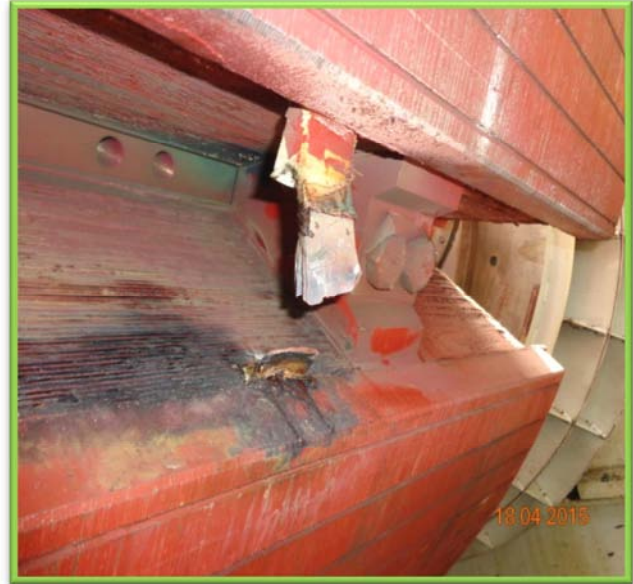
Upon opening of the generator rotor, two poles were found to have faulted and insulation damage was seen on the poles. The insulation resistance test revealed insulation failure of the poles. Damages were observed at inter turn area and connecting terminals of the respective poles. The photographs of the damages are shown below.

The photograph on the right shows fault at the connecting terminals and the photograph on the left shows fault in the winding inter turn area.

The poles were replaced by the spare poles available at site by M/s EMCO Electrodyne and the unit was put back into operation on dated 24/04/2015 at 12:30 PM.

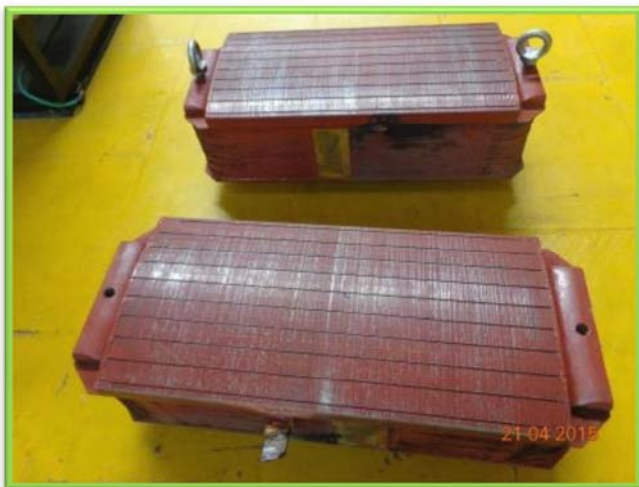
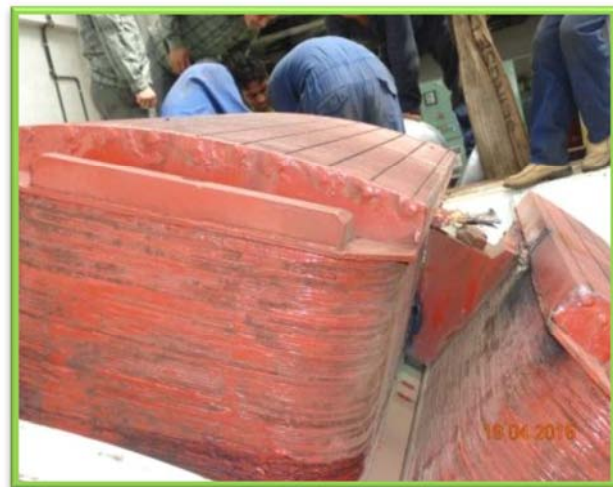
Scratches were observed on the stator which would have come from the rotating rotor during the fault. The stator was later checked for insulation resistance and was reported to be OK.

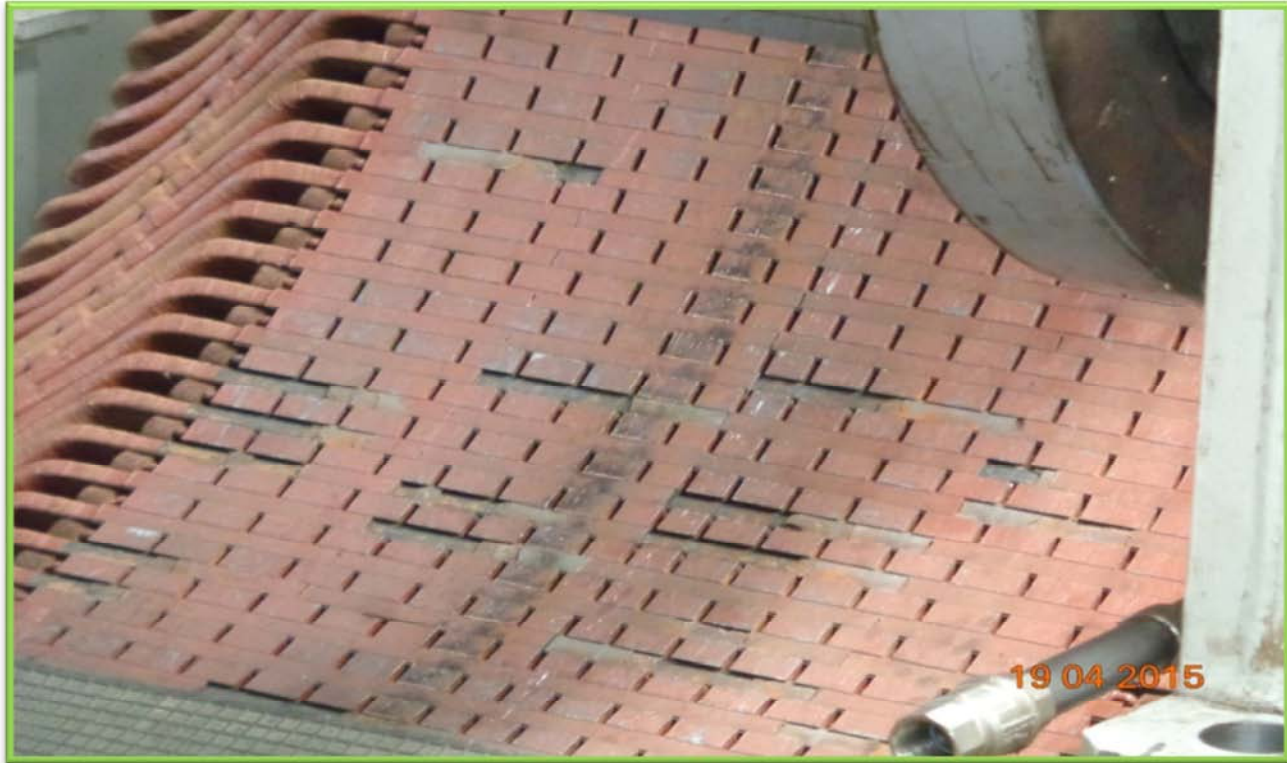
Photograph showing Scratches observed on stator of unit 2

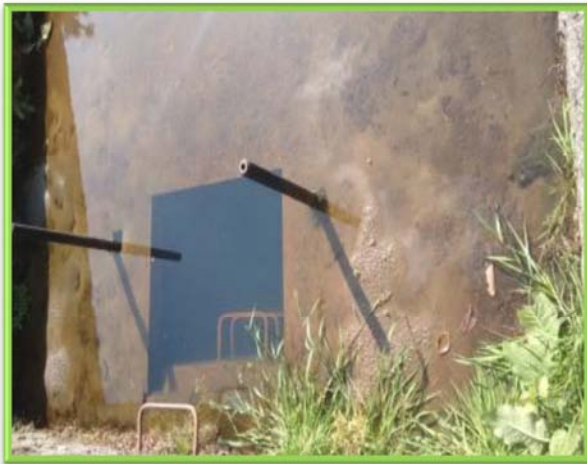
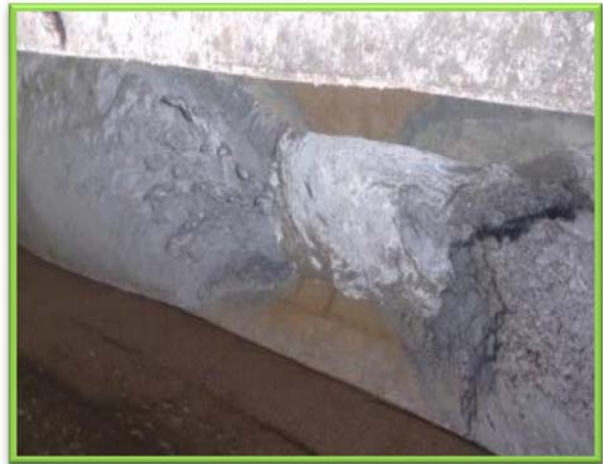
The factors such as silt flushing duct choking, trash rack choking, cooling water filter choking, failure of 11/33kV breakers etc. were major cause for the plant outage. The matter of choking of silt flushing ducts was referred to civil design wing for their suggestions on the further improvements in the existing de-silting arrangements to obviate the problems of choking.

Completely choked silt flushing duct

To avoid choking, Civil Design wing had suggested removal of every third Chequered plate from the cut out of the silt flushing duct for improving the efficiency of the De-silting arrangement because the hole size in the plate was not sufficient to cater such huge amount of silt . These suggestions in the Desander had been taken up. And success of the implemented scheme was monitored in the monsoon and found that the problem of the silt deposition was not resolved. At this time the silt flushing duct was completely choked due to huge amount of silt flow from the duct. The photograph of the completely choked duct is shown above.

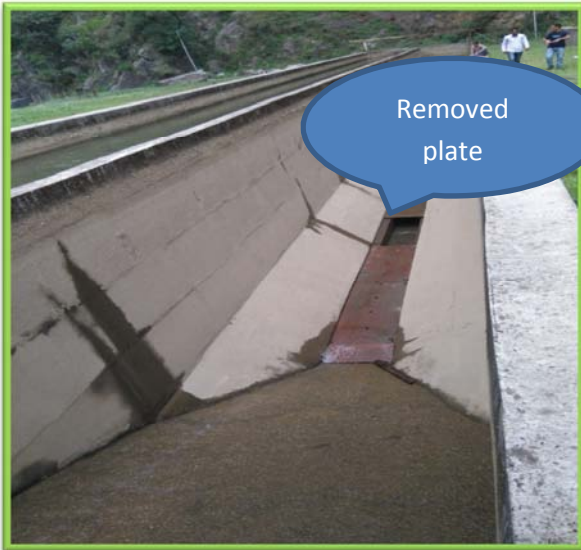
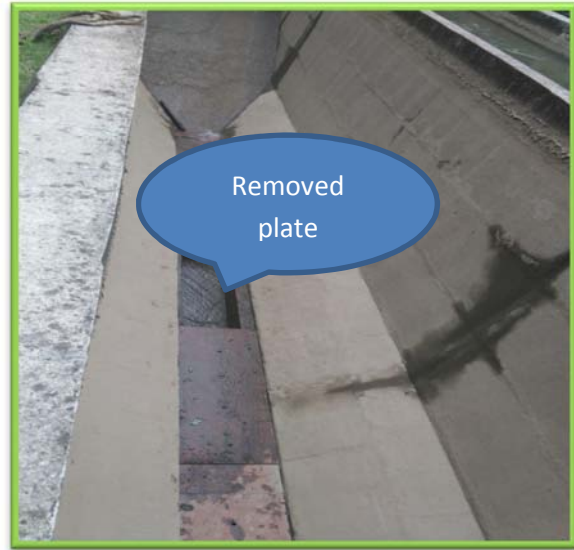
Removal of plates from alternate holes

The below photographs depict the implemented suggestion of the civil wing.
