PATIKARI POWER PVT LTD

2 X 8 MW

Annual O&M Report

FY 2011-12

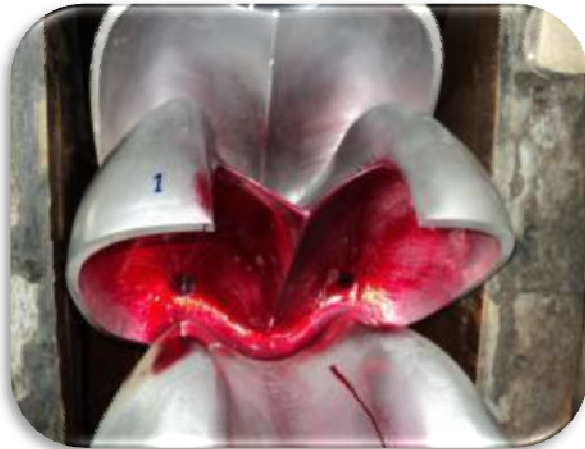
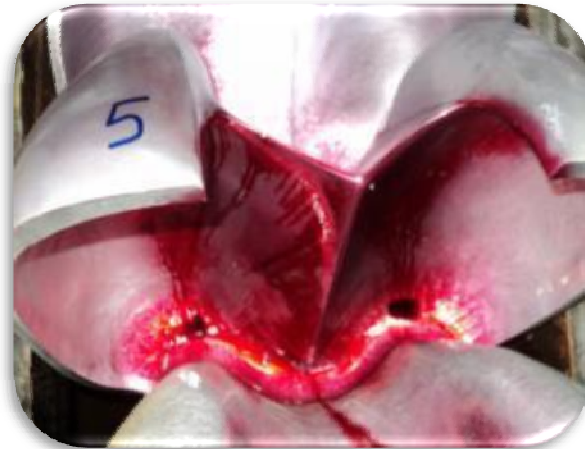
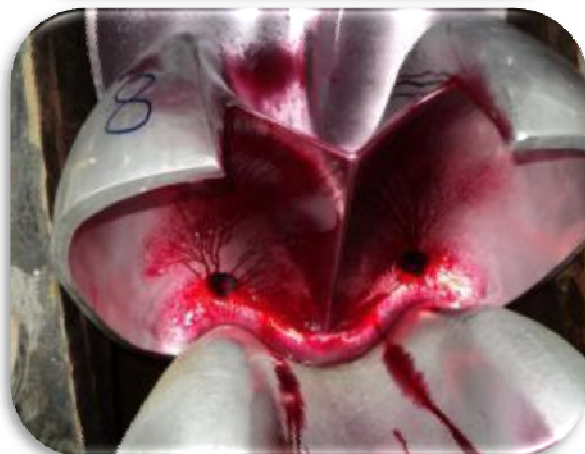
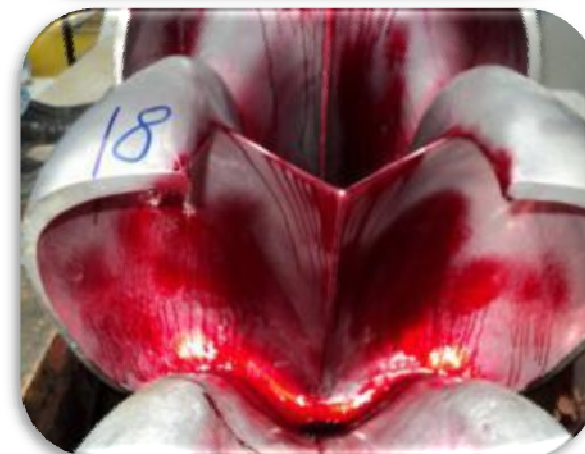
Unit-I:

Runners of both the units have been inspected after the monsoon months. The unit wise photographs of Runner Buckets as taken during Dye Penetration Tests (DPT) are shown below.

No traces of appreciable erosion damages were found and as such no major overhauling works were required to be undertaken on the runners.

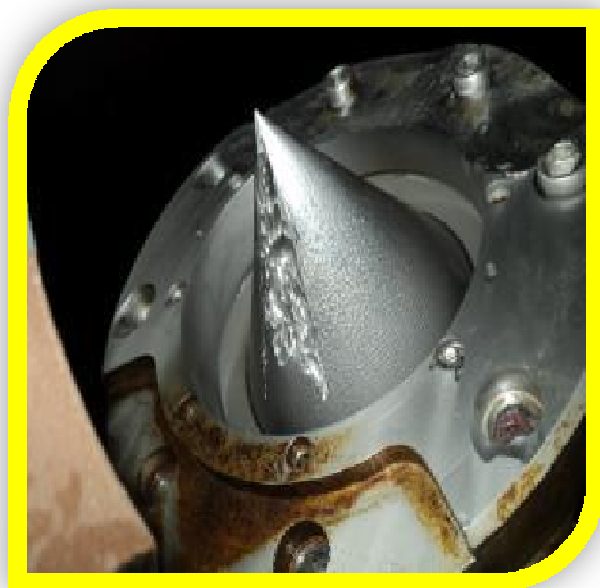
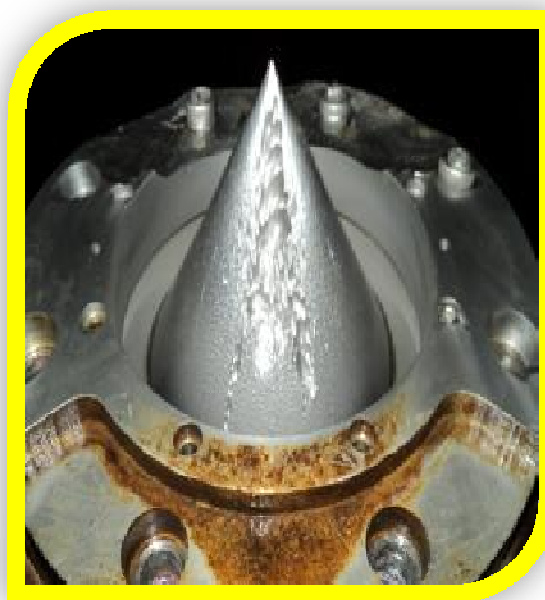
Unit-I:

- ✓ Major dents & erosion were found on Unit-I Nozzle
- ✓ One dent in Unit-II nozzle due to striking of foreign material

The nozzles of unit-I were replaced with the available spare ones. The damaged nozzles need touch-up works to be done. Nozzles of Unit-II, as such, didn't require any major maintenance/overhauling work.

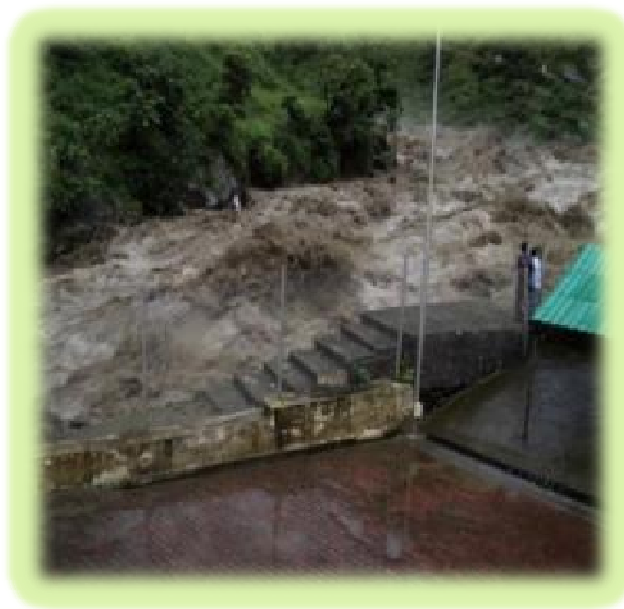
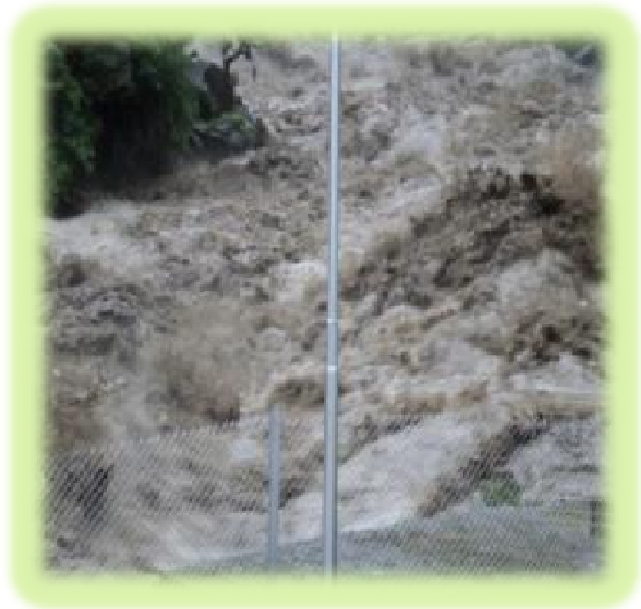
Due to heavy rains and Floods from 13th to 16th August 2011, some damages have taken place to the approach roads to the Power House & Weir site. Wire crates for protection of De-sanders had also been damaged. Intensity of heavy flood waters in the river at power house site can be seen in the pictures given below.

The maximum river water level along the boundary of the Project structures observed during the heavy rains and floods from 13th to 16th August 2011 was recorded as 1032.50 m against the Machine Hall Floor elevation of 1032.35m.

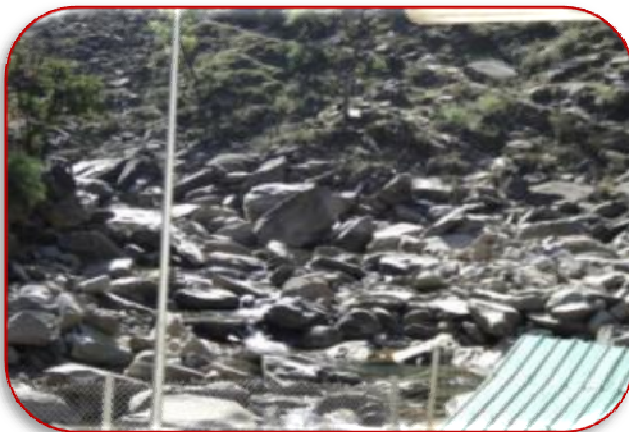
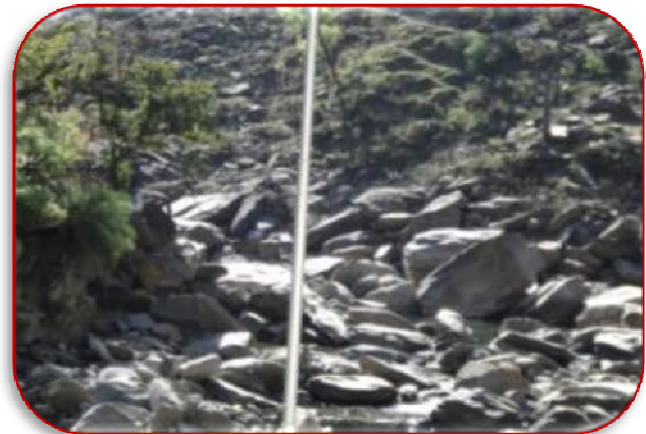
In view of the flood like situations during monsoons in preceding years of operation of the plant, the river widening works upstream of the power house is an important work to be completed on the priority as the power house is situated on the sharp turn at the left bank. Upstream view of the river where the river widening works are to be carried out are given below.

The above said works are planned to be completed before the onset of monsoons in the first quarter of the coming year i.e. 2012-13 as per the availability of the funds.

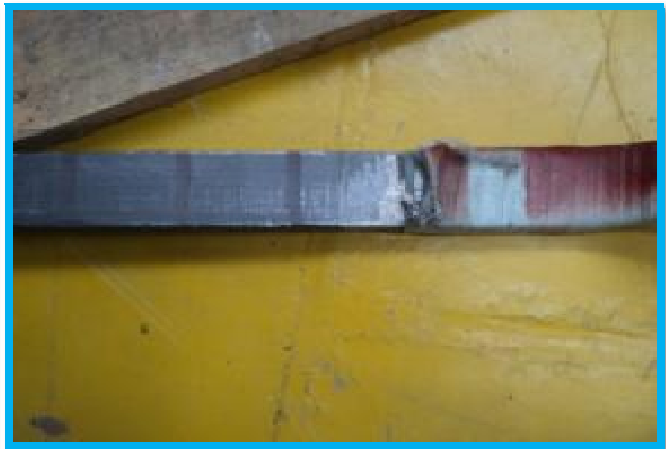
Photograph 9: Burnt Coil

M/s Fitwell team worked very hard round the clock to restore the damaged Generator within the minimum possible time. The damaged coils of the stator were replaced with the available spare ones.

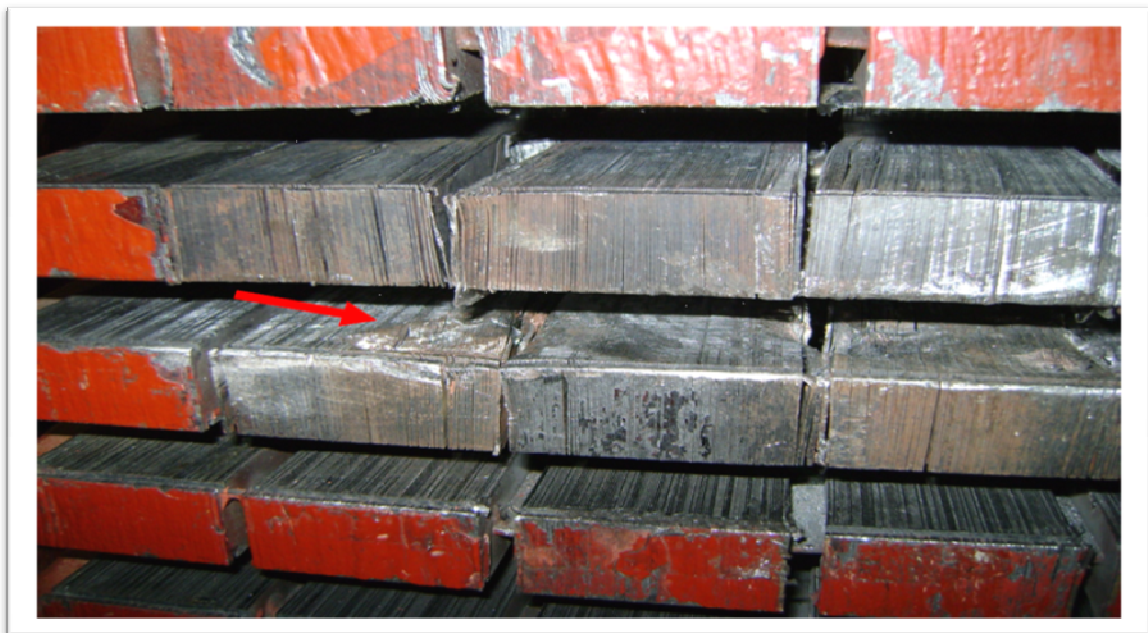
ELCID Test through M/s Prognosys EMS Pvt Ltd was conducted before the core repair and damaged core packets were identified. The ELCID test report before core repair is enclosed as **Appendix-1**. Some of the photographs showing damaged slots are shown below.

Photograph 13: Core Faults seen in Slot no. 14

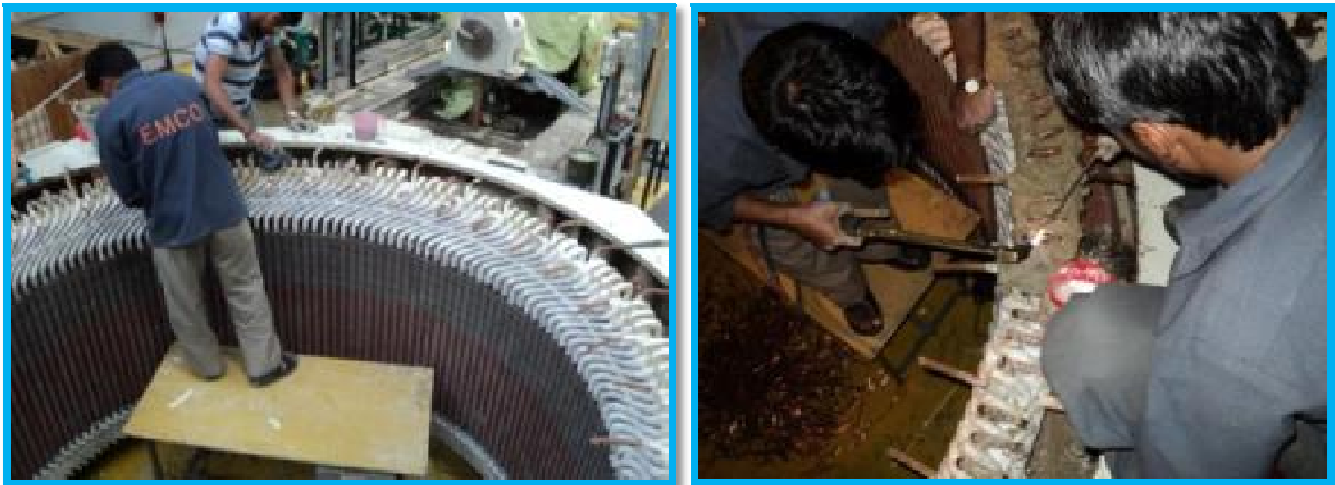
Photograph 17: Stator Coil Rewinding works

Laying of new winding coils in the Stator Core by the rewinding team of M/s EMCO was completed and brazing of end connections had been carried out where after taping, varnishing and drying out and HV testing of complete stator winding was taken up and completed.

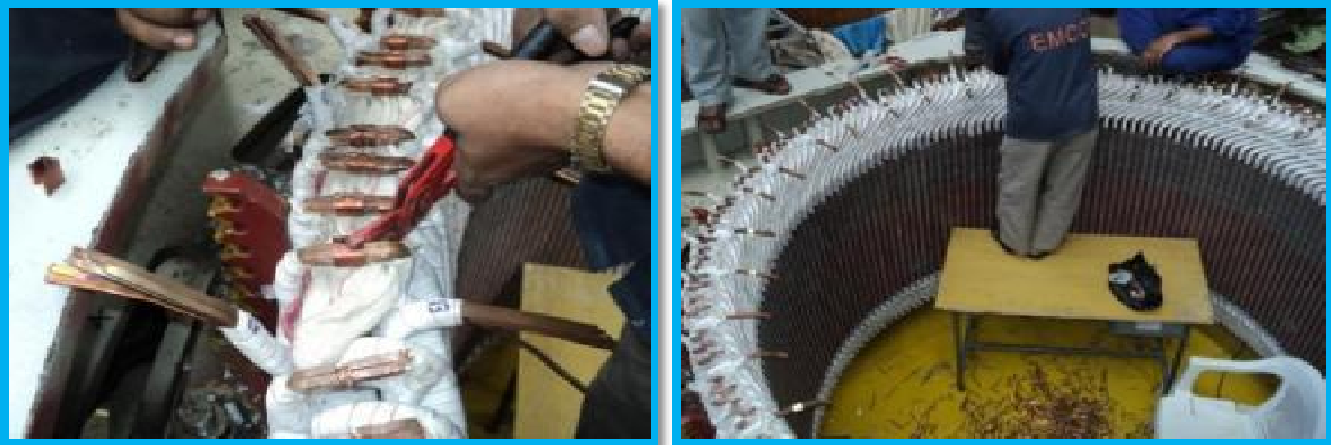
Photograph 18: Stator Coil Rewinding works

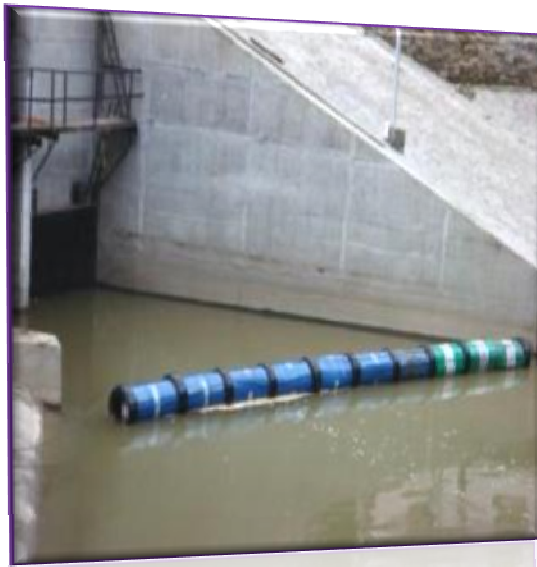
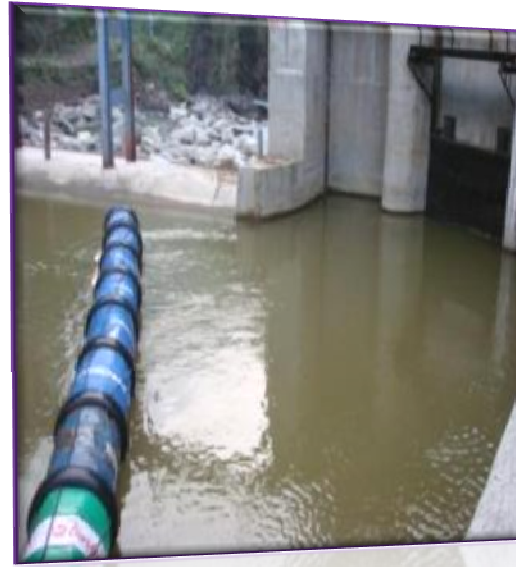
Trash Rack choking has contributed to the generation loss during monsoon season. Floating Drums arrangement for diversion of drift wood towards open Weir has been provided at the intake to avoid the clogging of the trash racks to the maximum extent possible. Continuous clearing of Trash Racks manually during monsoon months is also being carried out. These measures have yielded the desired positive results.

For ensuring uninterrupted clearing out of the trash / debris upstream of Trash Racks during monsoon months, a CGI sheets covering arrangement has also been provided over the trash rack bridge to enable workmen to continue working during rains as well.

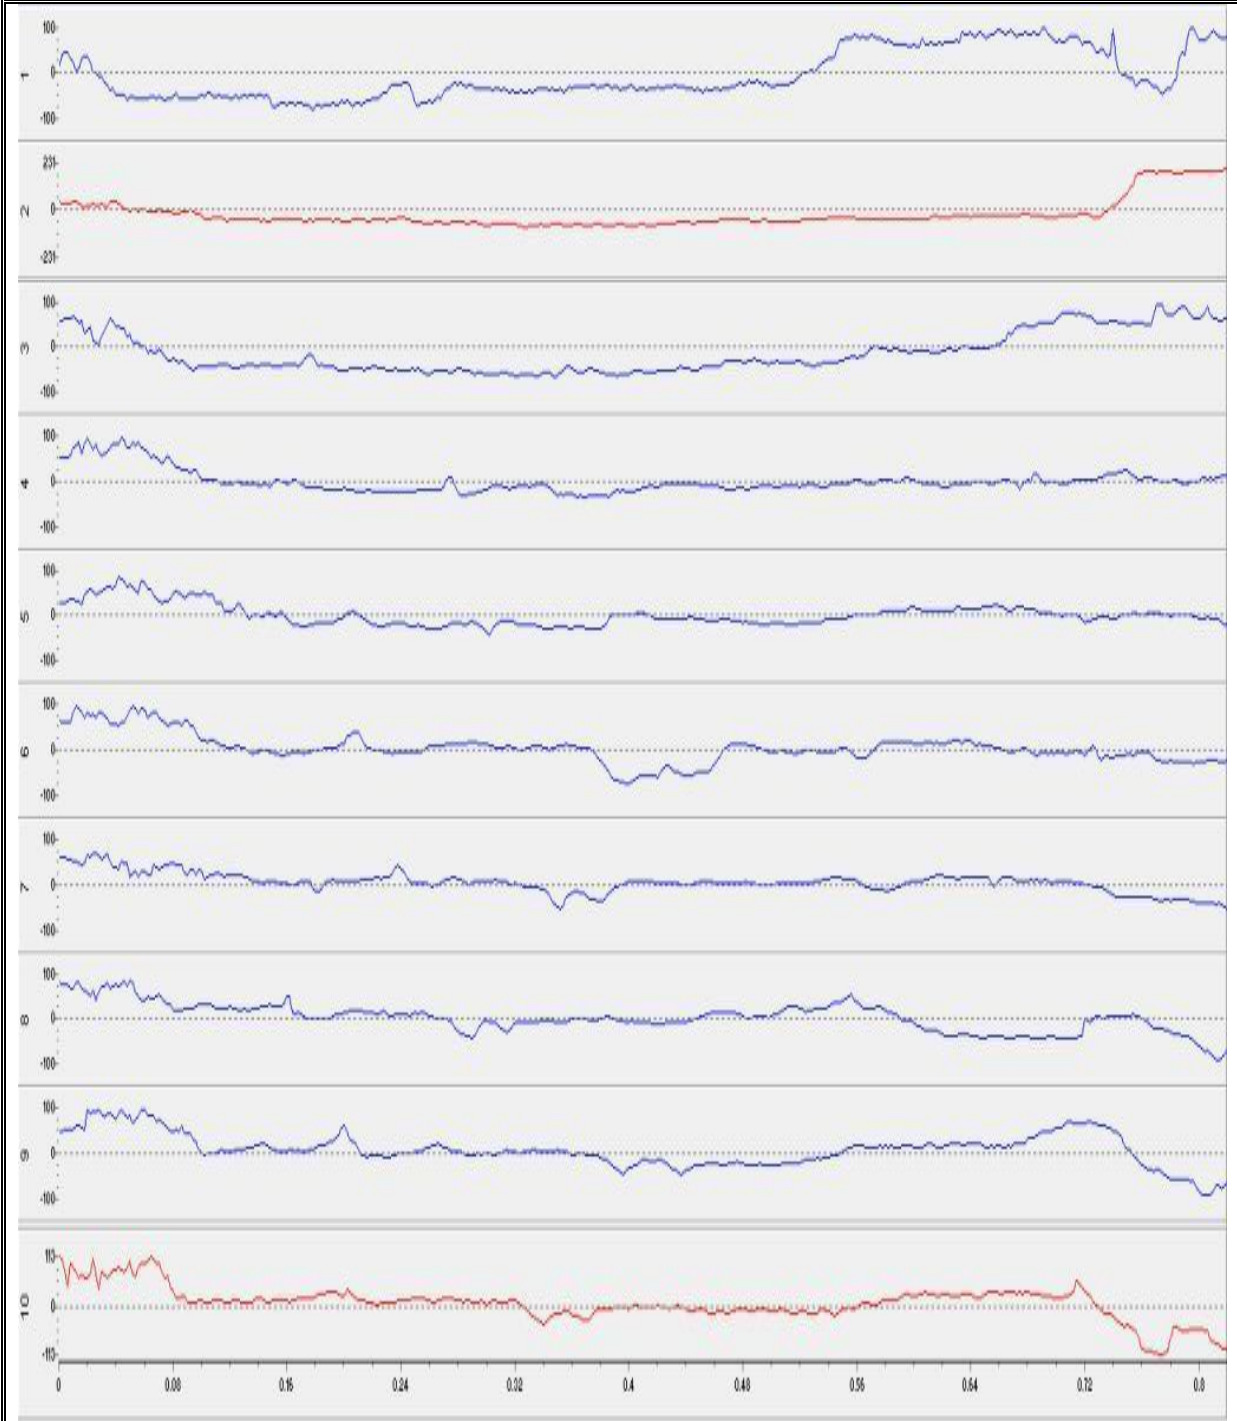
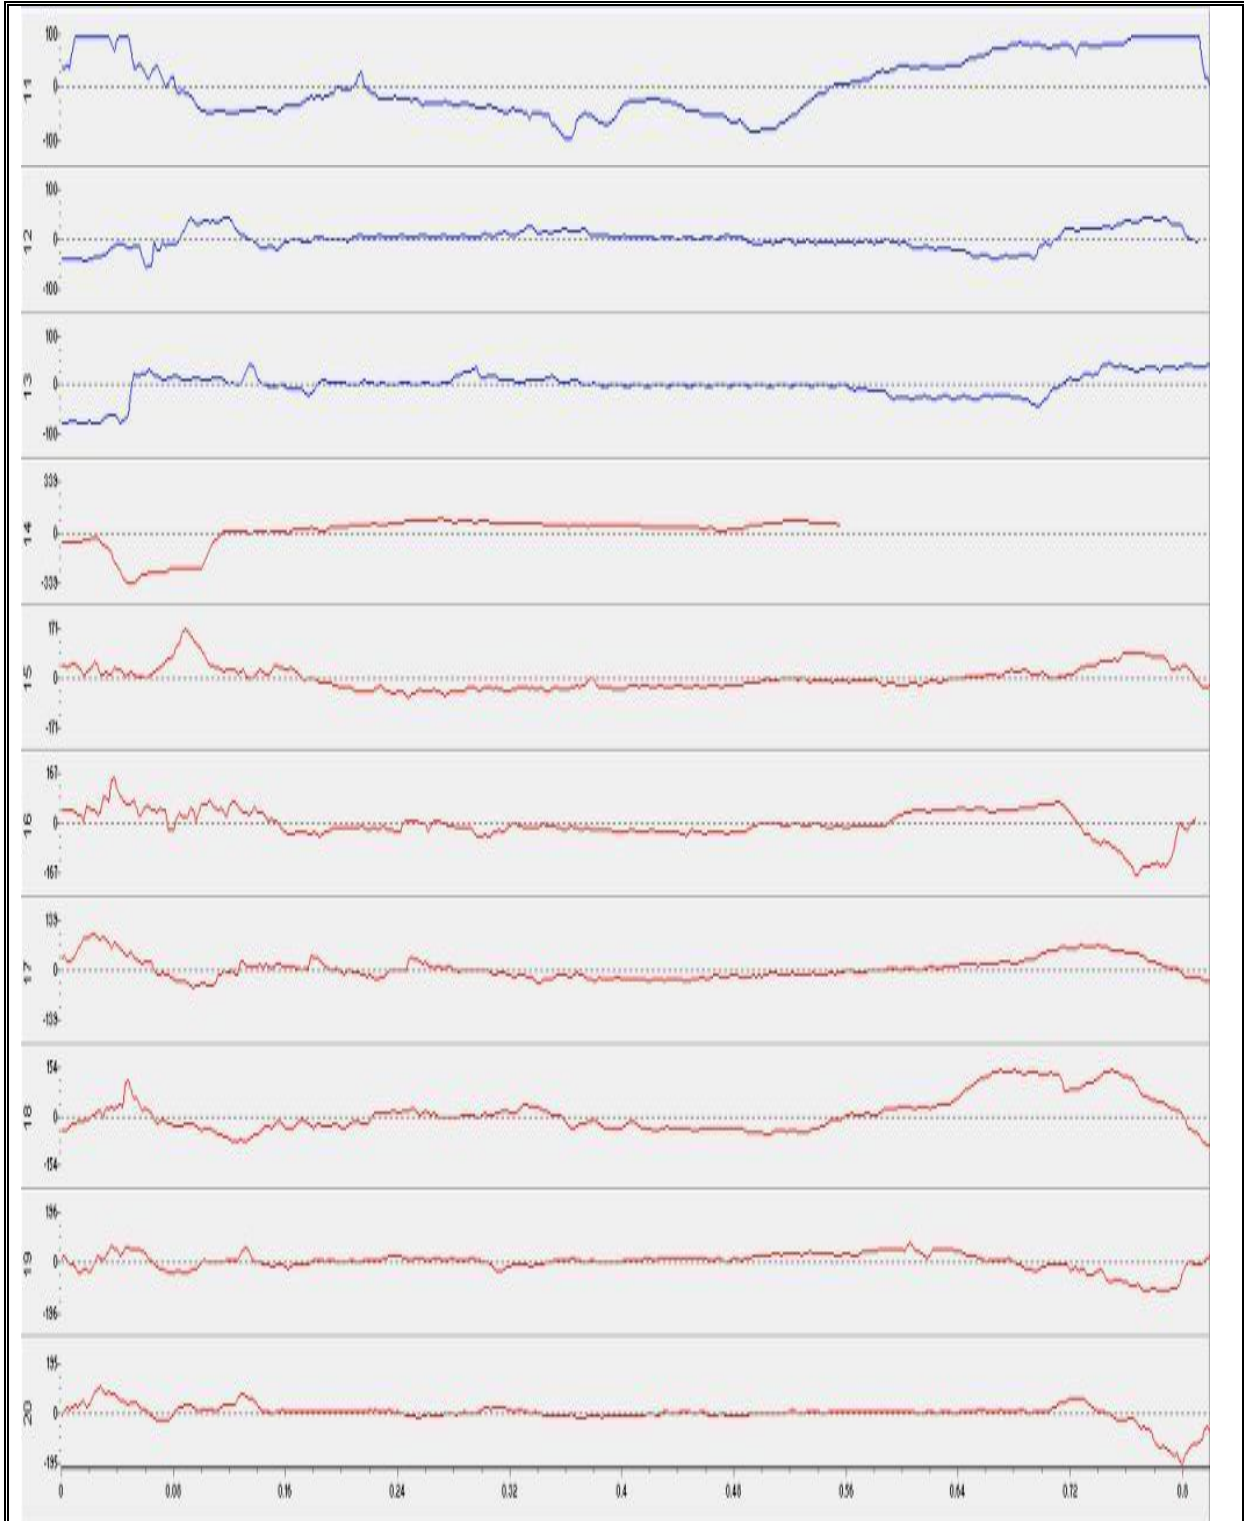
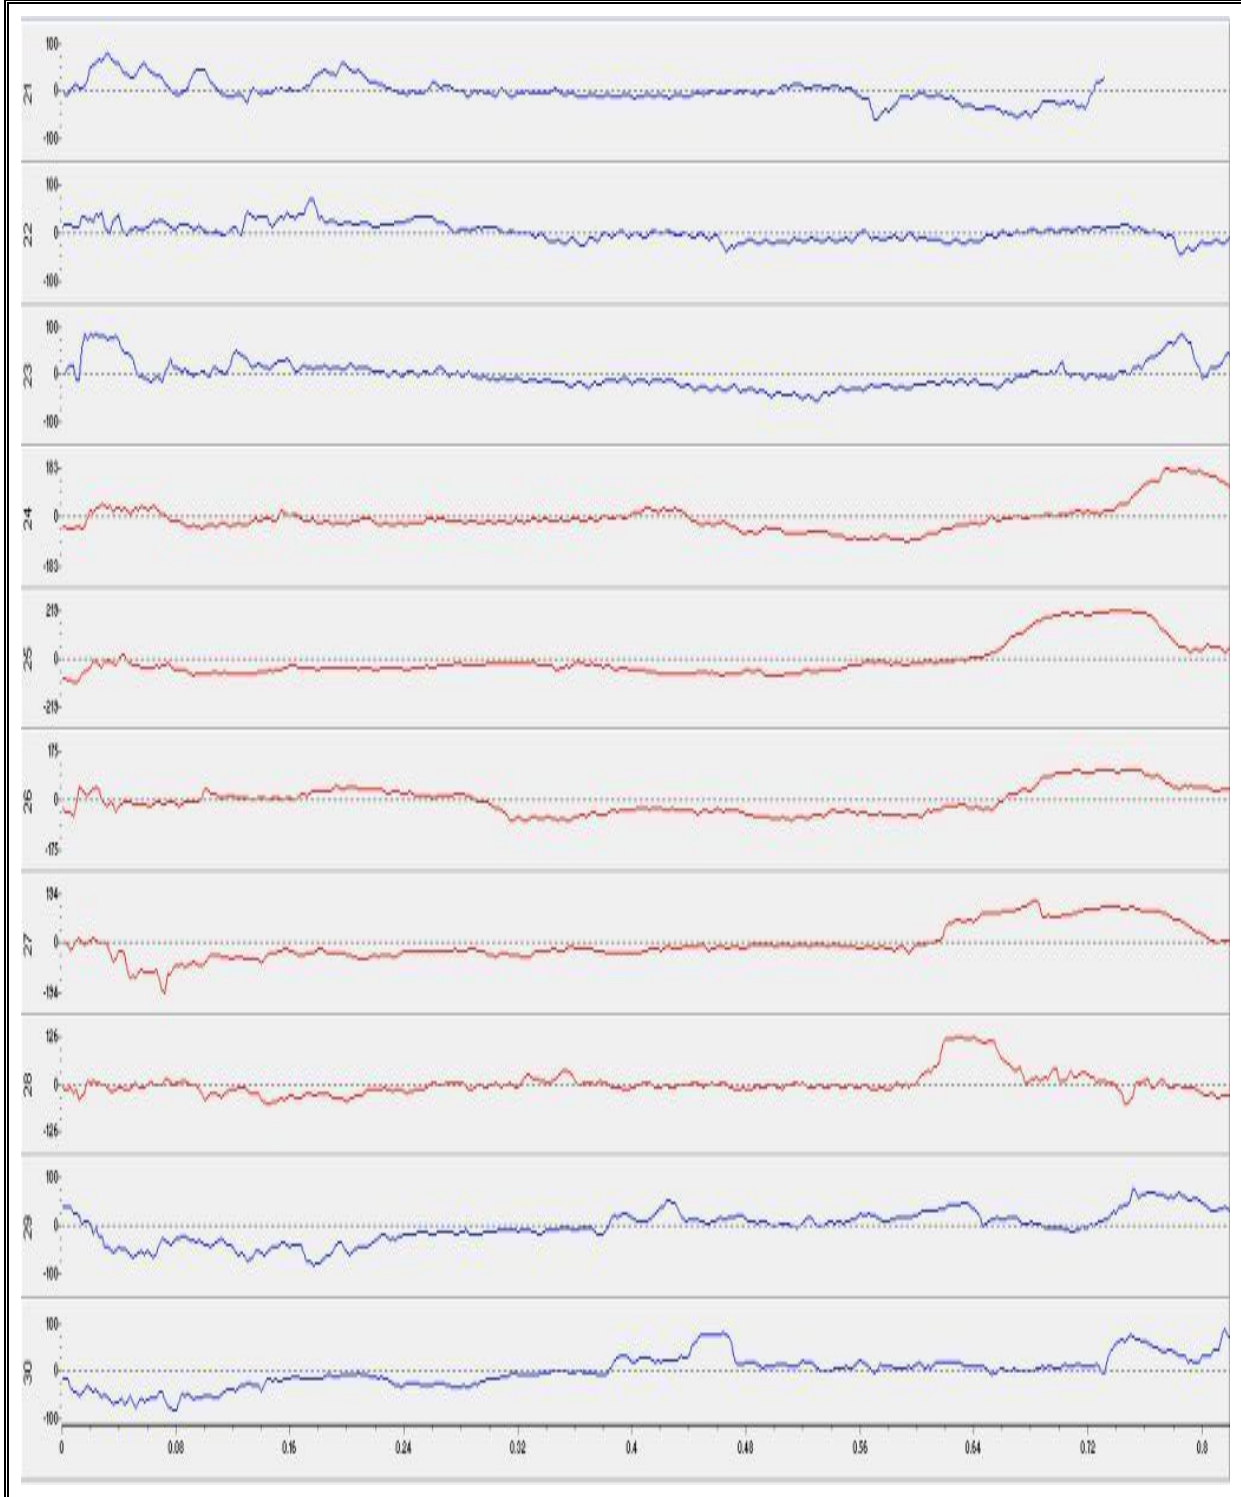
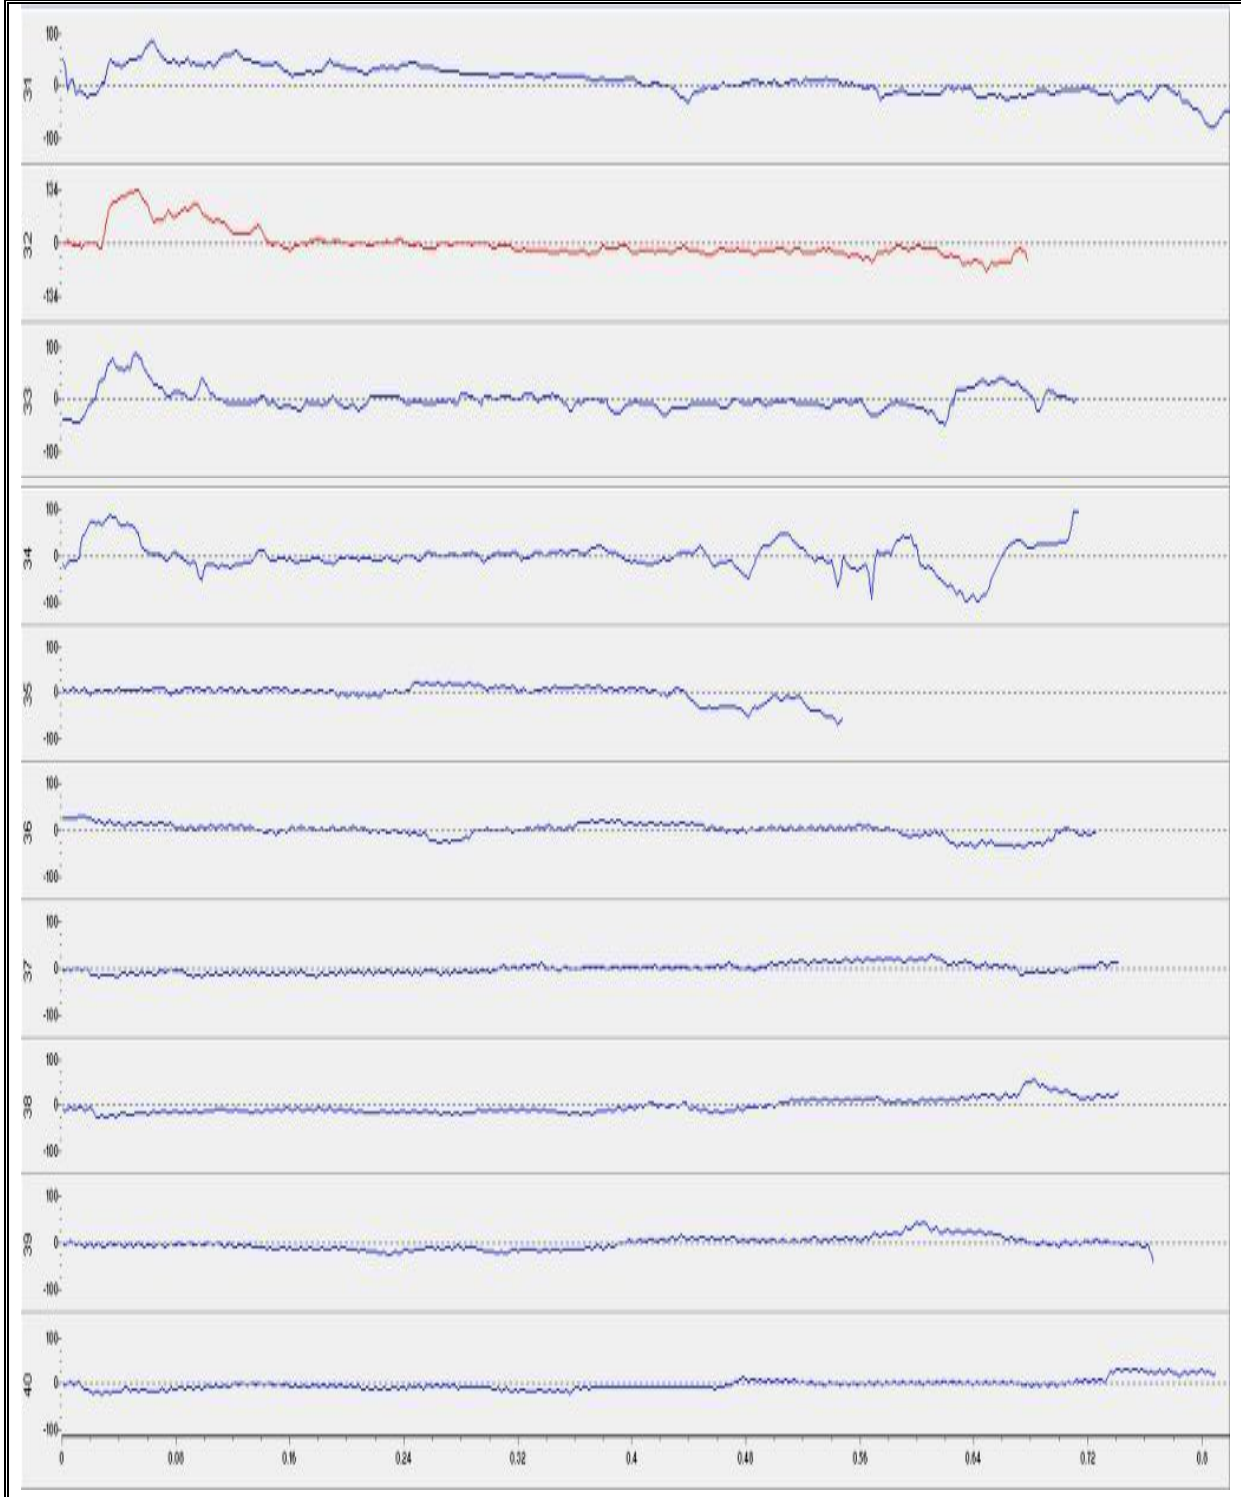
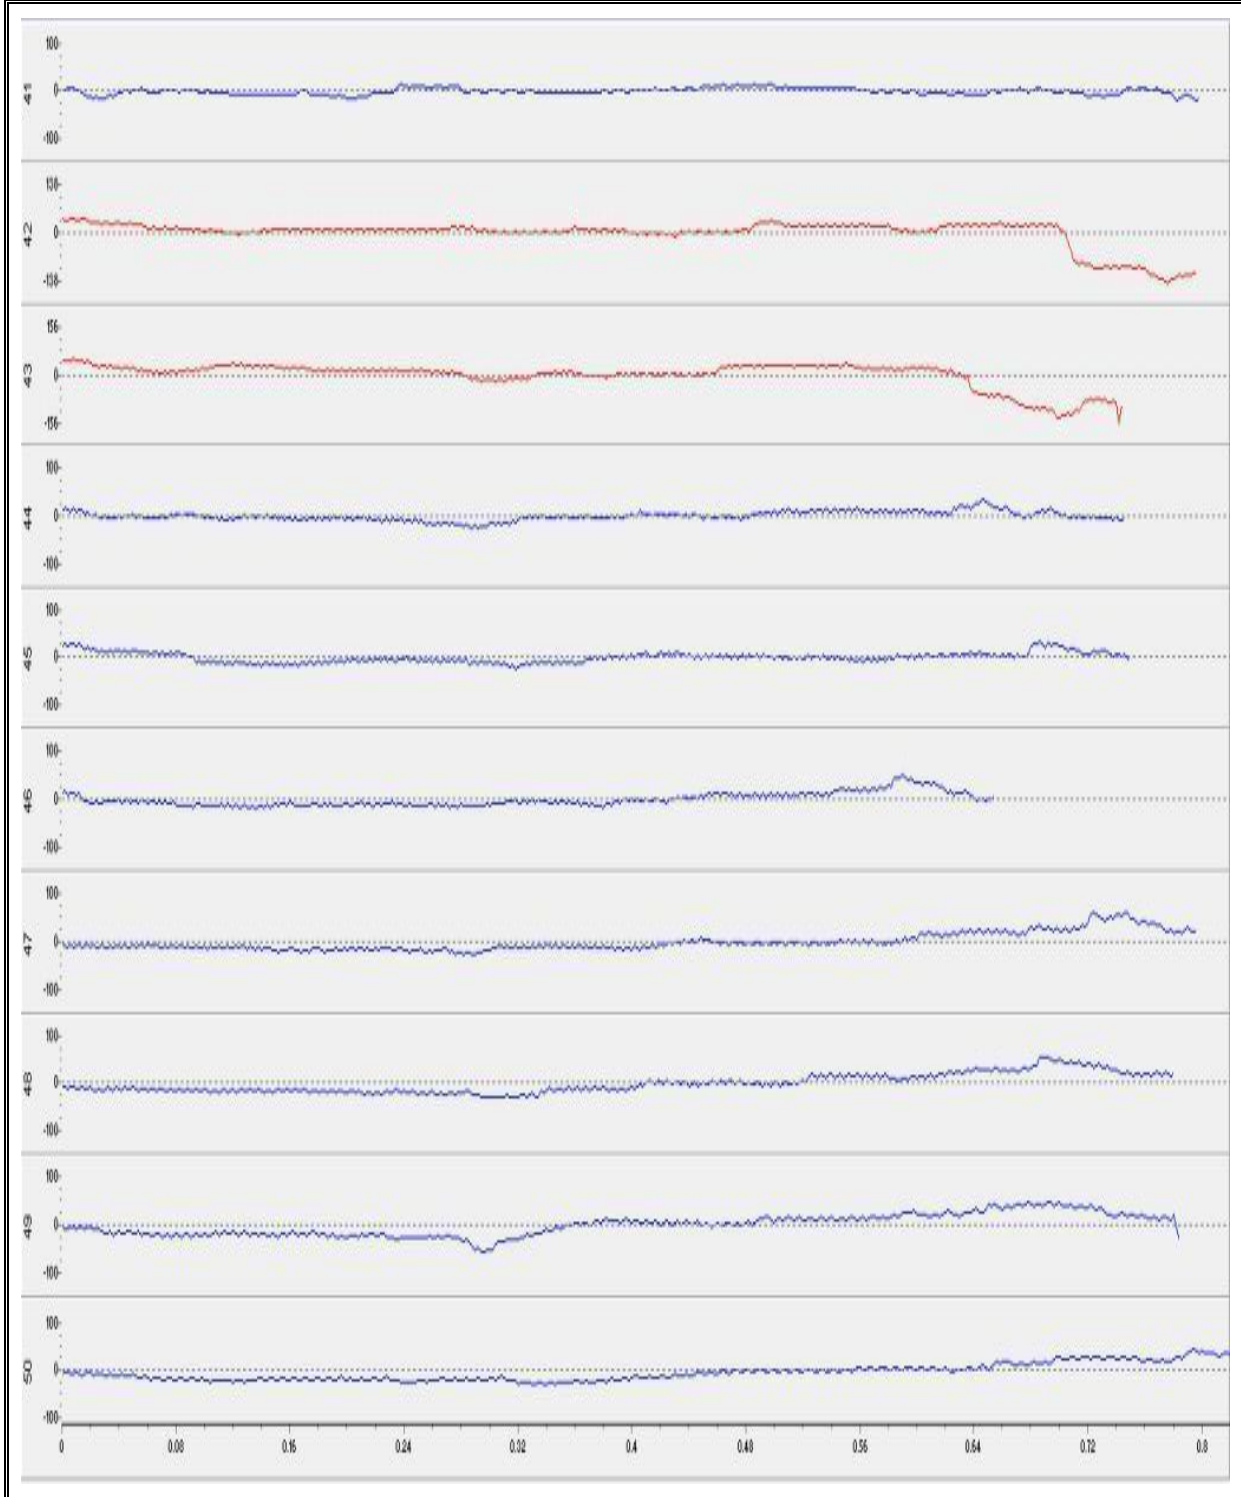
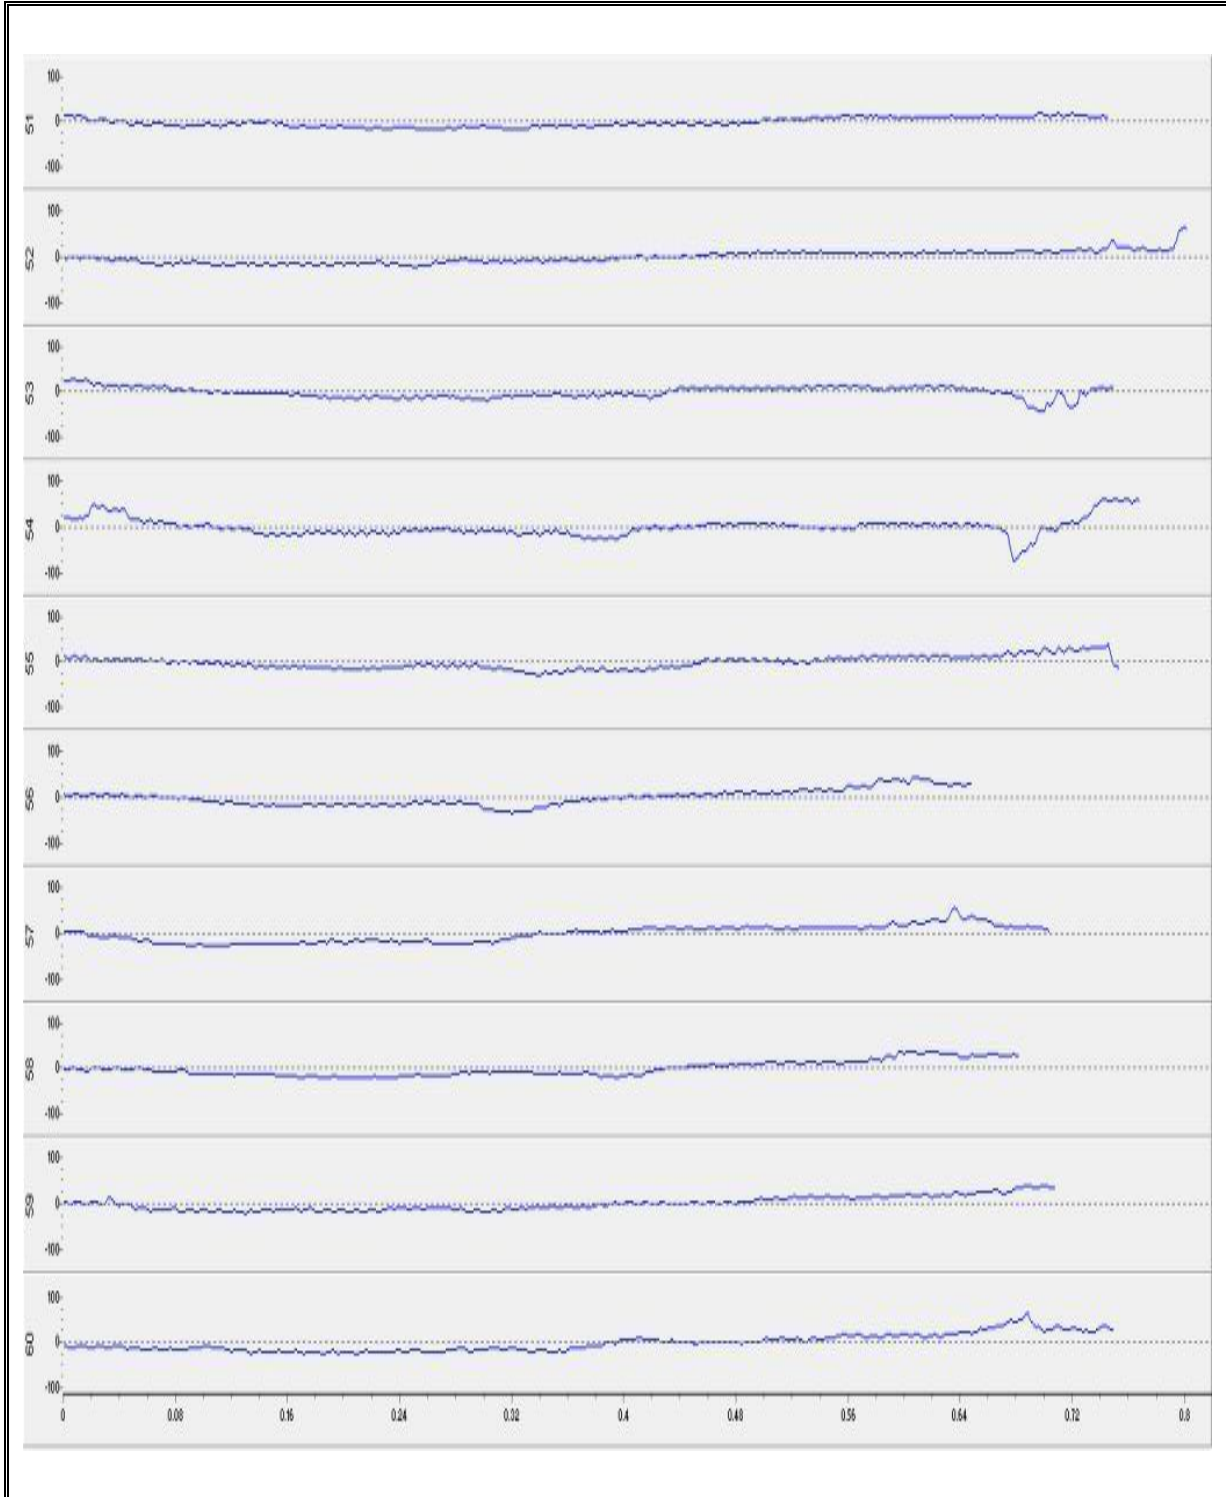
ELCID FAULT CURRENT GRAPHS OF SLOTS

- 1.0 The major core fault is observed in slot no 14 on both side wall regions, the fault is observed in packet 2, 3 and 4. The maximum fault current in slot 14 is found to be 331 mAs, which is much above threshold value.
- 2.0 Repair attempt was performed in slot 14 in packet 4 by filling mica flakes and the ELCID fault current values have come down from previous observed values.
- 3.0 The fault current was also observed to be more than threshold value in other locations as given in the table above. Graphs indicate all of this faults locations are in teeth portion.

The detailed assessment on ELCID test indicate that the intensity of core lamination shorting is more in slot 14, to remove the lamination shorting various repair techniques needs to be attempted like grinding of molten metal on the surface, applying electro-chemical etching at the fault area, filling the mica flake insulation between the laminations by loosening the core as possible.

Also the above repair techniques need to be applied on other than slot 14 locations, where the ELCID fault current values are above threshold limit.

ELCID test needs to be repeated after entire core repair, to assess the core condition after repair.

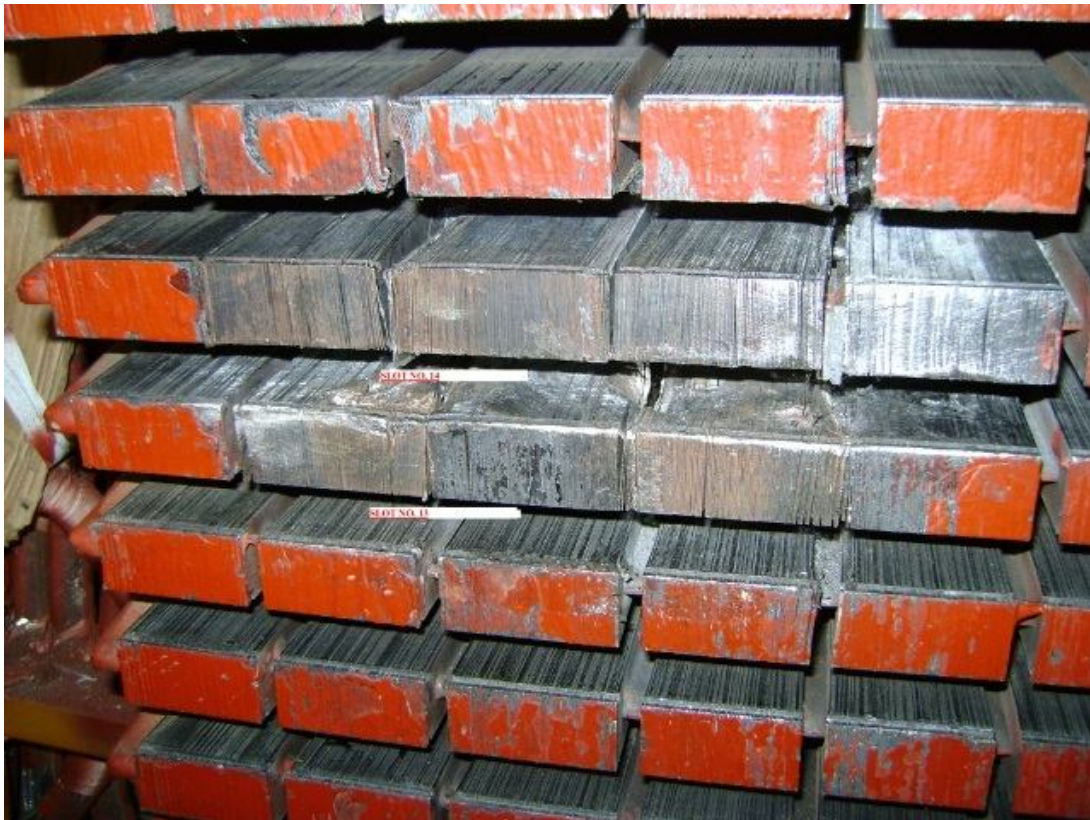
1. Core fault seen in slot no. 14

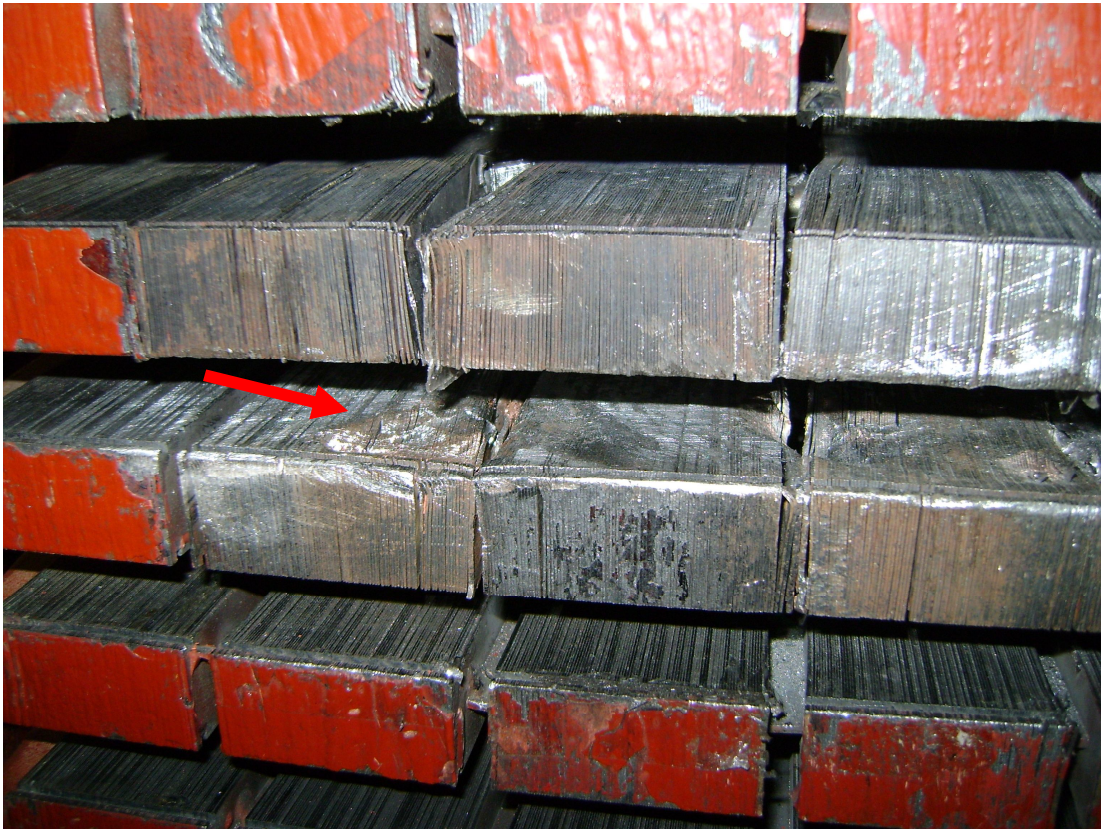
2. Core fault seen in slot 14.
