PATIKARI POWER PVT LTD

2 X 8 MW

Annual O&M Report

FY 2011-12

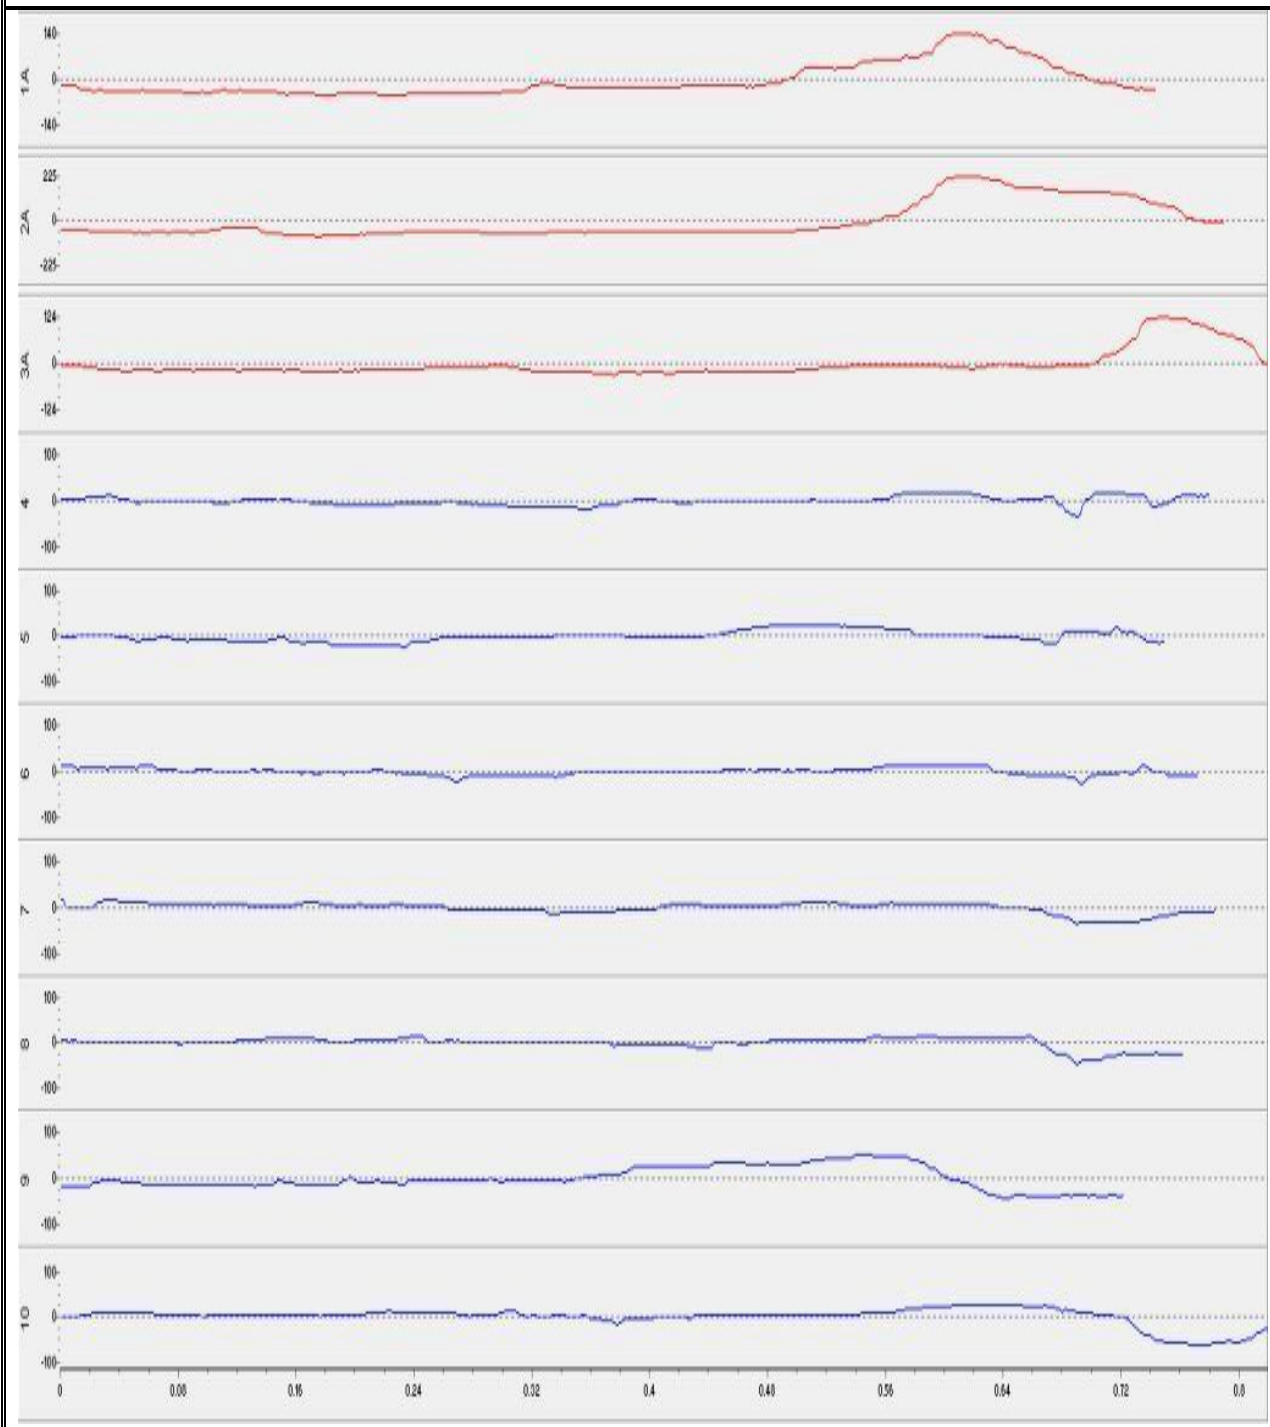
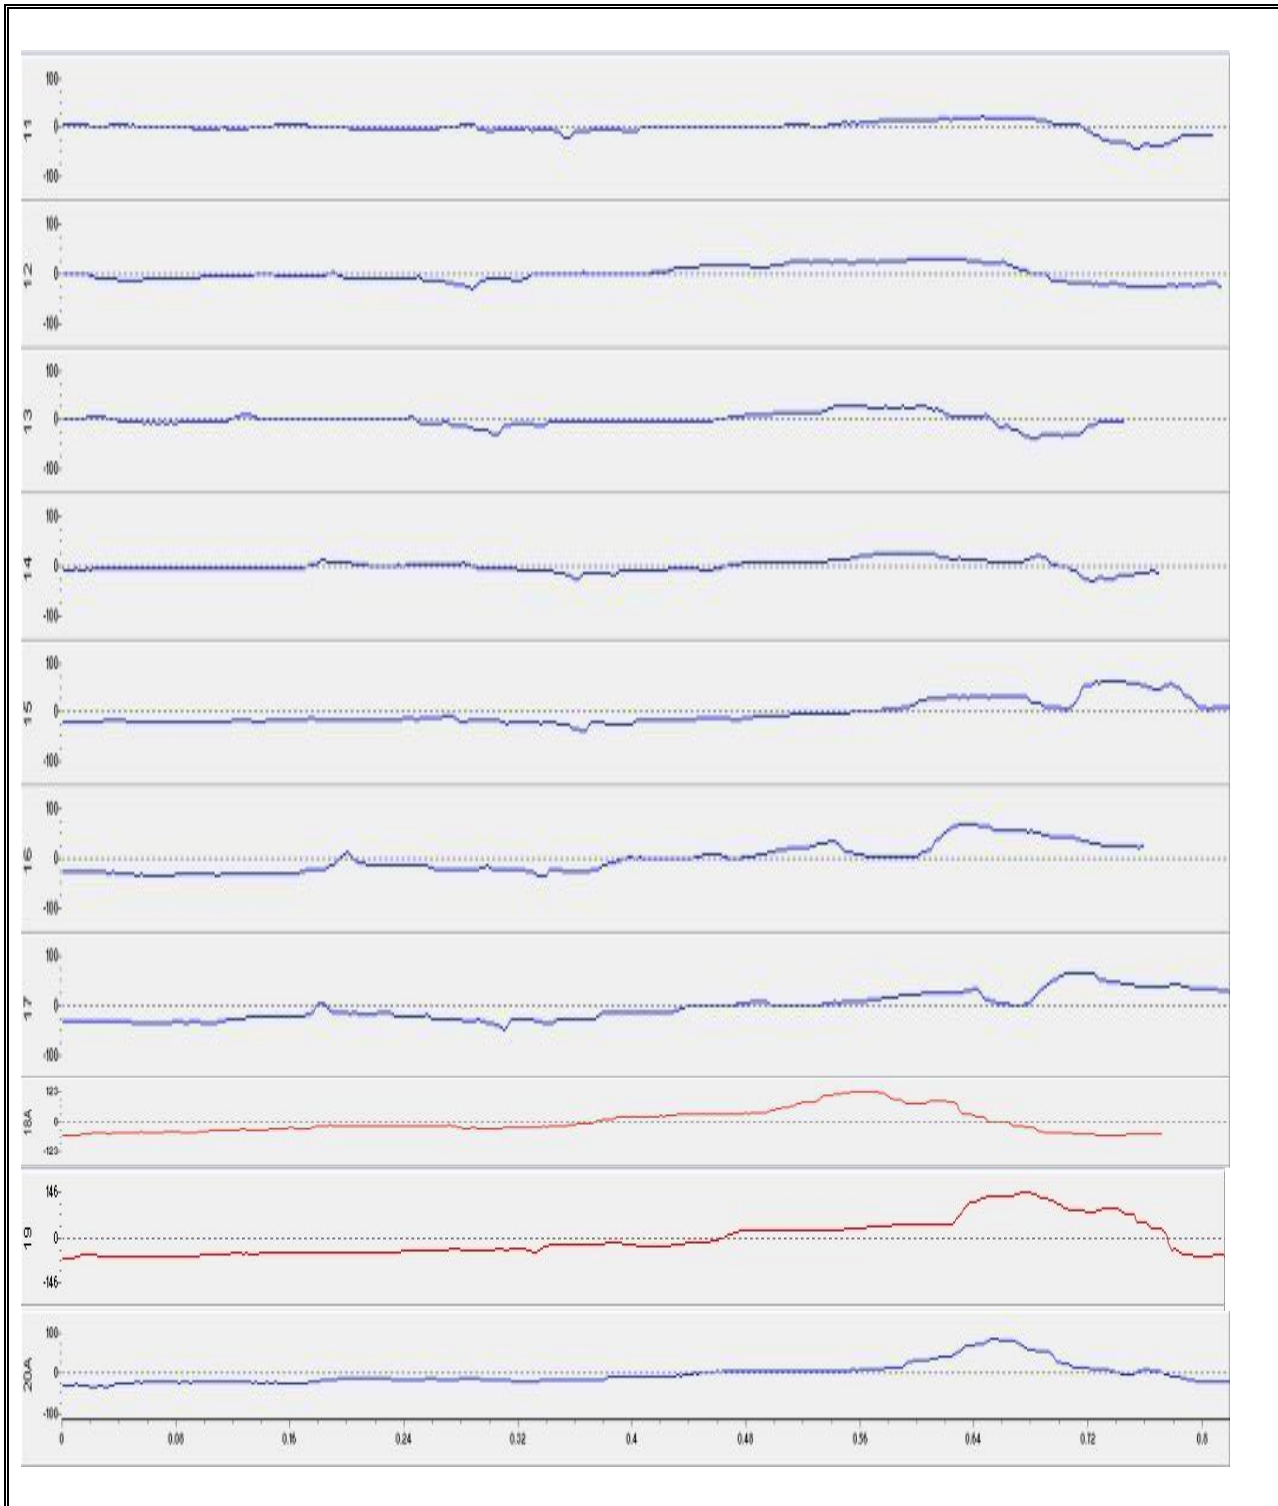
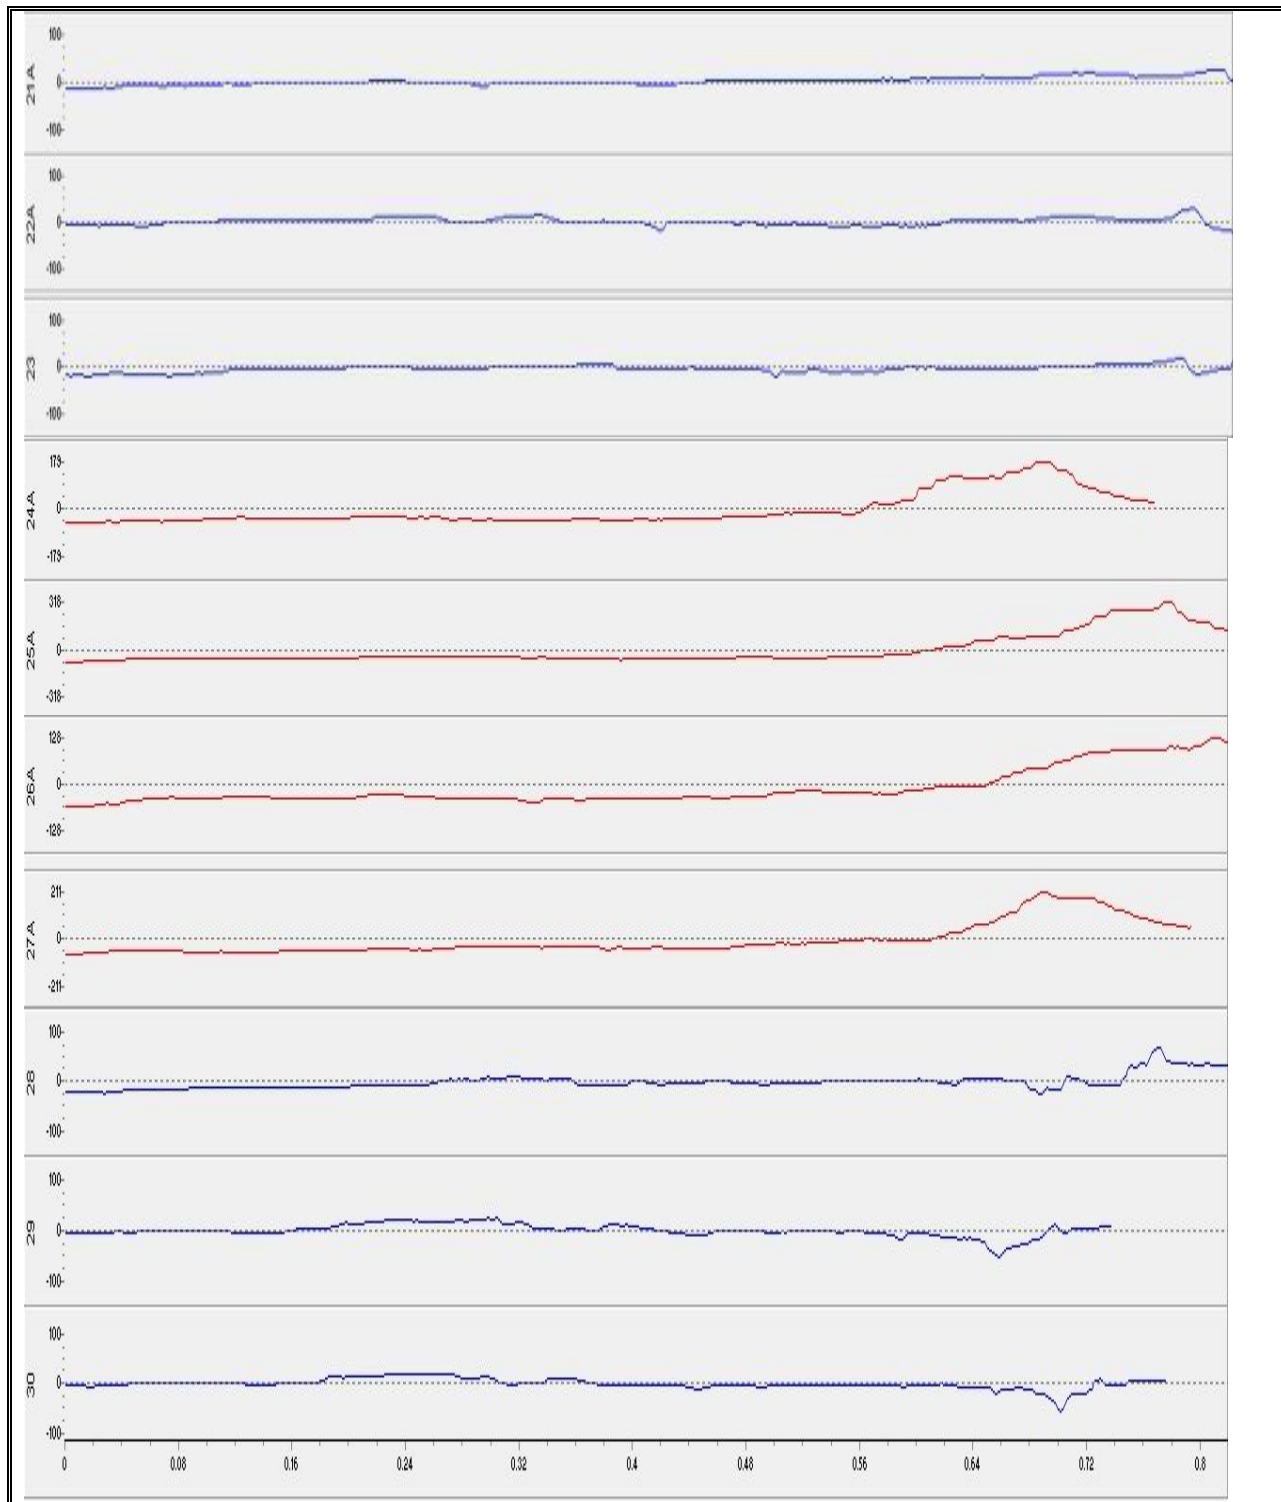
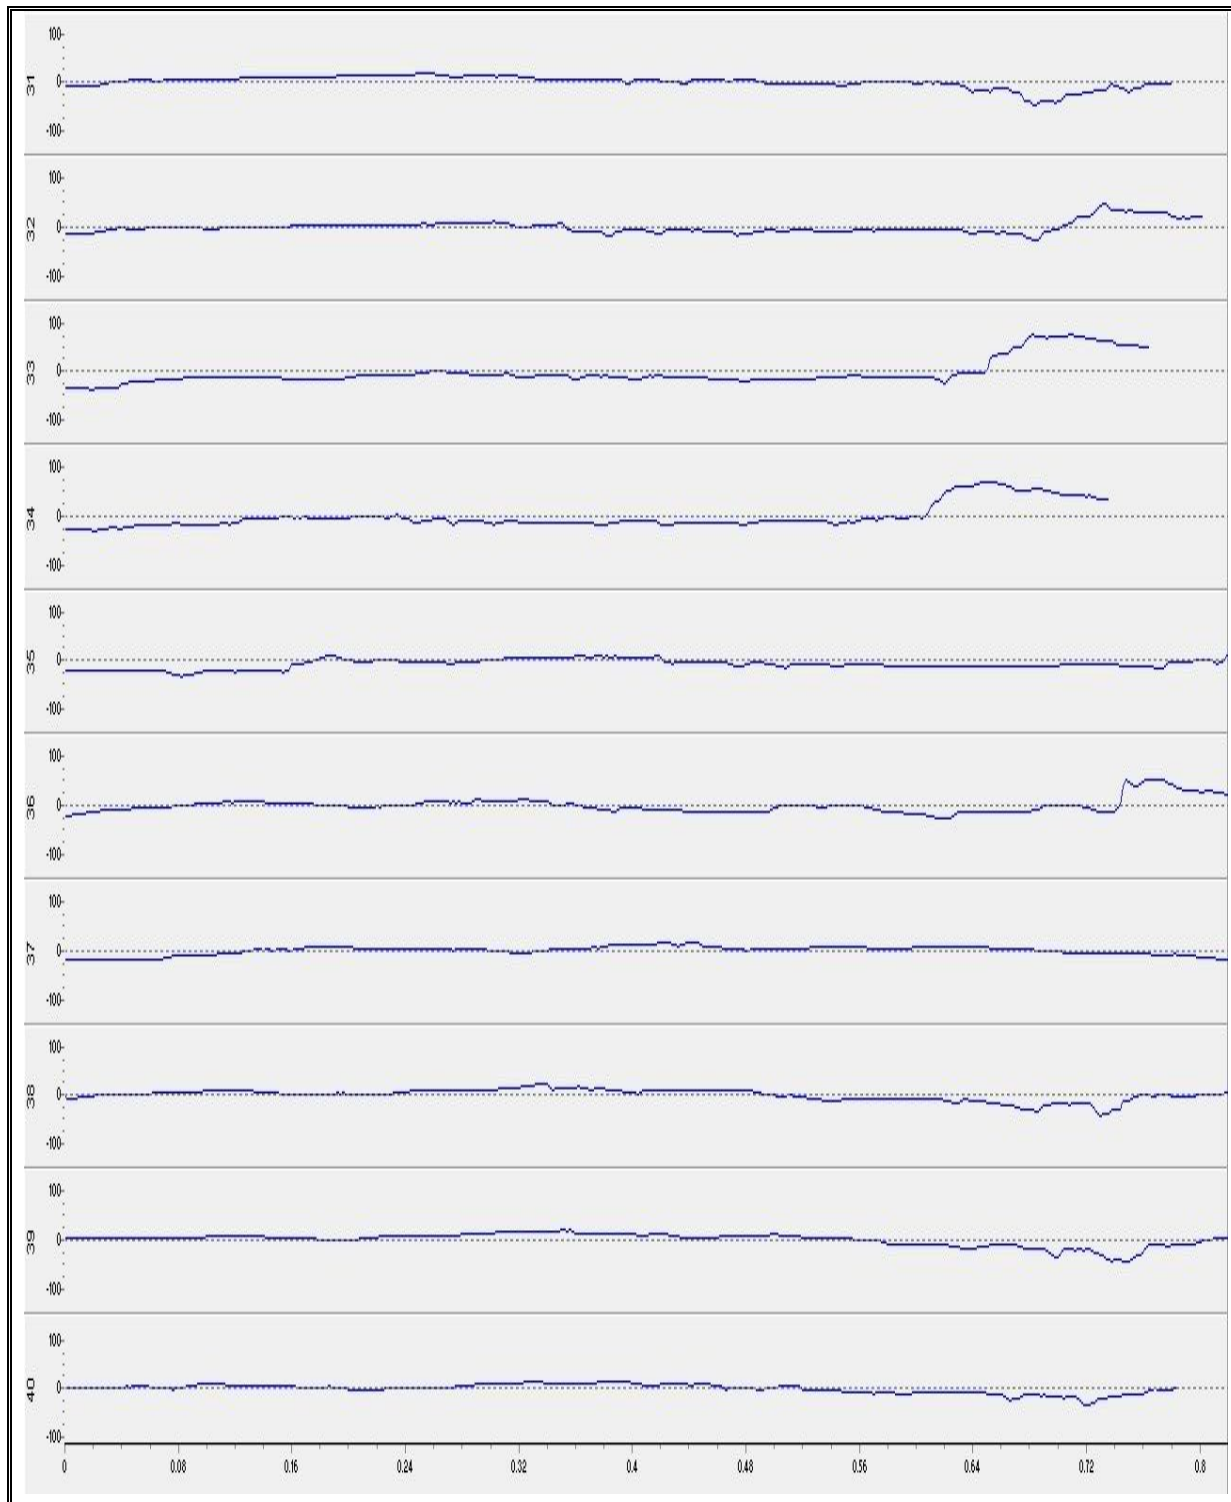
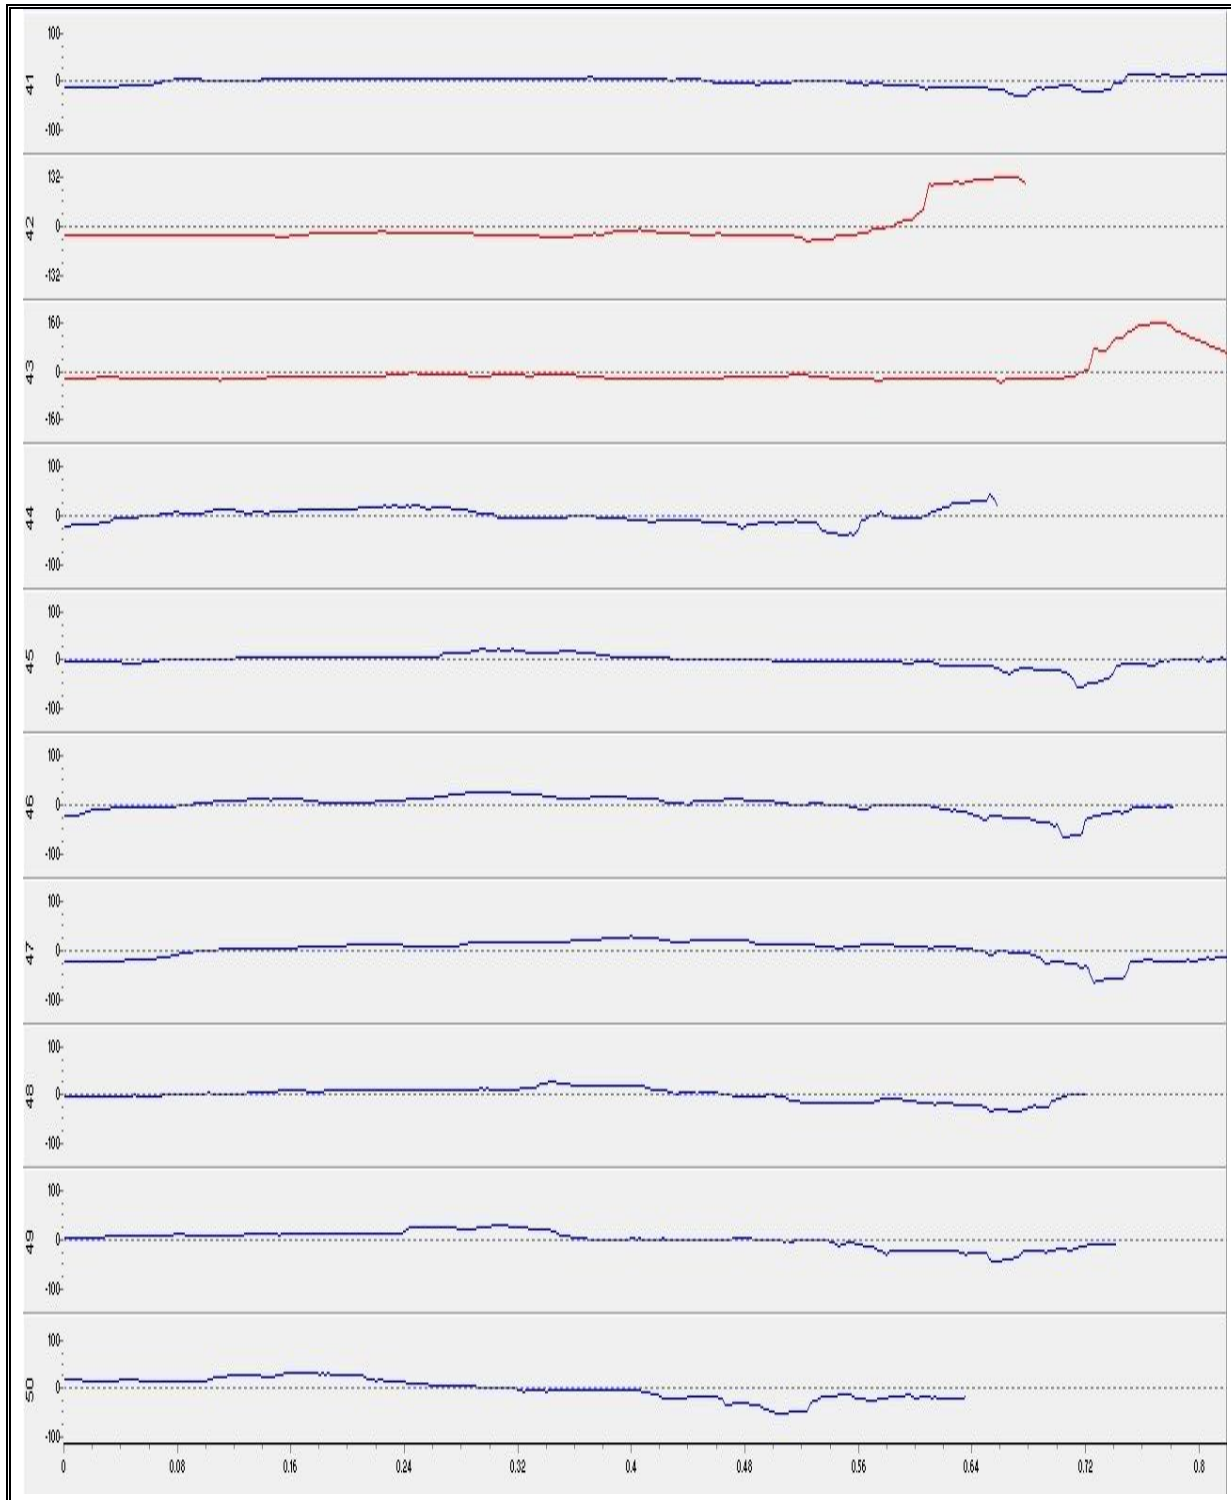
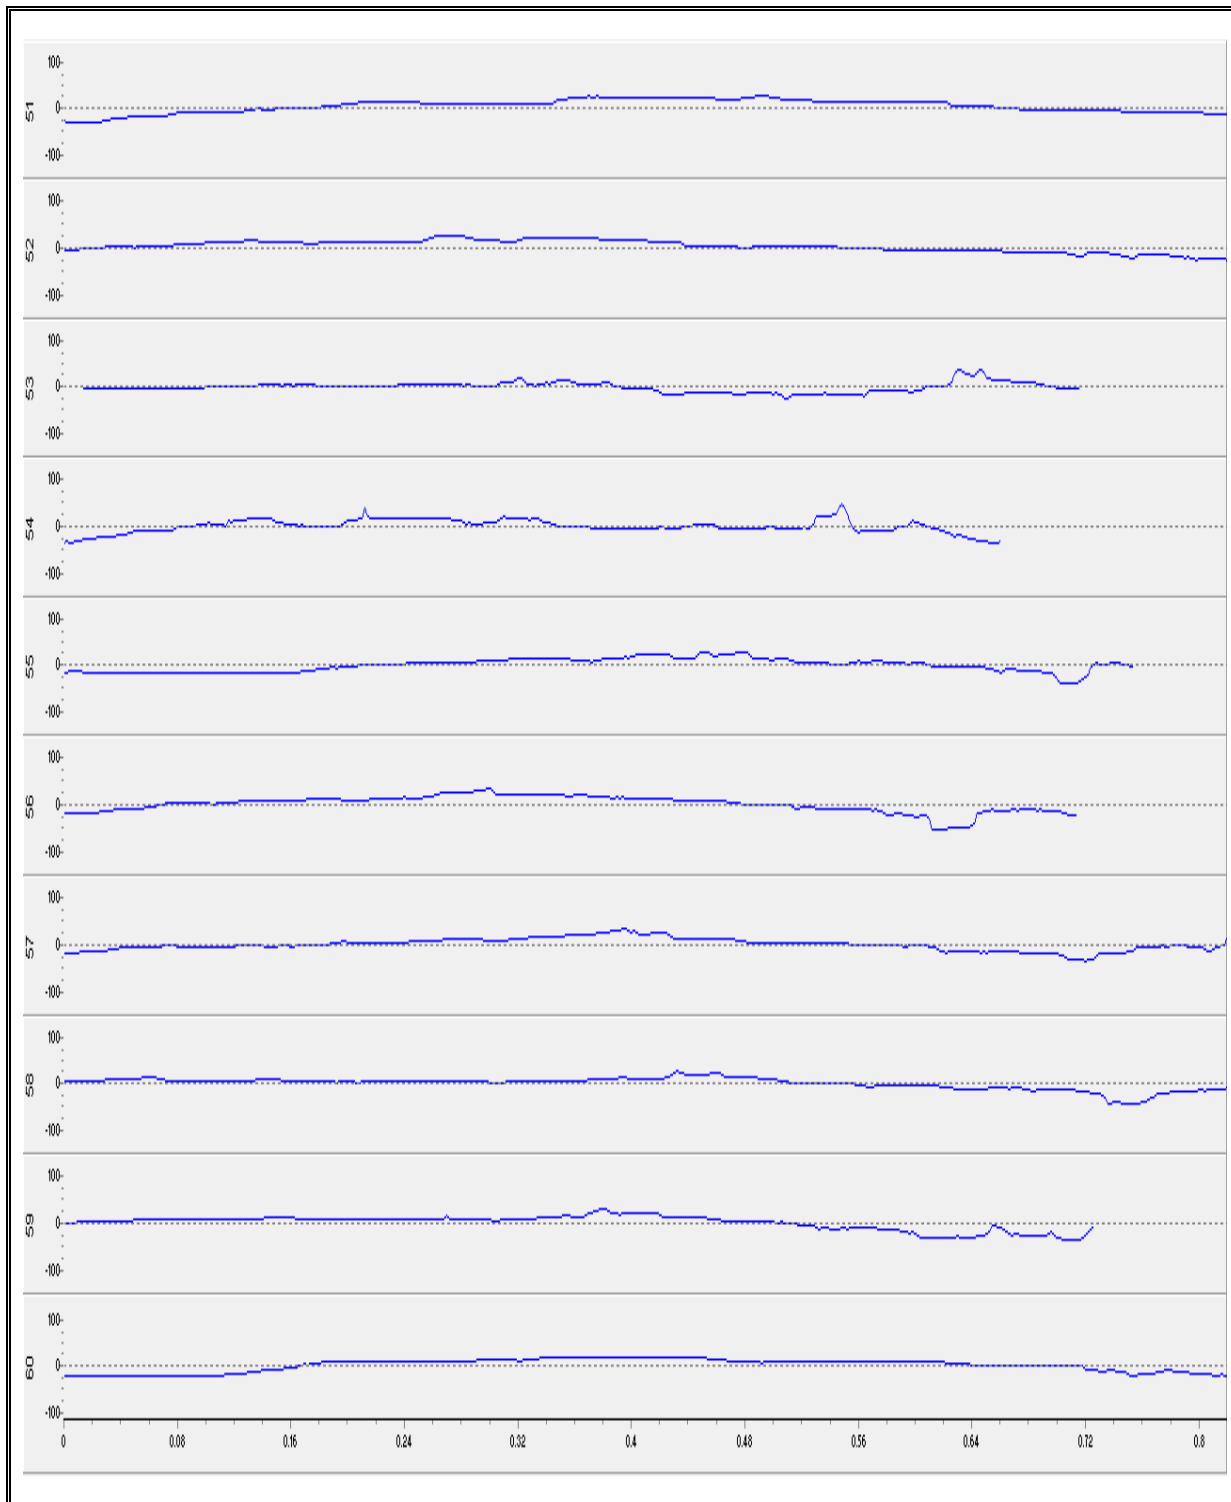
ELCID FAULT CURRENT GRAPHS OF SLOTS

1.0 The major core fault which was observed in slot no 14 on both side wall regions in packet 2, 3 and 4. Before restacking the maximum fault current in this slot 14 is found to be 331 mAs, which is much above threshold value.

Partial Repair was performed at this fault location by partially restacking the core and the ELCID test was repeated, ELCID test indicated the fault current values are well within limits indicating the removal of lamination shorting which was existing before the repair. The fault current values and graphs are as given in the report above.

2.0 The fault current which was observed to be more than threshold value in other locations as given in the table above could not be reduced further by the repair techniques adopted. The fault current values and graphs are as given in the report above.

The detailed assessment on ELCID test after repair indicate that the major core lamination shorting which was in slot 14 was successfully removed and thereby restored the core healthiness, However in few locations where the ELCID currents are above threshold limits, needs to be monitored for any abnormal temperature rise in this locations, this can be done by placing the RTD sensors at this locations and monitor the temperature, this is already recommended in our preliminary site report.

Also recommended to repeat the ELCID test, during next major overhaul to assess the core condition.

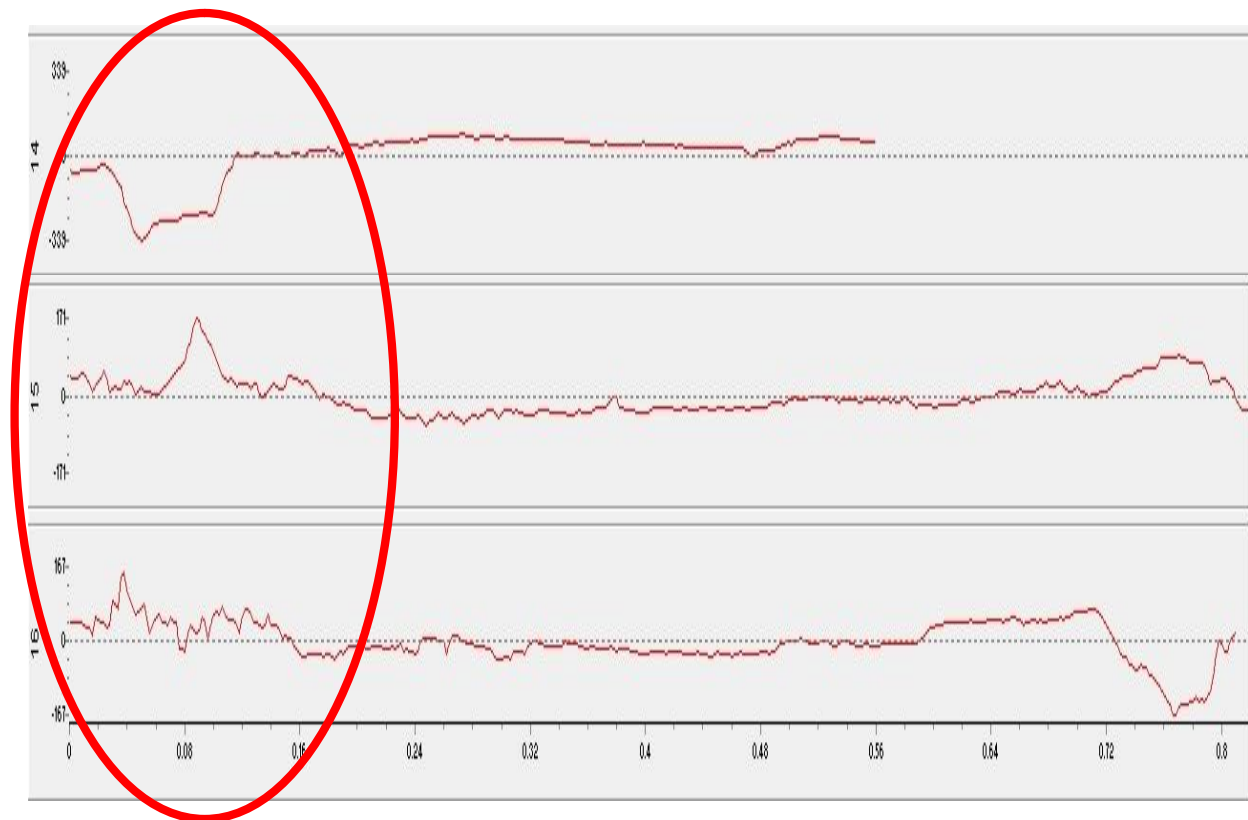
ELCID GRAPHS BEFORE PARTIAL RESTAKING OF THE CORE

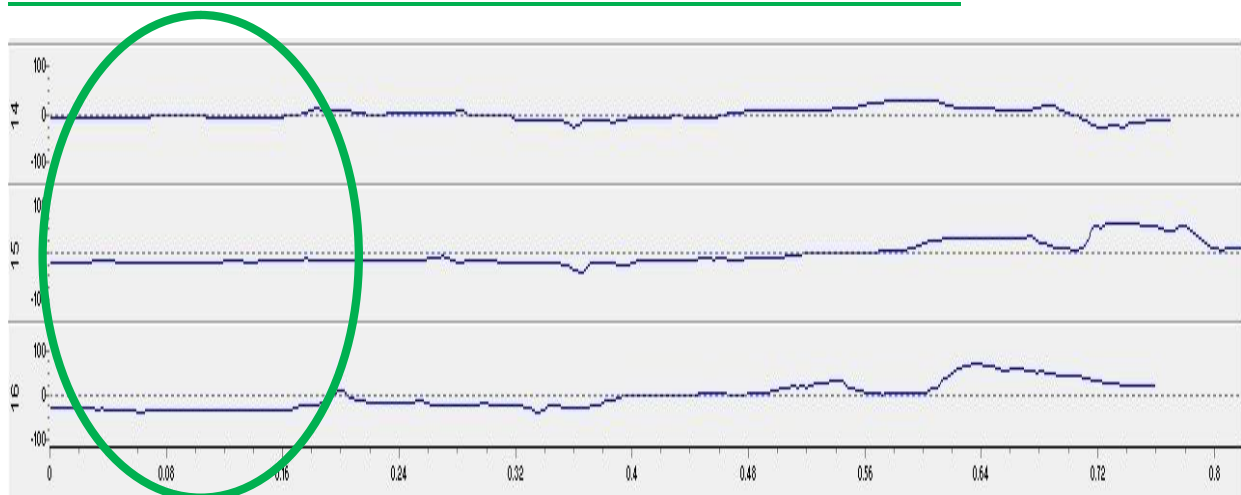
ELCID GRAPHS AFTER PARTIAL RESTAKING AND REPAIR OF THE CORE

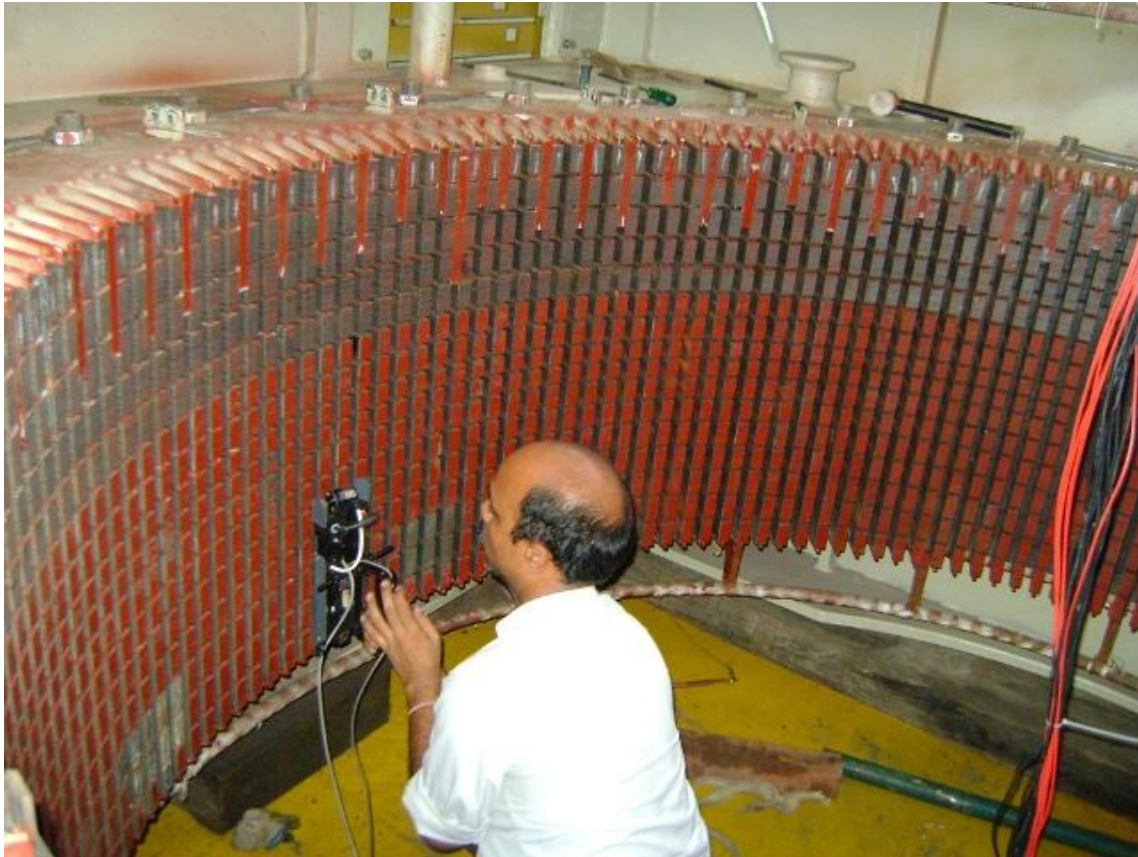
1. ELCID test performed after partial restacking of core

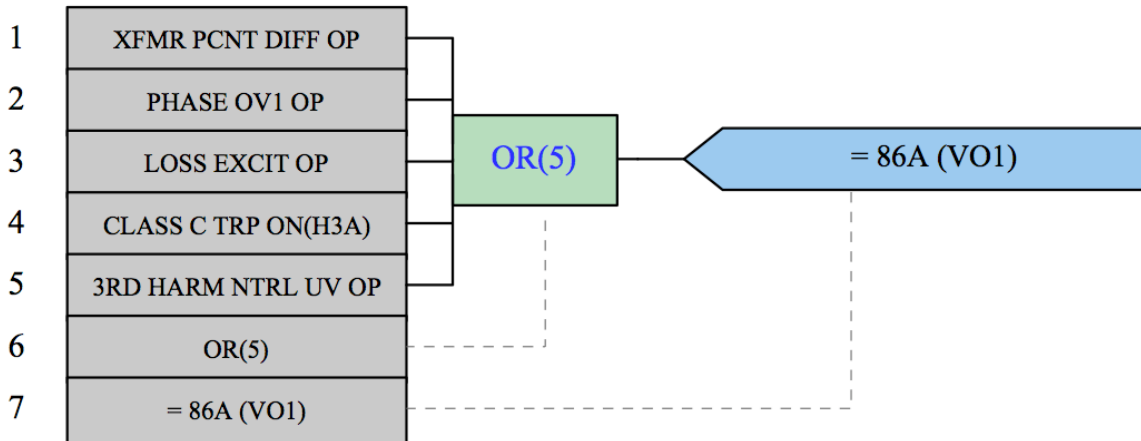
Figure 2.1: Graphic representation of Flex Logic Equation for CLASS A tripping

The 86A master trip relay is assigned for total shutdown of the machine and is wired to trip the generator circuit breaker (GCB), field circuit breaker and turbine. In the G30 relay configuration, all protections that operate for generator internal faults are to be assigned to trip this master trip relay. Figure 2.1 shows the graphic representation of the "Flex Logic Equation" for the CLASS A tripping. The "Virtual Output 1"(VO1) is assigned to operate the output contact 1 of G30, which is wired to initiate tripping of the 86A master trip relay.

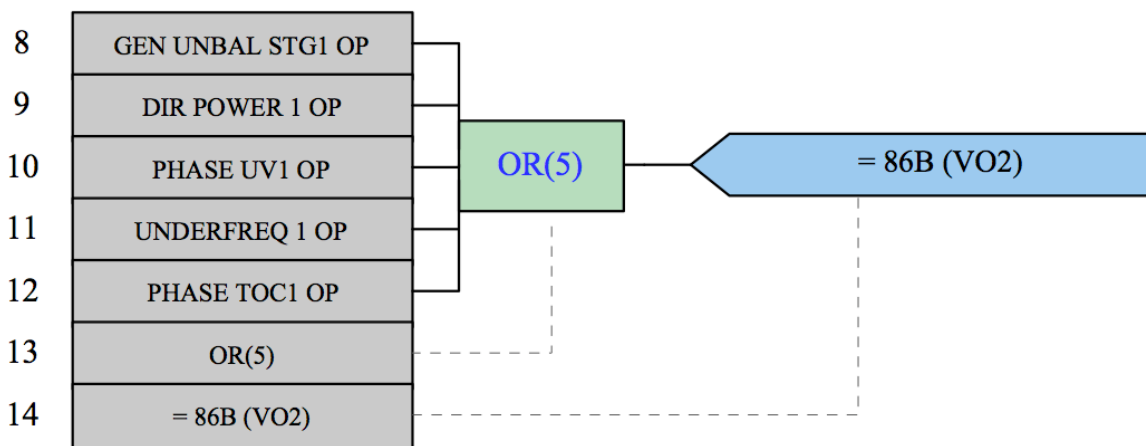
Figure 2.2: Graphic representation of Flex Logic Equation for CLASS B tripping

generator breaker is tripped, the load on the generator will become zero and most generators will not be able to sustain 100% load throw-off and continue to run with no-load.

If this class of tripping has to be effective then the isolation will have to be done by tripping the 33kV circuit breaker. By doing so for any un-cleared fault in the 33kV system, this class of tripping will isolate the power plant from the grid and allow the generator to continue to operate feeding its own auxiliary load. And as soon as the grid is healthy the power plant can be re-synchronized.

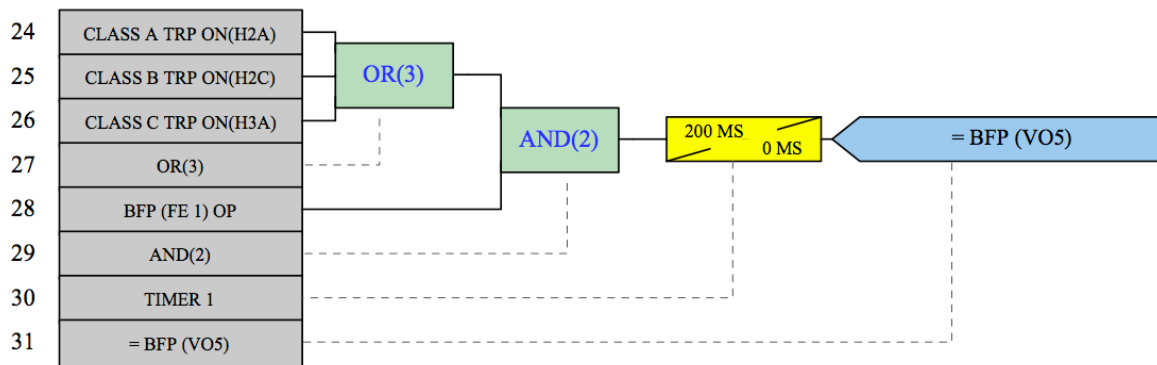
Figure 2.4: Graphic representation of Flex Logic Equation for CBF protection

The time delay for the CBF element is usually set to 200ms (to account for the breaker opening time, current comparator reset and safety margin). This delay is provided in the "Flex Logic Timer1". The existing value of this timer is 1000ms and it is proposed to reduce it to 200ms. Figure 2.4 shows the graphic representation of the "Flex Logic Equation" for the CBF protection. The "Virtual Output 5"(VO5) is assigned to the "Digital Element 1" in G30 relay and labelled as "BFP TRIP". This "Digital Element 1" is assigned to operate the output contacts 4, 9, 10, 11, 12 and 13 of G30, which are wired to

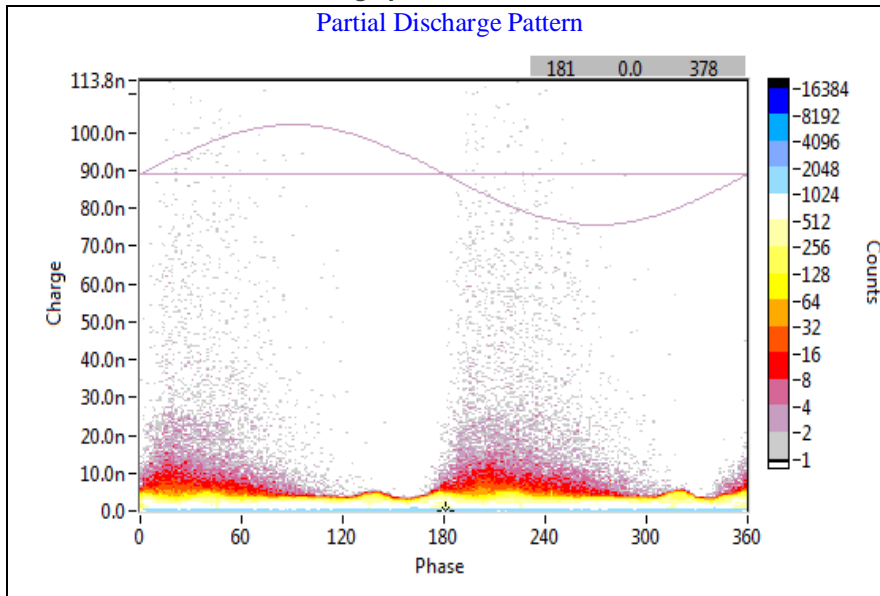
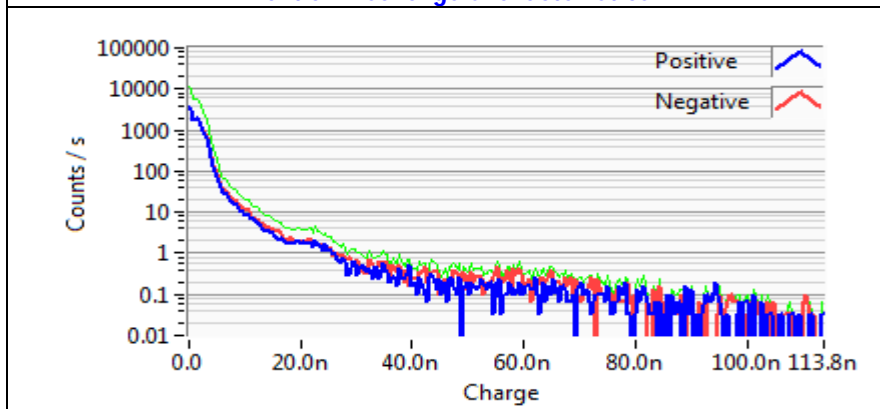
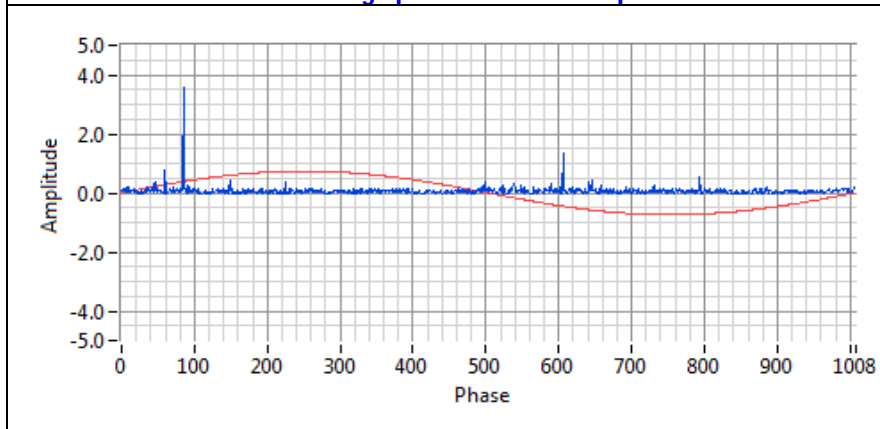
Partial Discharge pattern of B Phase @ 3 kV

1. Partial Discharge pattern for all phases suggest that the partial discharges are occurring at slot region and end winding region, the discharge pattern also indicates the internal discharges occurring within the insulation.
2. Partial discharge magnitude charge value as measured is found to be on much higher side, indicating that the discharge levels in the winding are occurring to greater extent. The partial discharge inception voltage is also found to be on lower side indicating deterioration of insulation condition.
3. Assessment indicates the partial discharges levels on this winding are much above limits for this type and age of insulation.

Partial Discharge pattern for all phases suggest that the partial discharges are occurring at slot region and end winding region, the discharge pattern also indicates the internal discharges occurring within the insulation. Partial discharge magnitude charge value as measured is found to be on much higher side, indicating that the discharge levels in the winding are occurring to greater extent. The partial discharge inception voltage is also found to be on lower side indicating deterioration of insulation condition. Assessment indicates the partial discharges levels on this winding are much above limits for this type and age of insulation.

From the assessment conducted based on tan delta and partial discharge test analysis, which is as mentioned in **section 2.0**, it is concluded that the stator winding is not in healthy condition. Assessment indicates that, stator winding has deteriorated to larger extent. The deterioration process is of serious concern as the Generator is put into operation, with time this deterioration processes will effect the main ground wall insulation leading to winding failure. **Hence for a permanent solution, we recommend to completely rewind the stator with new coils at next available opportunity.**
