PATIKARI POWER PVT LTD

2 X 8 MW

Annual O&M Report

FY 2011-12

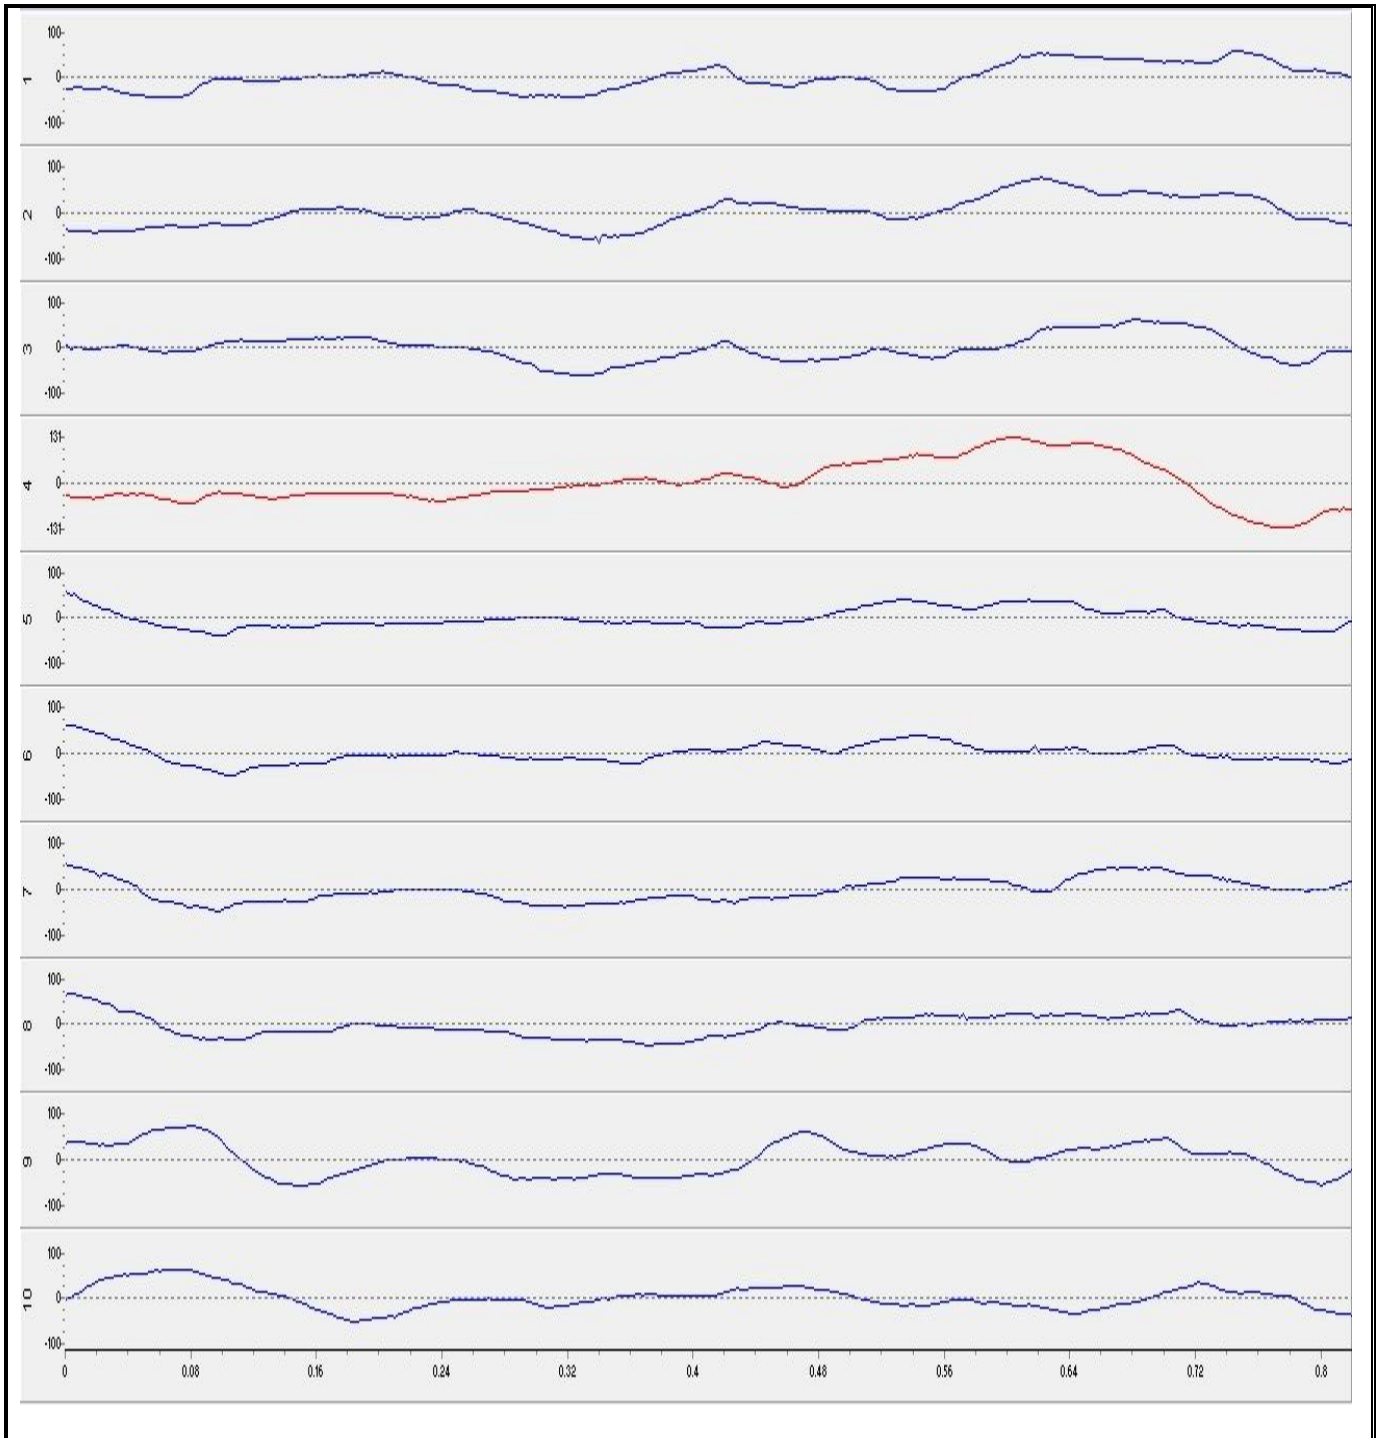
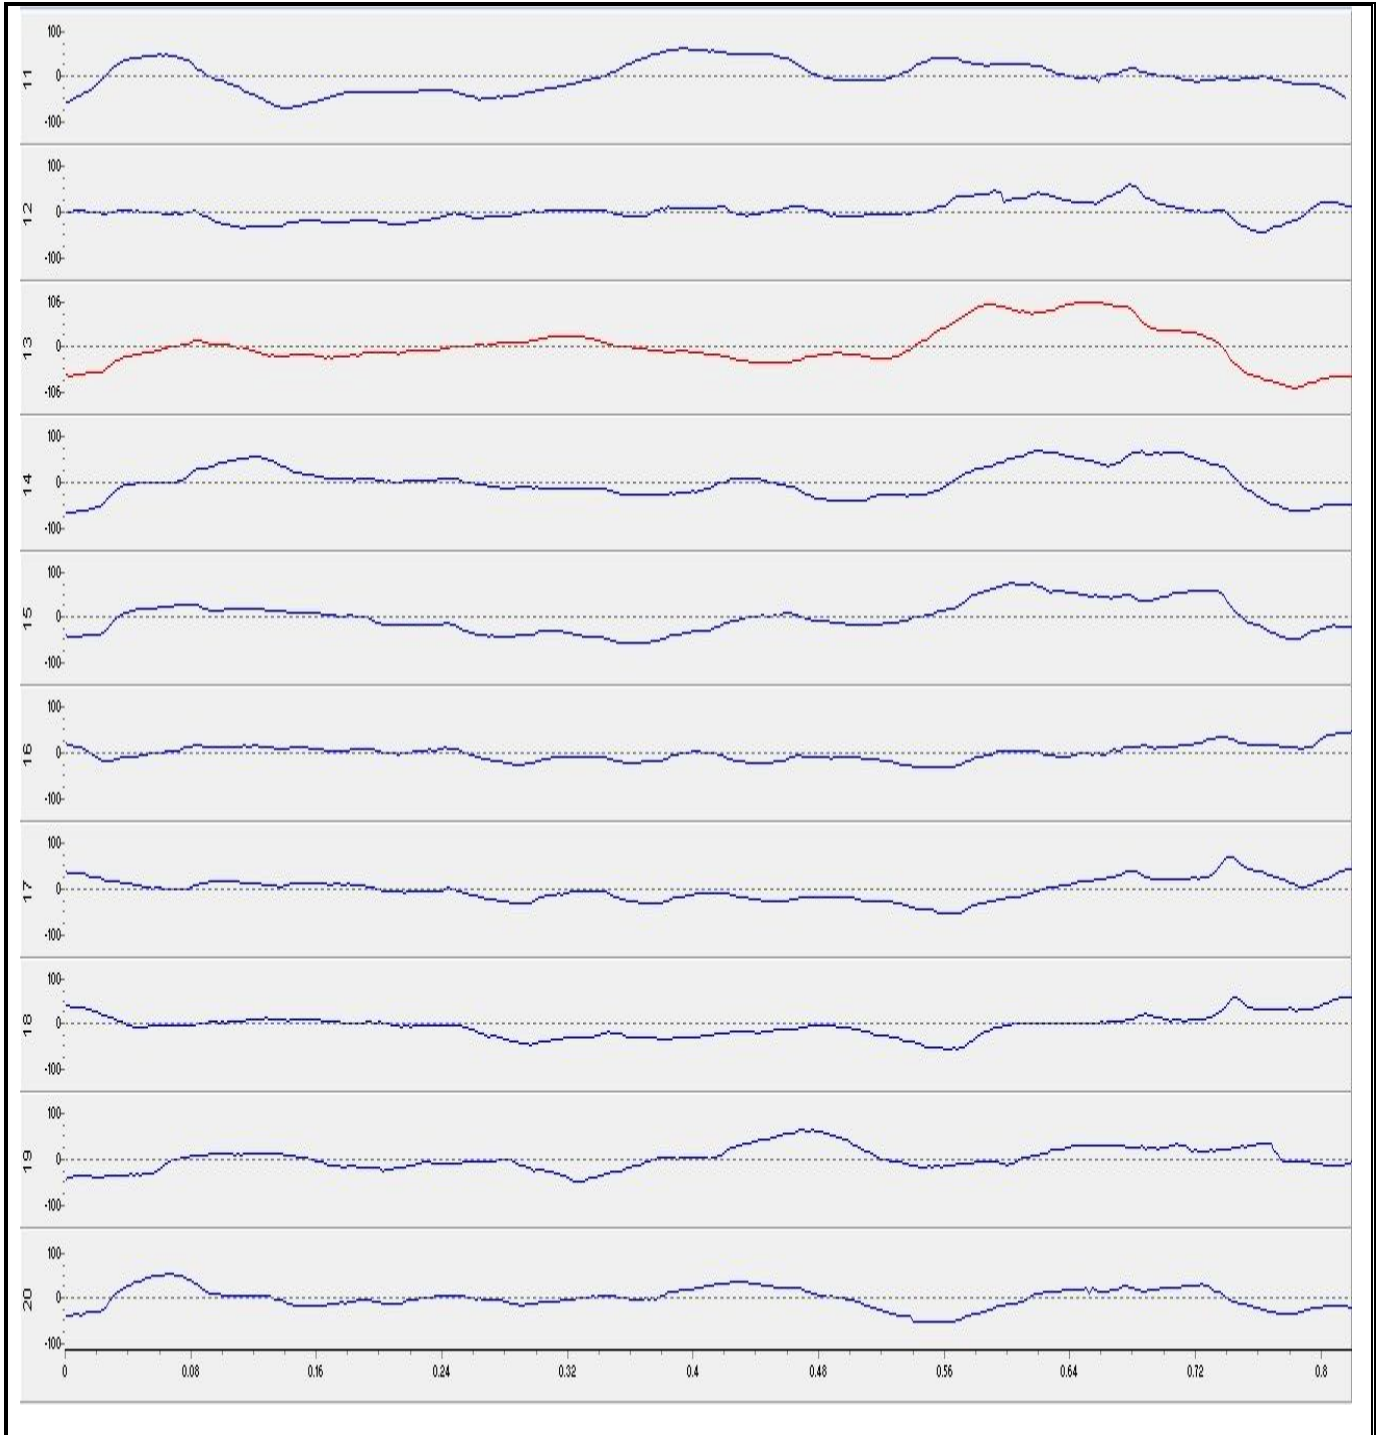
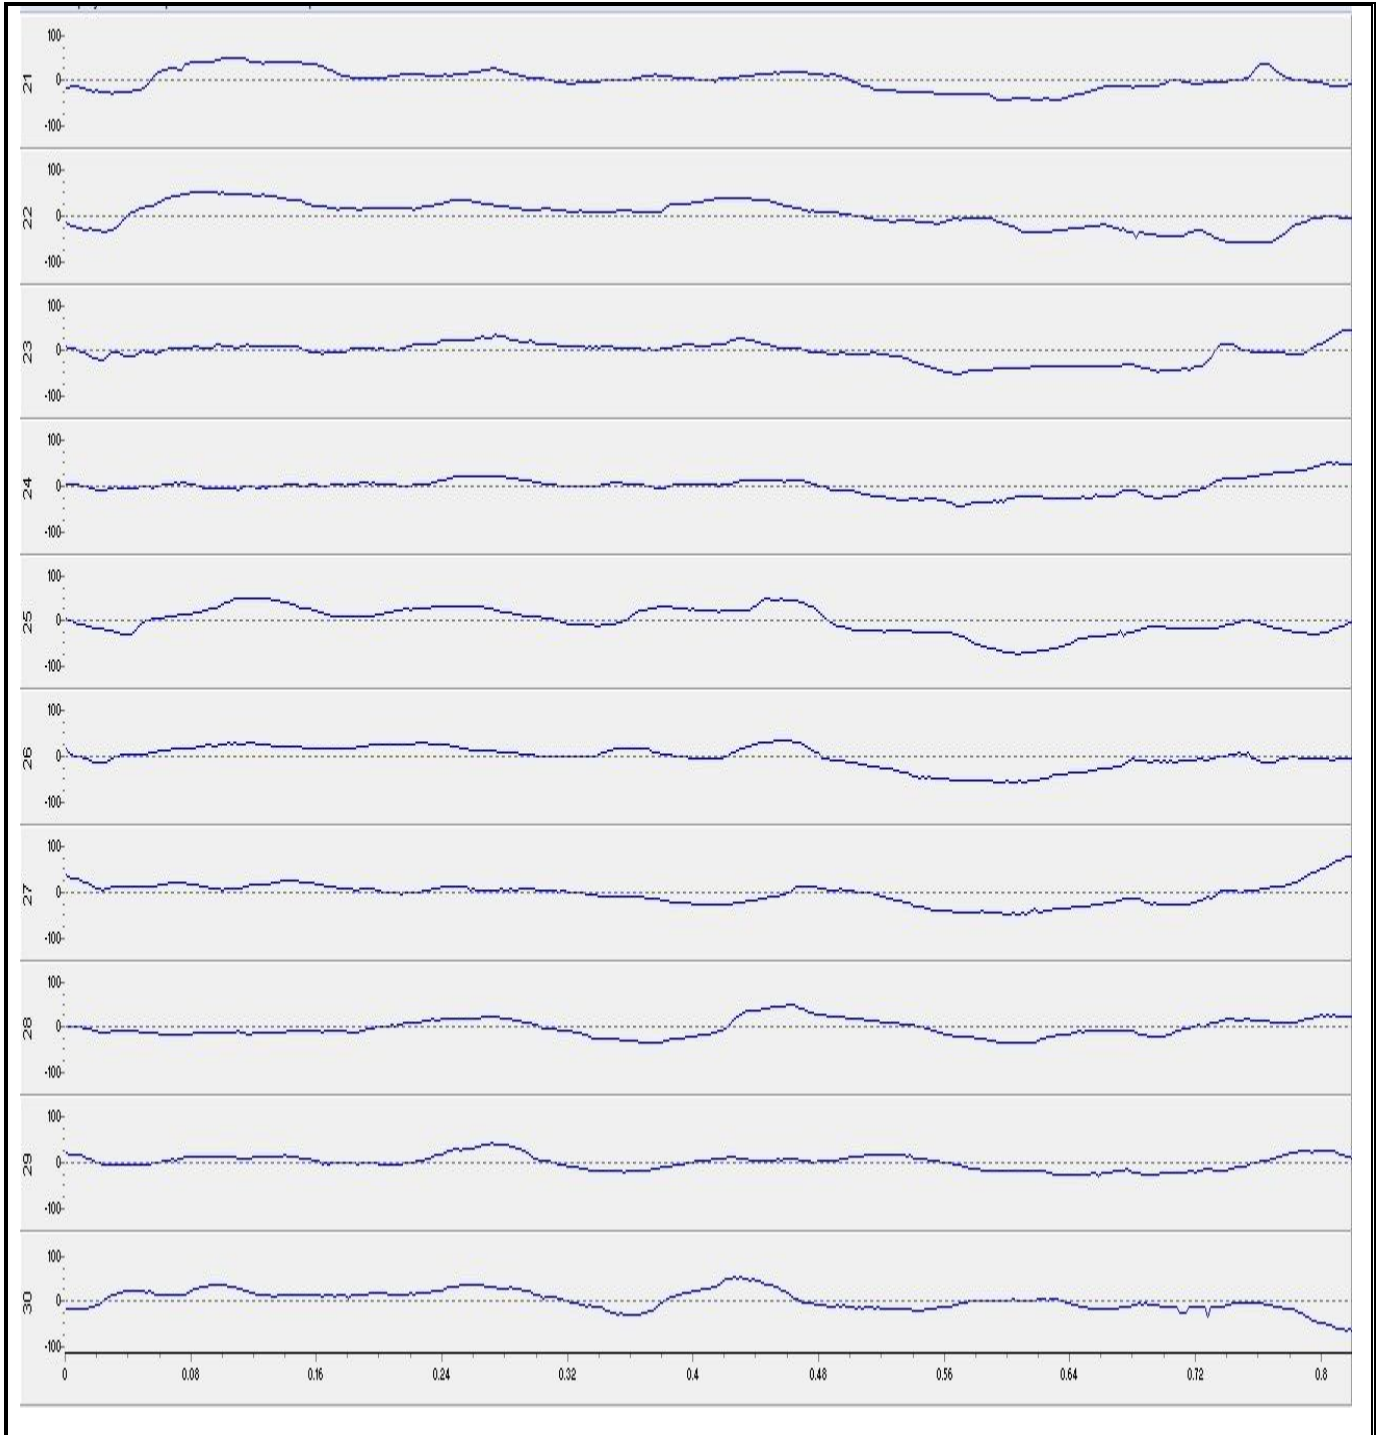
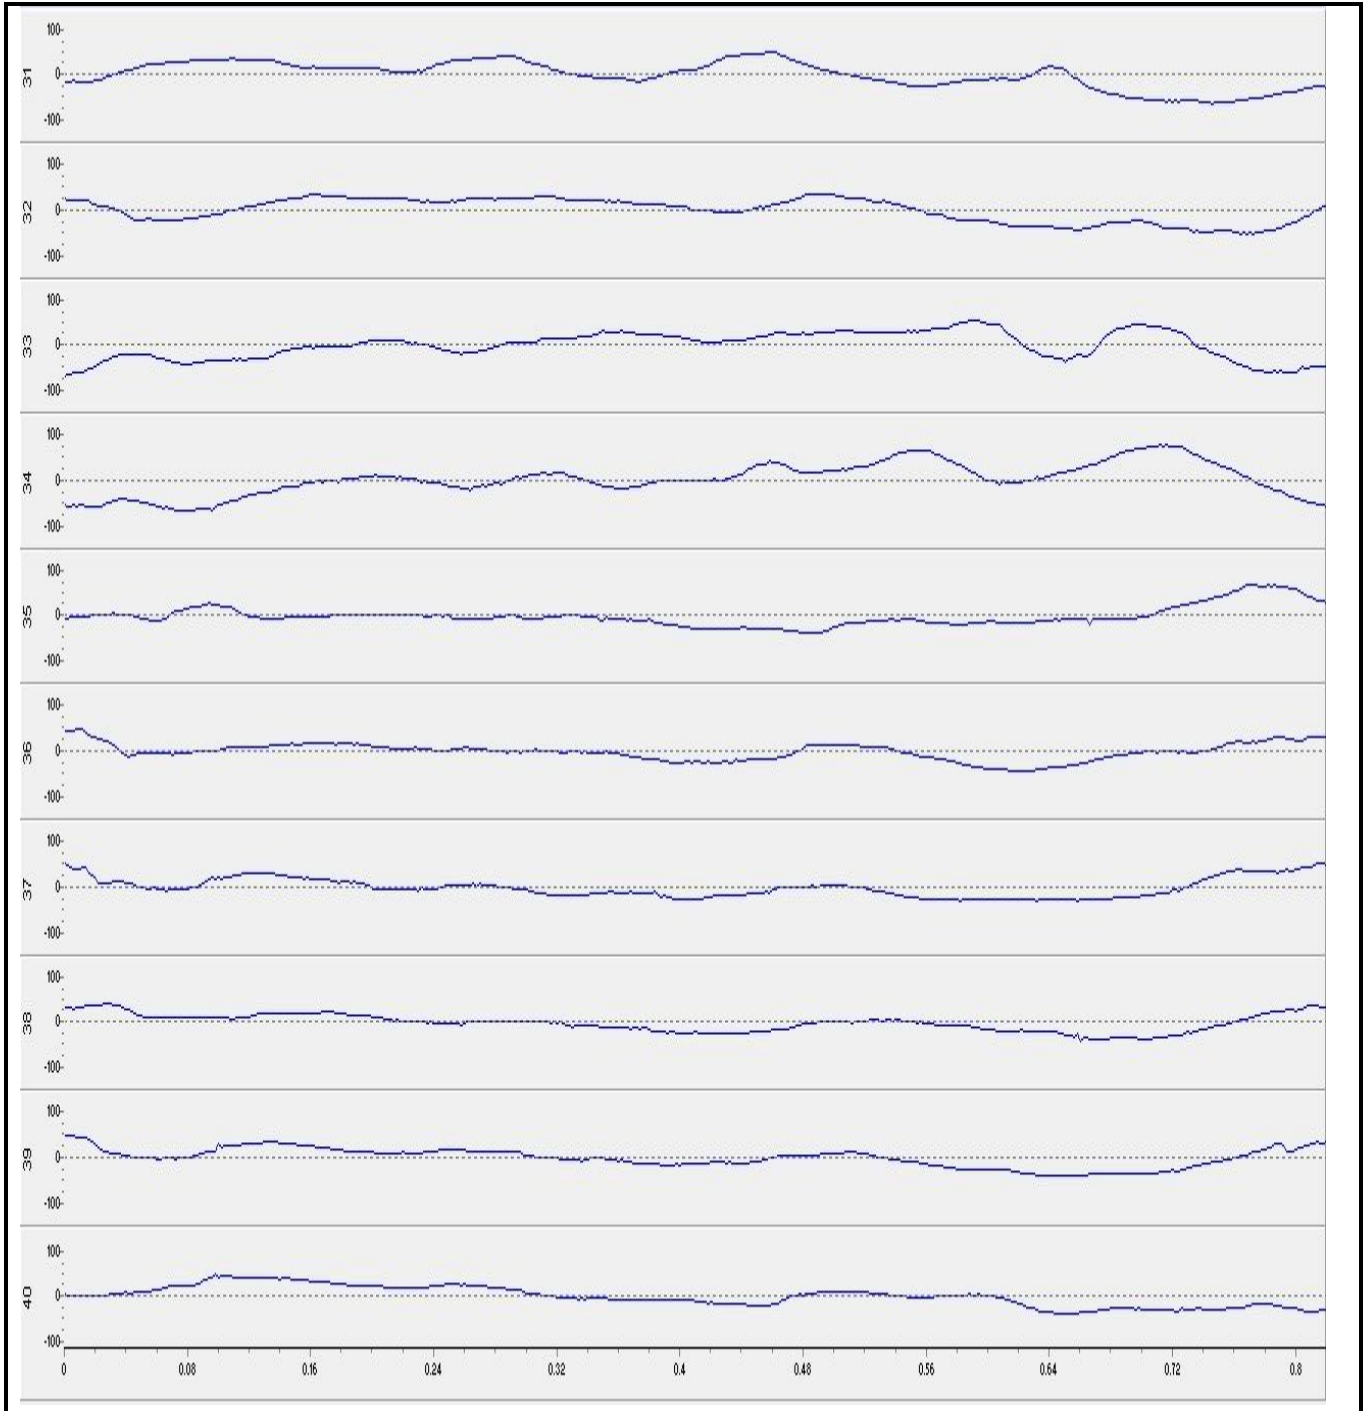
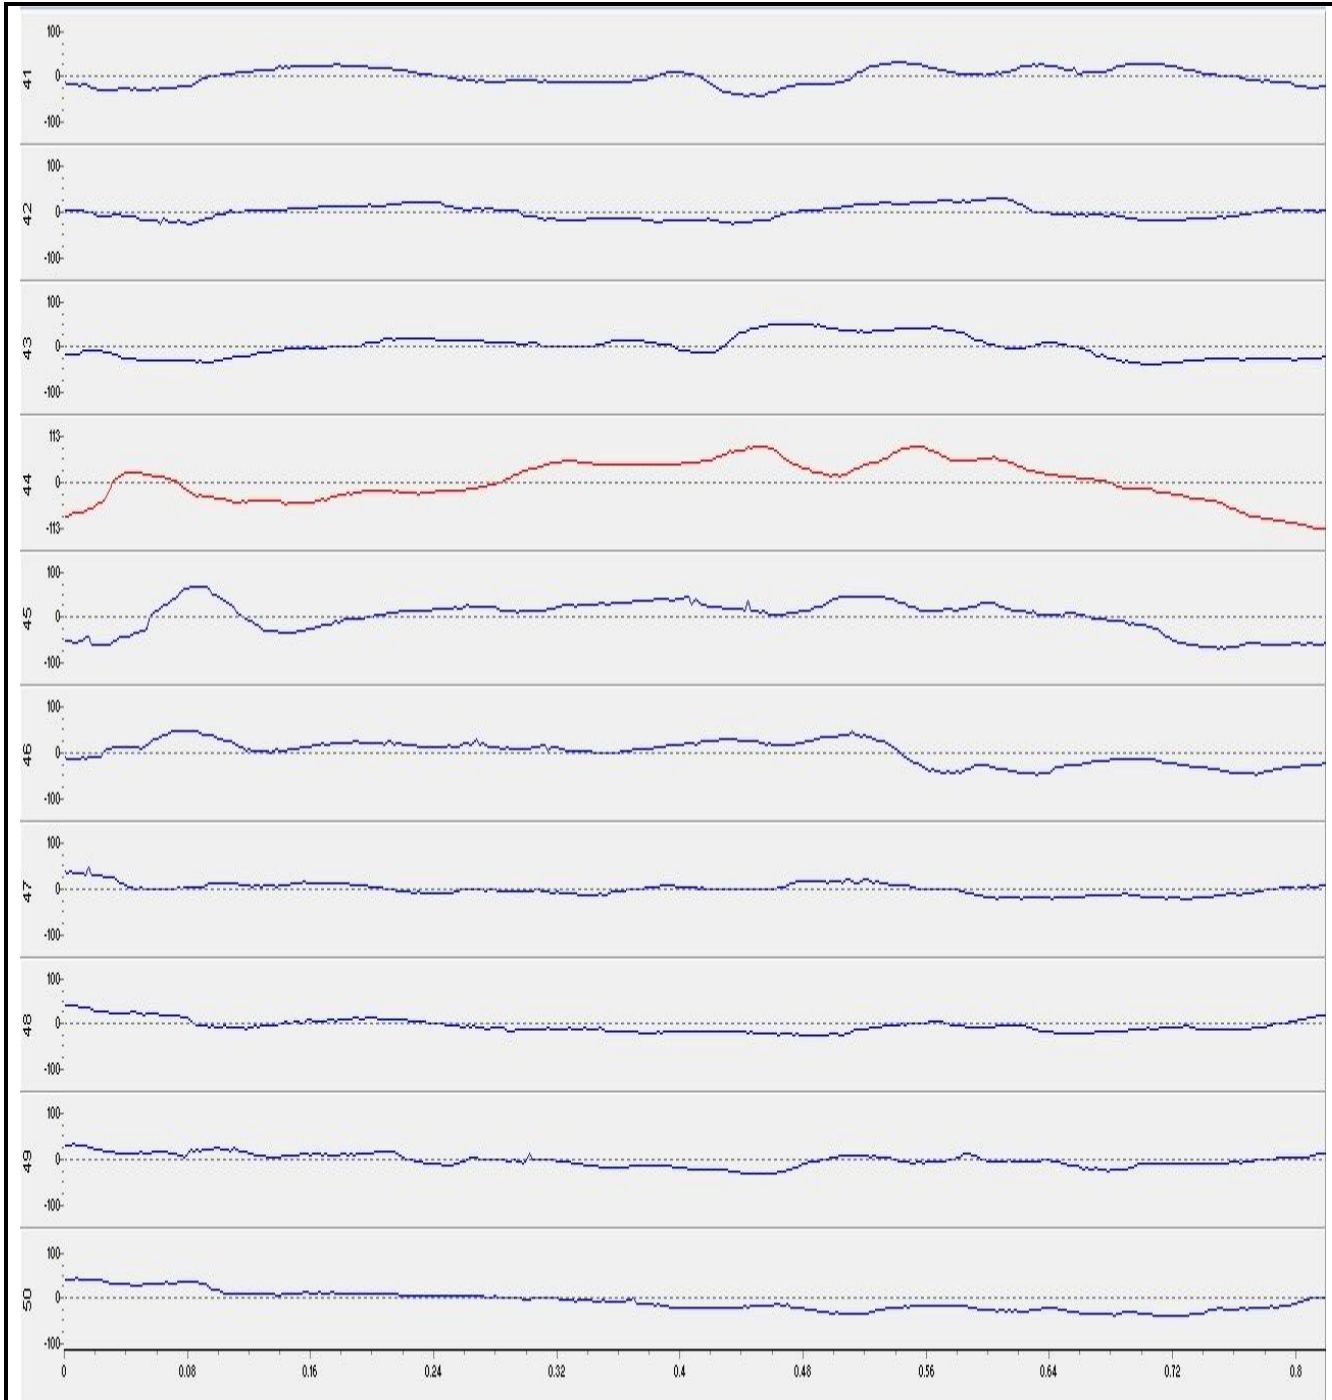
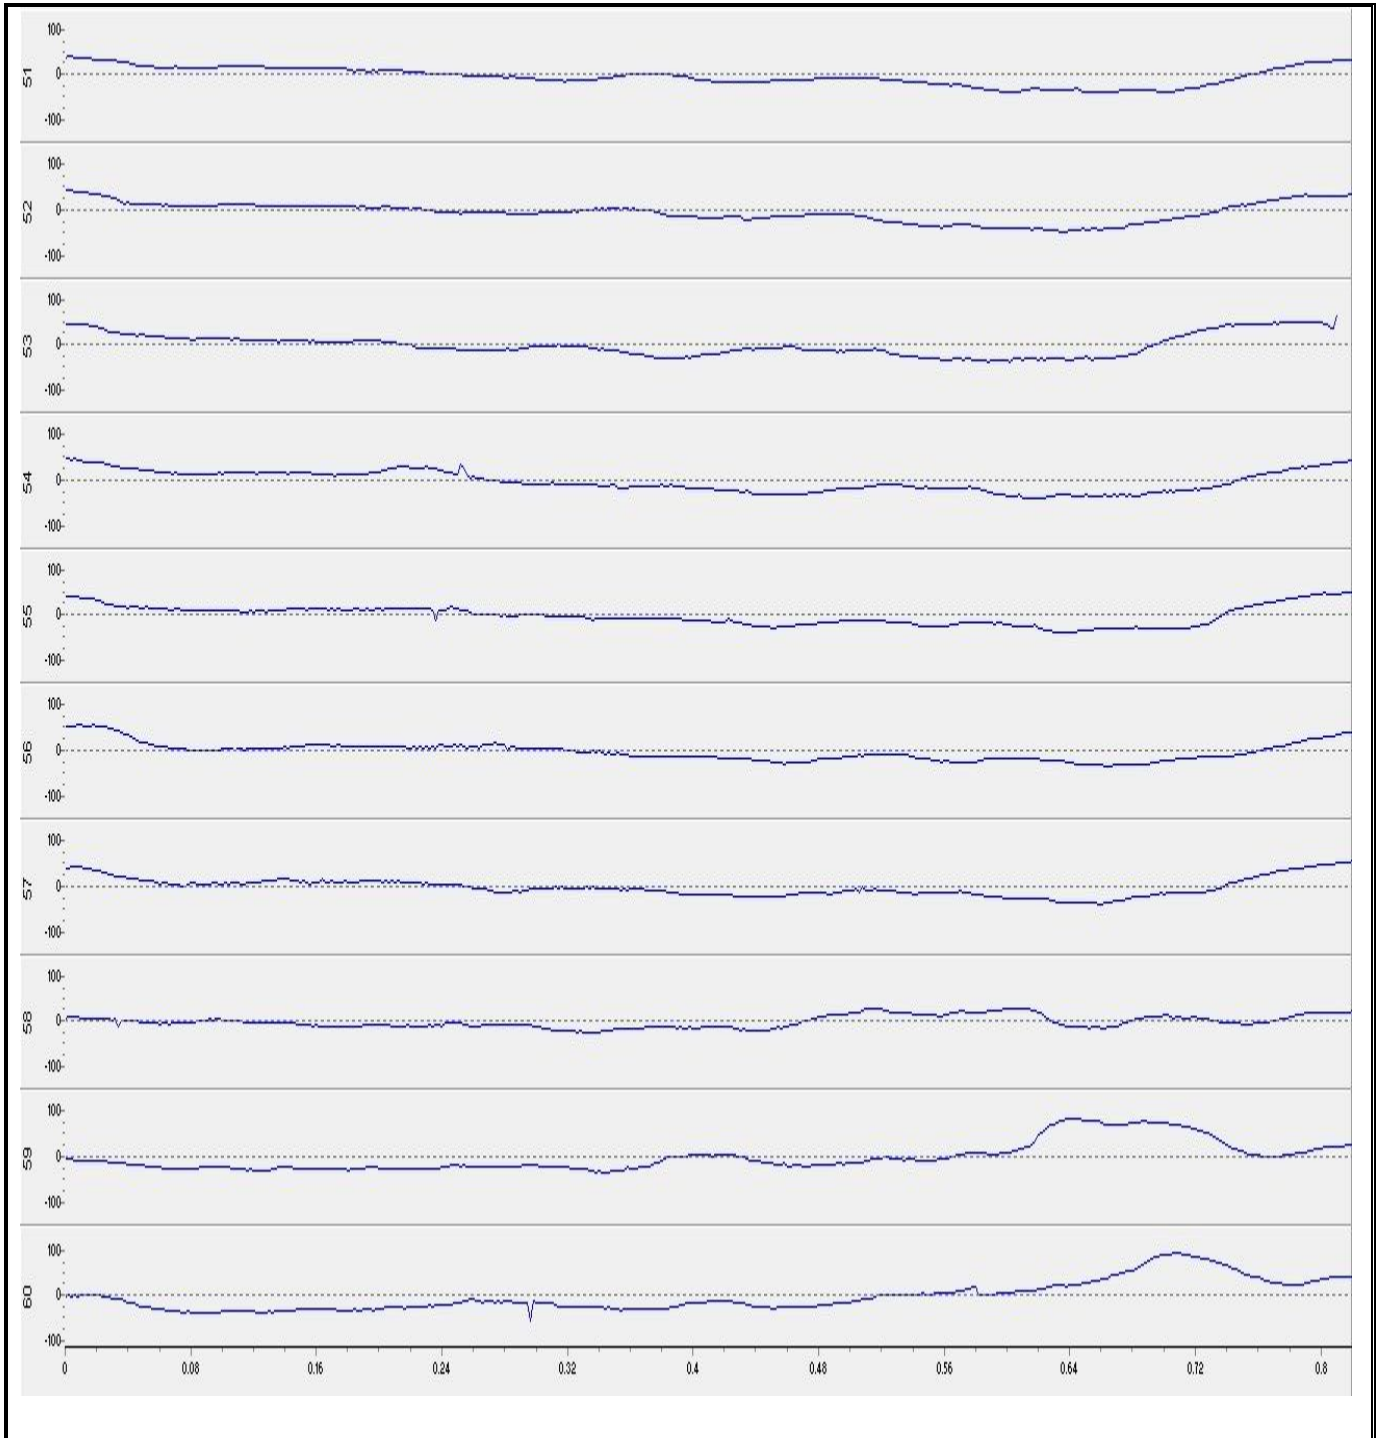
ELCID GRAPHS :

All the 162 slots were scanned for checking of core inter-laminar insulation shorting. Graphs and tables of maximum fault current in each slot is as follows. The graphs indicate values less than **200 mA** in all slots. The fault current values at few locations in various slots as mentioned in table below is observed to be more than 100 mA.

The ELCID test results indicate fault current values less than **200 mA** in all slots. The fault current values at few locations in various slots is observed to be more than 100 mA, these points need to be monitored during next testing and necessary action to be taken as required.

From the detailed assessment conducted, which is as mentioned in **section 2.0**, Stator core assessment indicated excess fault current more than 100 mAs in few locations, **it is recommended to attend this points to remove lamination shorting portions and restoring of insulation between the lamination in this areas.** This core repair can be taken up during rewind process.
